**NATIONAL TRANSPORTATION SAFETY COMMITTEE
REPUBLIC OF INDONESIA**

FINAL
KNKT.15.06.02.03

Marine Safety Investigation Report
Collision between
Panama Registered
Container *LEO PERDANA*
and Indonesia Registered
Gas Tanker *NAVIGATOR ARIES*
Surabaya Western Access Channel, 28 June 2015

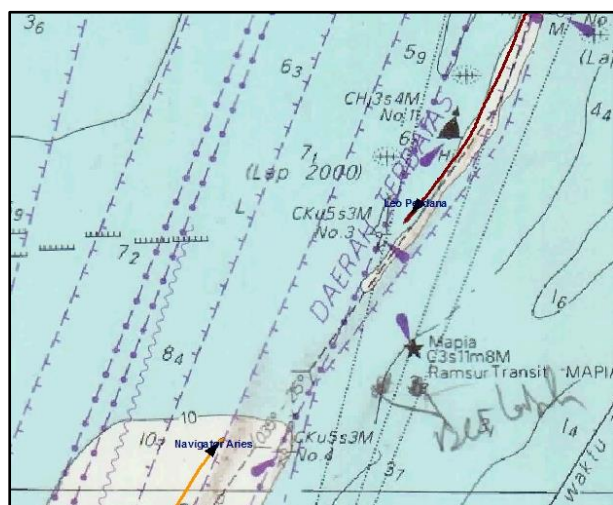
Figure 2: Ships' position at 23.15 LT

At about 23.15 LT, the LP approached the oncoming *Pahala* and *Serasih 2* with green-to-green passing agreement. The head-on passing was successfully done without any issue. Right after passing with the barge, the LP Pilot asked the confirmation to the NA Pilot about the red-to-red passing. The NA Pilot confirmed to stay on the red-to-red passing. Accordingly, both ships gradually steered their headings. The heading and speed of NA and LP were at about 045° T/15 knots and 220° T/14 knots, respectively.

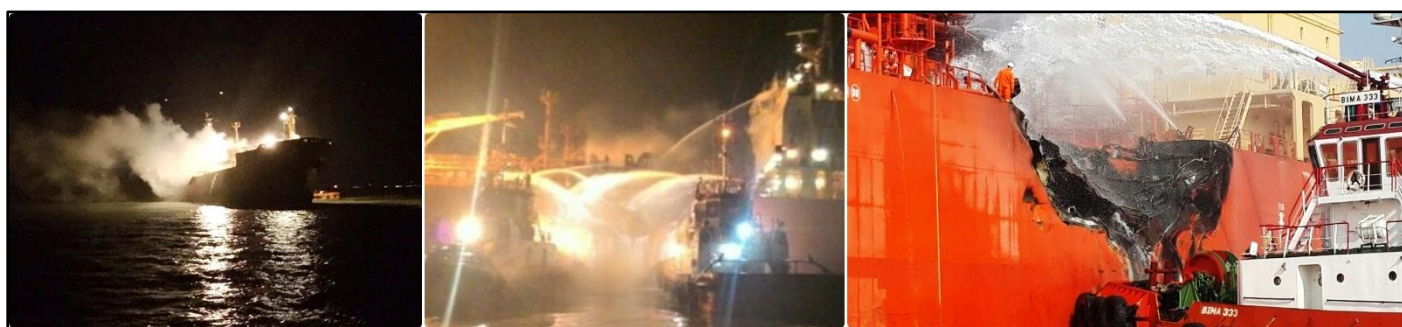
At 23.17.52 LT, the LP's bow hit the NA's port side hull. The accident occurred nearby the Buoy 6 and Karang Jamuang Island. A couple of seconds after the collision, the fire spread on the damaged part of NA. At the time, the LP's stem attached to the NA's hull.

Figure 3: The initial fire on NA (left); and fire extinguishing on NA (middle and right)

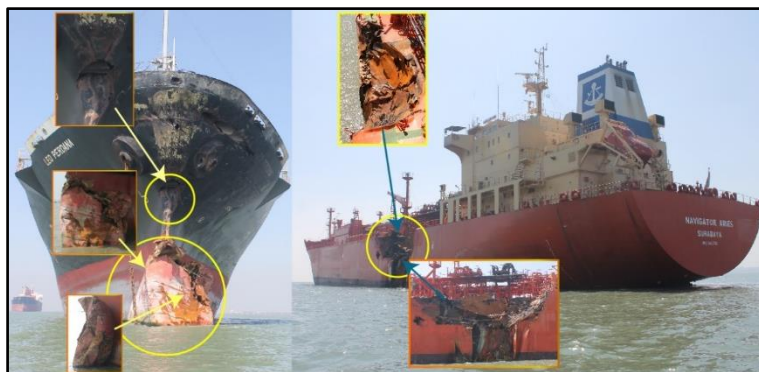
The collision made both ships damaged. The NA had a severe torn and burnt approximately 30 metre square width on her tank no. 4 port side. Whereas, the LP got a serious damage on the bow and stem construction.

Figure 4: The damaged parts on the LP (left) and NA (right)

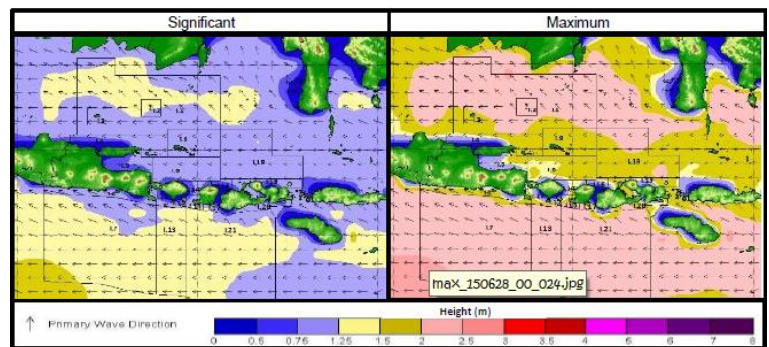
Based on the weather information from the Indonesian Meteorological, Climatological, and Geophysical Agency (*Badan Meteorologi, Klimatologi, dan Geofisika/BMKG*), the wave and wind in the vicinity of the accident spot was normal. The wind speed reported various between 2-24 knots, while the waves were between 0.3-1.3 m.

Figure 5: The marine weather report on 28 June 2015

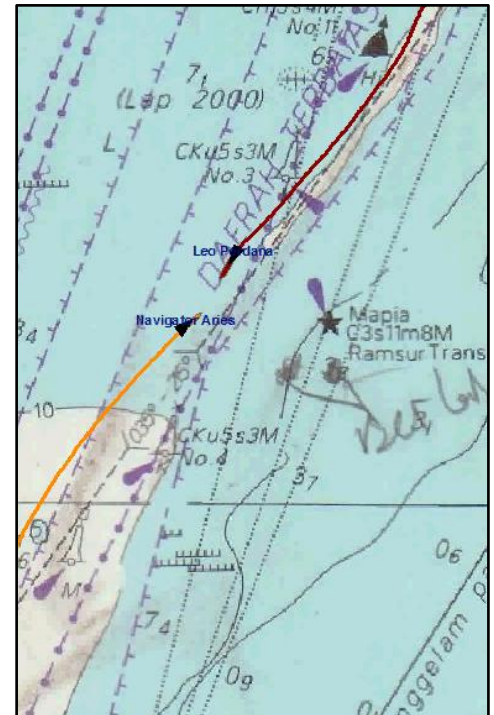
Whilst both ships approaching (NA and LP) each other, none of both pilots maintained their awareness in terms of safe speed and the under-keel clearance. Based on the UKC data on the LP's VDR, the UKC was around 4-5 m prior to the collision. Within one minute towards the collision, the lowest UKC recorded was 1.0 m. This situation supposed to be the main concern of both Pilots to inform the both Masters in reducing the speed, instead of kept going with the speed of around 16 knots. Both Pilots should take into account the uneven seabed related to the safe speed to ensure the safety for both ships, even though the Indonesian nautical chart did not show any message regarding shallow seabed in the vicinity of the collision location.

Figure 6: Both NA and LP were approaching each other

The collision between *Leo Perdana* and *Navigator Aries* in Surabaya Western Access Channel, was due to the lack of situational awareness on both ships. This circumstance, further, allowed the *Leo Perdana's* to elapse the shallow water. In this accident, the investigation team found several findings related to the accident as follows.

1. To set the speed limit in the Surabaya Western Access Channel (APBS).

1. To enhance the role of Pilots in providing information as described in the IMO Resolution A.960, particularly about shallow water and make an early necessary communication.
2. To report any significant uneven depth of the APBS to the Tanjung Perak Harbour Master and Navigational District of Surabaya.
