**NATIONAL TRANSPORTATION SAFETY COMMITTEE
REPUBLIC OF INDONESIA**

FINAL
KNKT.15.11.08.03

Marine Accident Investigation Report
Grounding of Indonesian Passenger Ferry *Sea Prince*
Nongsa Channel
Province of Riau Islands
Republic of Indonesia
29 November 2015

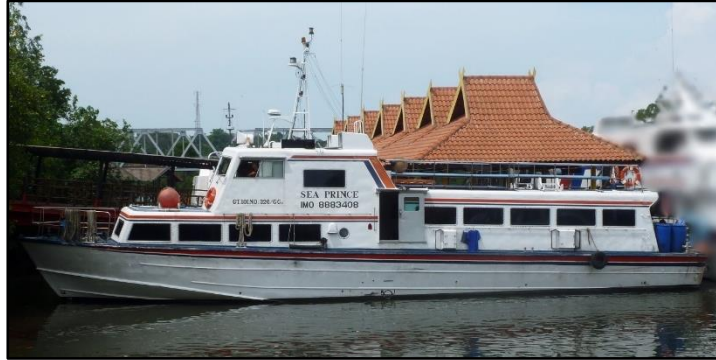
Figure 2: Sea Prince at NFT after the accident

There was no serious injury or pollution reported as a result of the incident. Sea Prince sustained material damage and was deemed unfit to continue on passage.

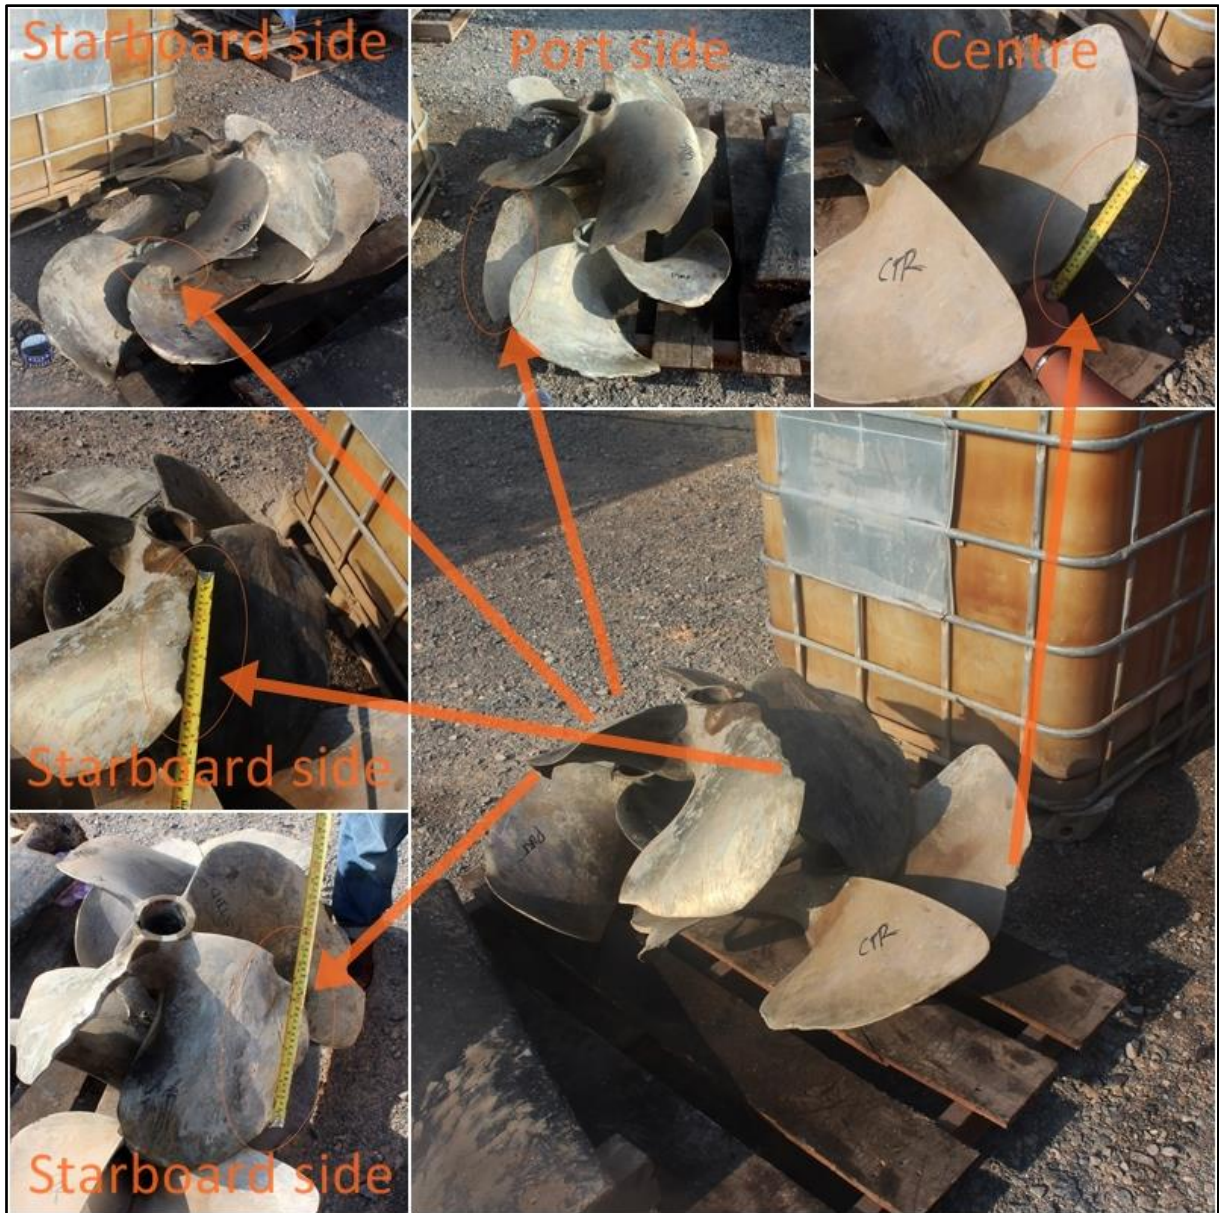
Figure 3: The damages on her propellers

All of the Sea Prince's propellers were broken. However, her starboard propeller had the most damage compared to the other. All blades of starboard propeller torn and dented as seen on Figure 3.

- Strong impact from vessel's forward movements with an obstruction, possibly hard sea-bed, caused first grounding and damages to starboard propeller and starboard rudder blade;
- Damaged starboard propeller caused the starboard engine to be immobilised;
- Damaged rudder blade appeared bend upward, with the trailing edge cutting into the bottom hull plating before falling into the sea – caused flooding inside the steering gear room; and

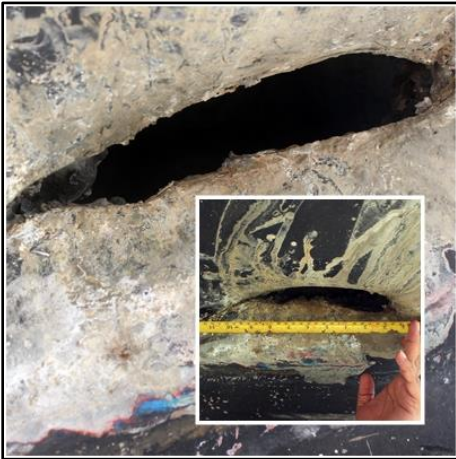
Figure 4: A Torn on the bottom plate

The starboard side bottom plate of Sea Prince was torn nearly 30 cm. This damage allowed sea water to ingres into the engine room. To stop sea water, the crew had poured mix of concrete onto the hole. This method successfully stopped water made further damage to the ship.

Compared to size and shape of rudder, the hole on the bottom plate was similar to the rudder. Although at this case the starboard rudder was missing, all rudders are identic.

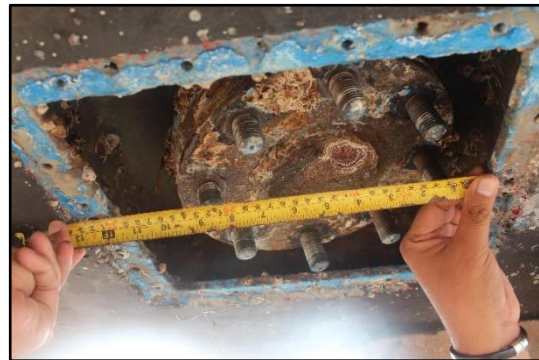
Figure 5: Dented rudder shaft

In addition, the rudder shaft was dented towards the aft.

Despite all 8 bolts on the rudder shaft were not deformed, the angle of the shaft was unsafe for the surrounding plates. At this situation, the new rudder cannot be installed directly onto the rudder shaft, unless the shaft has been adjusted to the desired angle.

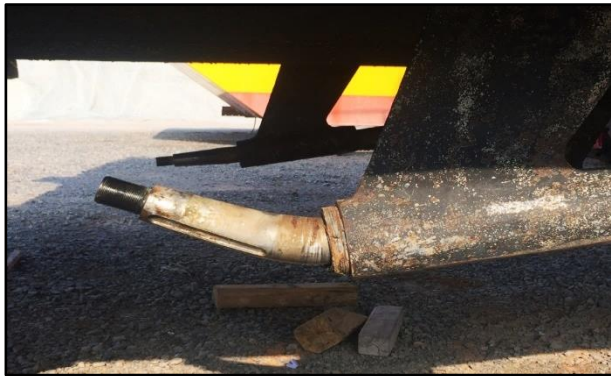
Figure 6: Bended Rudder Post after grounding

The starboard side propeller shaft had serious damage in which it was dented towards up as in the Figure 6. There was no other damage on the other propeller shafts.

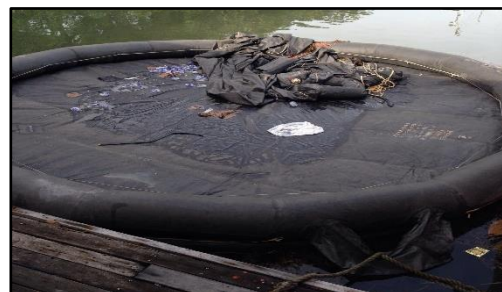
Figure 7: Unfloated ILR

As mentioned in the chronology, on einflatable liferaft failed to maintain its air pressure. As a consequence, the roof and other parts collapsed to big circle flat as can be seen on Figure 7.

Inspection of liferaft B, in deflated condition, showed the raft separated and detached into three different sections, i.e. the top buoyancy unit, bottom buoyancy unit and floor unit.

Additionally, there was evidence of broken one-way safety valve tube from its assembly unit i.e. both tubes were ripped off at the base (hardened glue compound) connected to the buoyancy unit – thus, the sudden loss of air.

However, due to inherent defect in the one-way safety tube to buoyancy unit connection, which could otherwise be identified during inspections, had caused total failure in the liferaft buoyancy unit, where the tube was ripped off from its based glue compound (refer to diagram)
