KOMITE NASIONAL KESELAMATAN TRANSPORTASI
REPUBLIC of INDONESIA

Marine casualty investigation report

Grounding of *HANJIN AQUA*

At Terumbu Koliot, Sunda Strait, Merak

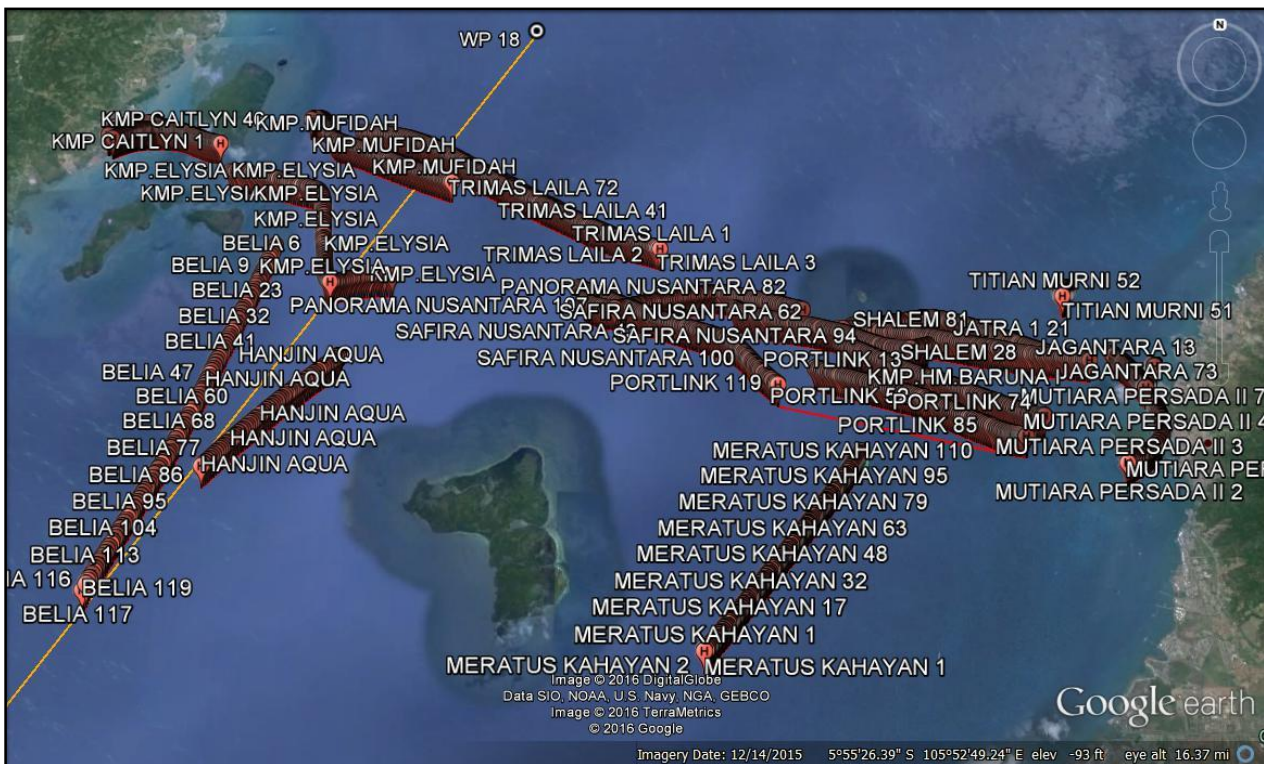
At about 19.00, the master had noticed from distant there were ferries crossing consecutively west bound (from Merak to Bakauheni), and also south bound vessel. While approaching to the ferries passage lane, the helmsman on duty was ready on the steering stand with mode switch to hand. The master was made steering adjustment by degrees to starboard.

Figure 1: Strait Traffic situation while Hanjin Aqua passing

At 19.16, the ship course was 043° (T) with speed 12.6 knots. The master ordered to steer to 050° in order to clear from the ferry traffic. Meanwhile the third officer was plotted the ship position and the master continuous observed the traffic visually. The third officer was operating radar no.1 (port) and the master standing on forward starboard side.

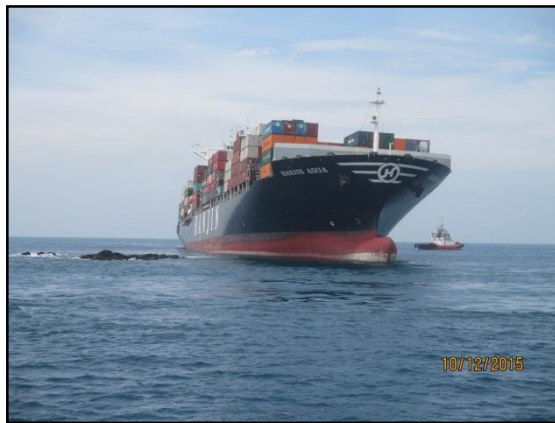
Figure 2: Ship condition when grounding

At 19.26, the ship speed rapidly decreased and seconds later the ship was stopped. The third officer spontaneously pulled the engine telegraph to stop.

After check thoroughly, it was known that the Hanjin Aqua had run aground on rocky shallow terumbu Koliot in position 5° 55.3'S - 105° 48.8'E, about 1.8 nautical miles North West off the Sangiang Island. As a result of aground the ship was listed to port side by three degrees.

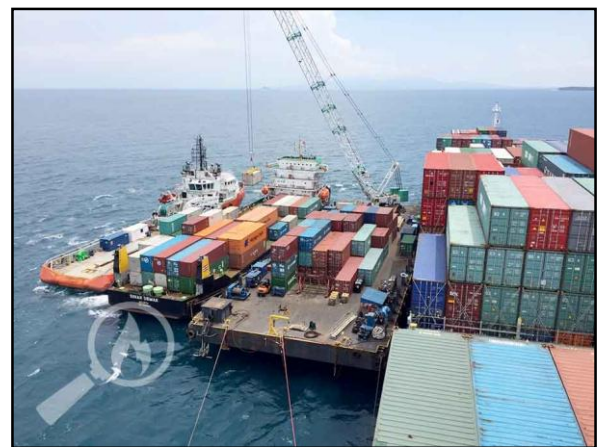
The Salvors has successfully pulled the Hanjin Aqua off the rocky shallows on 6 January 2016, after some containers were discharged to a barge to lighten the load.

Figure 3: Hanjin Aqua transfer containers to barge

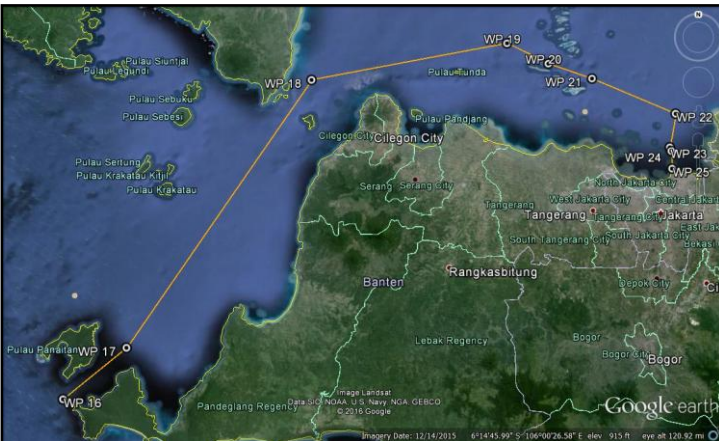
Figure 5: Hanjin Aqua passage plan

At the chart it contains the following warning 'Mariners are warned that ferries cross Sunda strait between Bakauheni (5° 52'S - 105° 45'E) in Sumatera and ports on the north coast of Java'. It was notice that 'No Go Areas' been drawn on the chart to alert the deck officers that the ship suppose not to exceed that area. Athwart distance from the course line to terumbu Koliot approximately 0.8 nm.

As per passage plan from way point (WP) 17 to way point 18 the ship transit Sunda strait, true course 033.3°, distant 55.4 nm, under keel clearance (UKC) 30 m, position fixing method: primary GPS secondary Radar and position interval 30 minutes.

In the passage plan states that from WP 17 to WP 18, GPS as primary position fixing method and radar as secondary method. When the ship is navigating in sight of a coast line, the officer on watch should fix the ship position by taking bearing and distant of conspicuous shore object using radar as primary method, and secondary would be GPS.

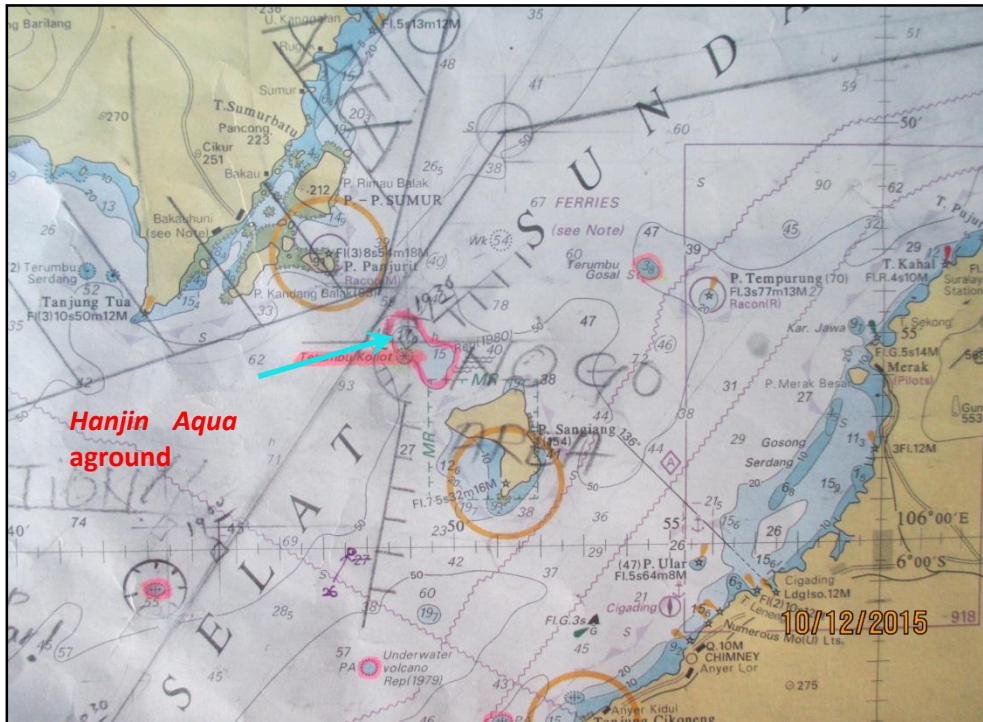
Figure 6: 'No Go Areas' drawn on the chart

KNKT investigation found that the ship positions were not effectively monitored when navigating close to rocky shallow water notwithstanding the bridge officer was aware of it and boundaries line of 'No Go Area' was made. Focus of each bridge personnel was distracted when encounter ferries crossing traffic. The ship keep move toward the terumbu Koliot unwittingly by the bridge personnel, and subsequently the ship went aground.

- To provide visual or electronic aid to navigation at the terumbu Koliot location in order to make coastal navigation safer and help prevent loss of life and marine pollution that could result from stranded ship.
