**KOMITE NASIONAL KESELAMATAN TRANSPORTASI  
REPUBLIC OF INDONESIA**

**Marine Safety Investigation Report**

**Fatality onboard Bahamian Registered Bulk Carrier GLOVIS MAPLE**

**4 April 2016**

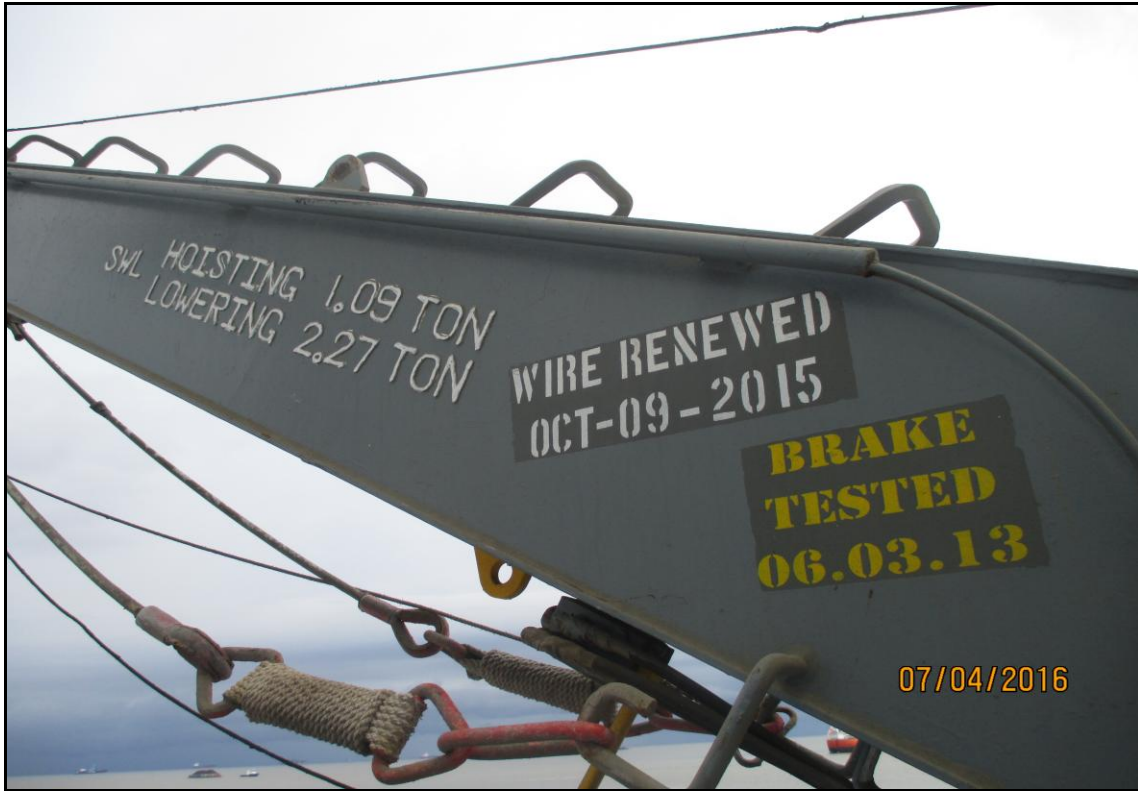
After 30 months of service the initial fall wire had been replaced with the spare wire. The replacement was performed on 9 October 2015 as stencilled on the davit.

Figure I-14: Davit marked with the last wire replacement

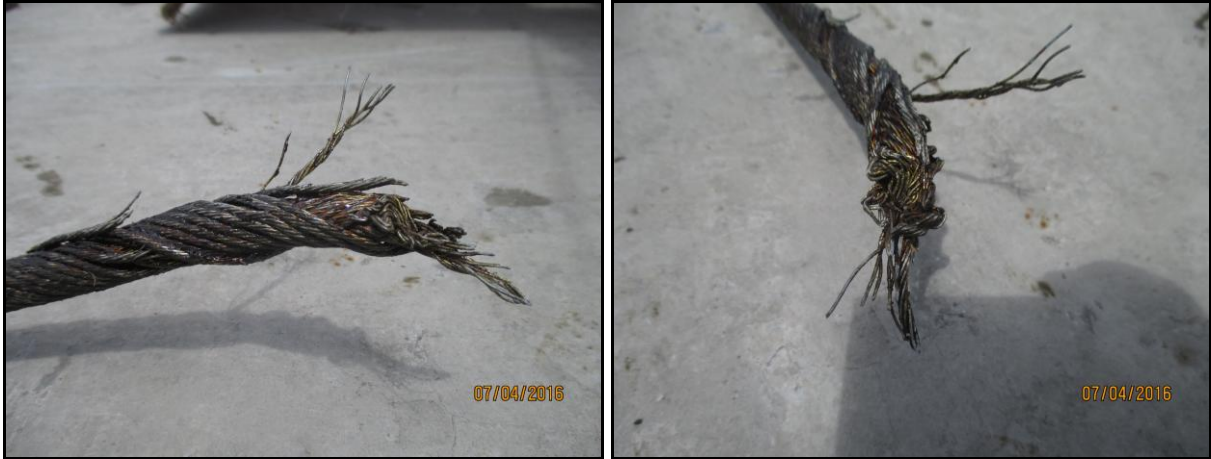
The fall wire was measured and found to have failed at about 6.15 metres from outboard end of the rescue boat. The failure point was approximately slight below the top sheave. The rescue boat had been installed when the ship was on the shipyard. Prior to the ship delivery, the shipyard had supplied a coil of wire rope for spare. Reportedly the spare wire rope came with the same diameter and specifications as the installed one.

*Figure I-15: The failed wire at the hook side (outboard)*

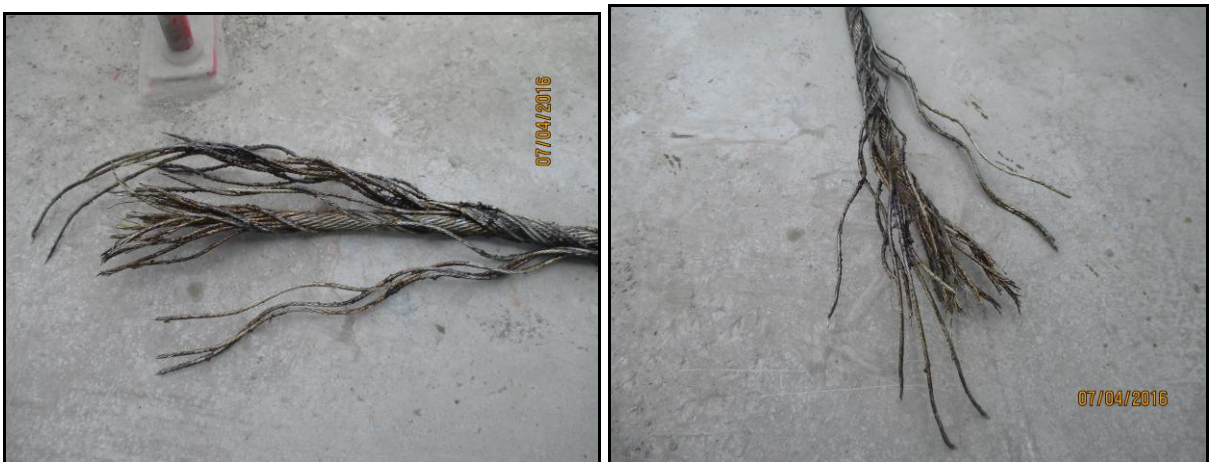
*Figure I-16: The failed wire at the winch side (inboard)*

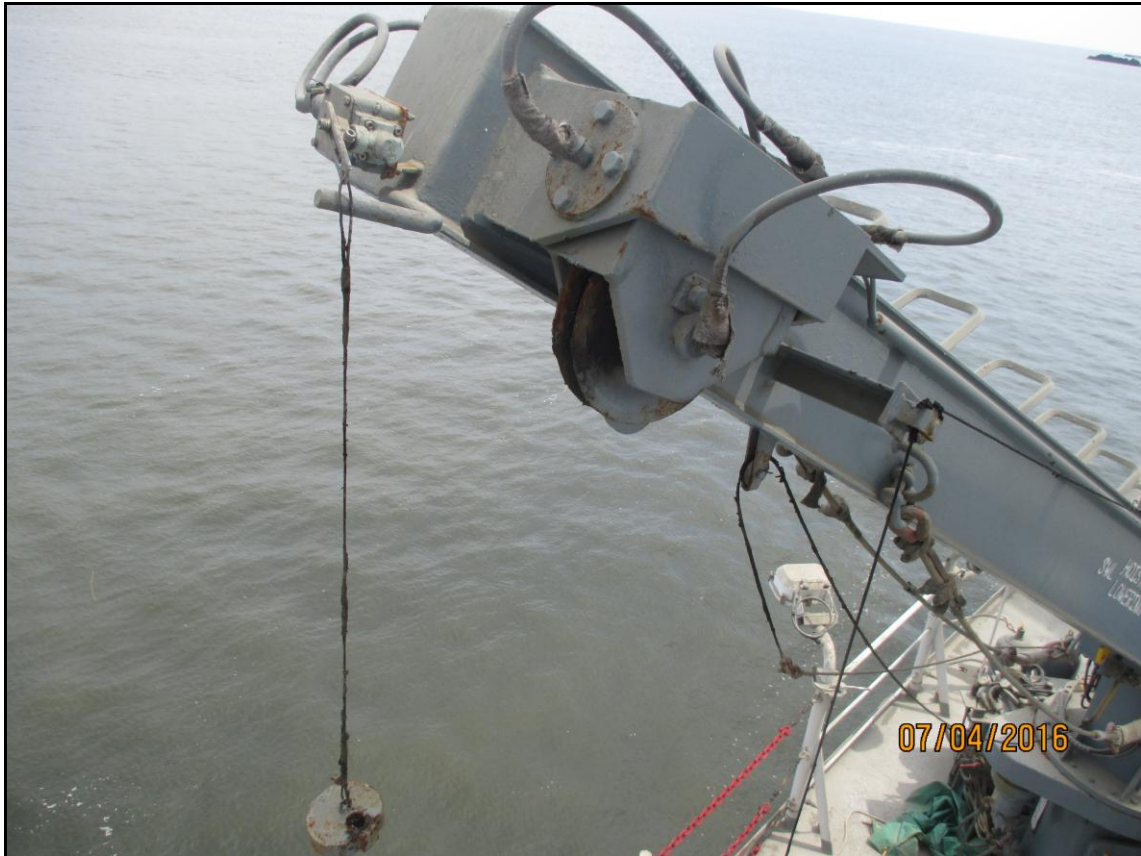
The davit system was equipped with a hoist limit switch and a slewing switch. The rescue boat hoist limit switch was intended to stop the winch motor just before the load block reaches the top sheave. The load block was connected to the quick release hook. It was reported that the limit switch was tested and in working condition. However, it was not tested prior to launch the rescue boat on that day.

**Figure I-17: Hoist limit switch**

- The KNKT recommends that the ship owner to consider enhance the senior officer role in supervise the junior officer works of maintaining the Lifeboats and Rescue boat Davits in the Planned Maintenance System.
- Furthermore it is prudent could adopt the guidelines from the MSC Circular.1206/Revision.1 to the ship procedures when performing drills with persons on board the boat.
- The KNKT recommends that the master to lower and raise the unmanned rescue boat to ensure that the boat arrangement are functions correctly before allowing operating crewmembers boarded the boat.
- Always test the function of davit limit switch prior to launch the rescue boat.

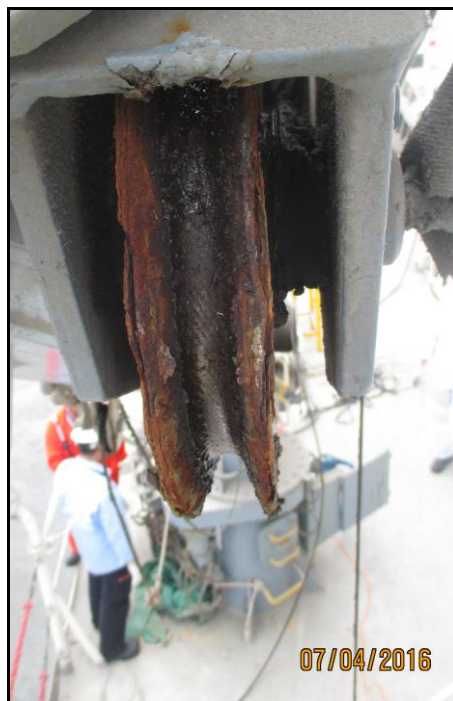
The top sheave cheek plate show corroded and have slight dented. There was a spot of rust on the upper housing of the top sheave. It seems when the counterweight travel up it might touched the upper housing.

**Figure I-18: Top sheave condition**

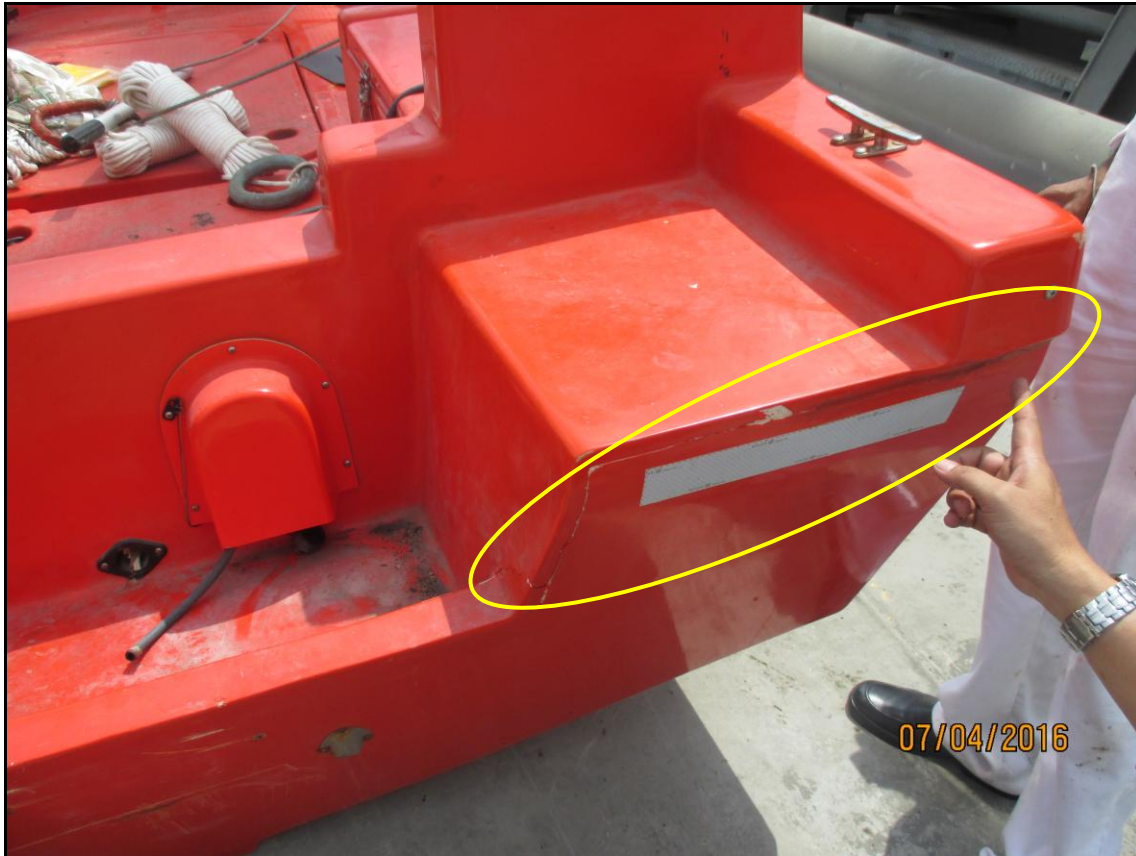
The rescue boat was laid up on the upper deck port side. It seems that there was no major damage due to impact on the rescue boat hull. There was line of cracks sighted on the boat starboard stern, however it was unsure whether the cracks due to impact or it already there beforehand.

Figure I-20: Cracks on starboard stern

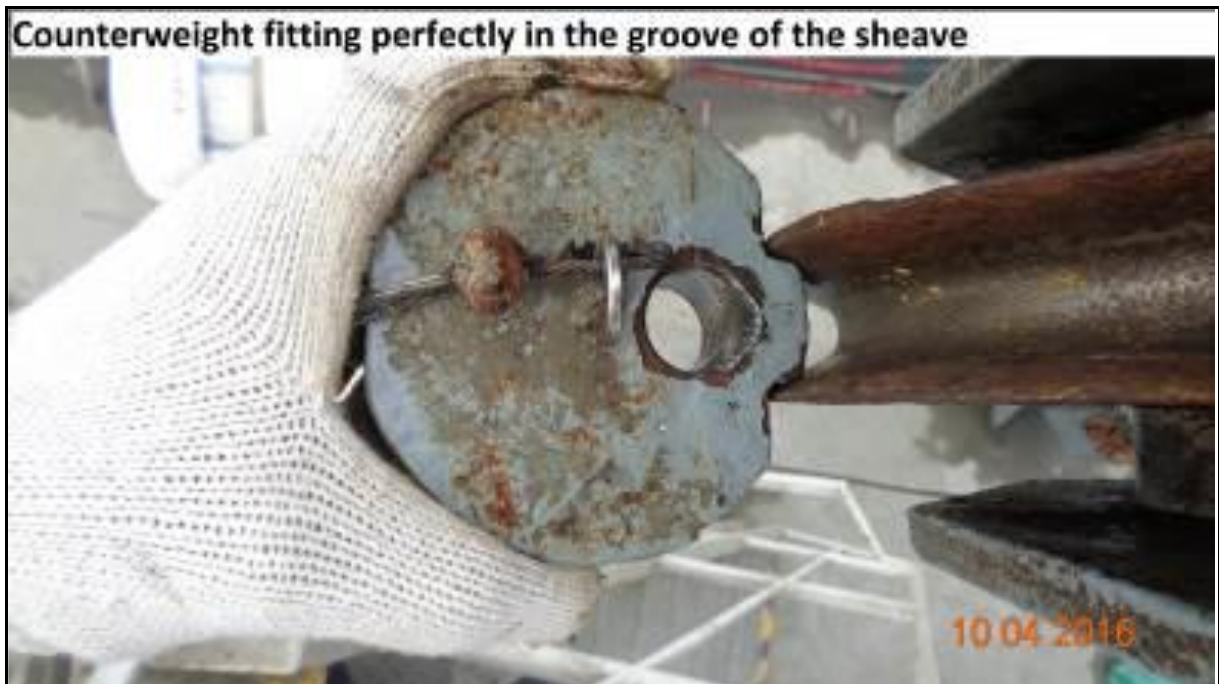
In compliance with the ISM Code, the ship owner carried out their own investigation to investigate the accident. There was possibility the fall wire became trapped by the limit switch counterweight and then cut has been proposed by the ship owner QHSE superintendent. It was evident that the limit switch counterweight eroded on the outer edge which was fit in the groove of the top sheave and it showed deep marks of wire scratch on the hole. *TTI Testing Ltd* point out that the counterweight has evidence of high transverse loads scraping across the inside of the diameter 20 mm hole. The combination of abrasion, transverse loading and tension through the hole in the counterweight cut the outer layer of strands and progressively led to failure of the inner strands.

Figure II-1: Limit switch counterweight eroded (picture taken from company investigation report)

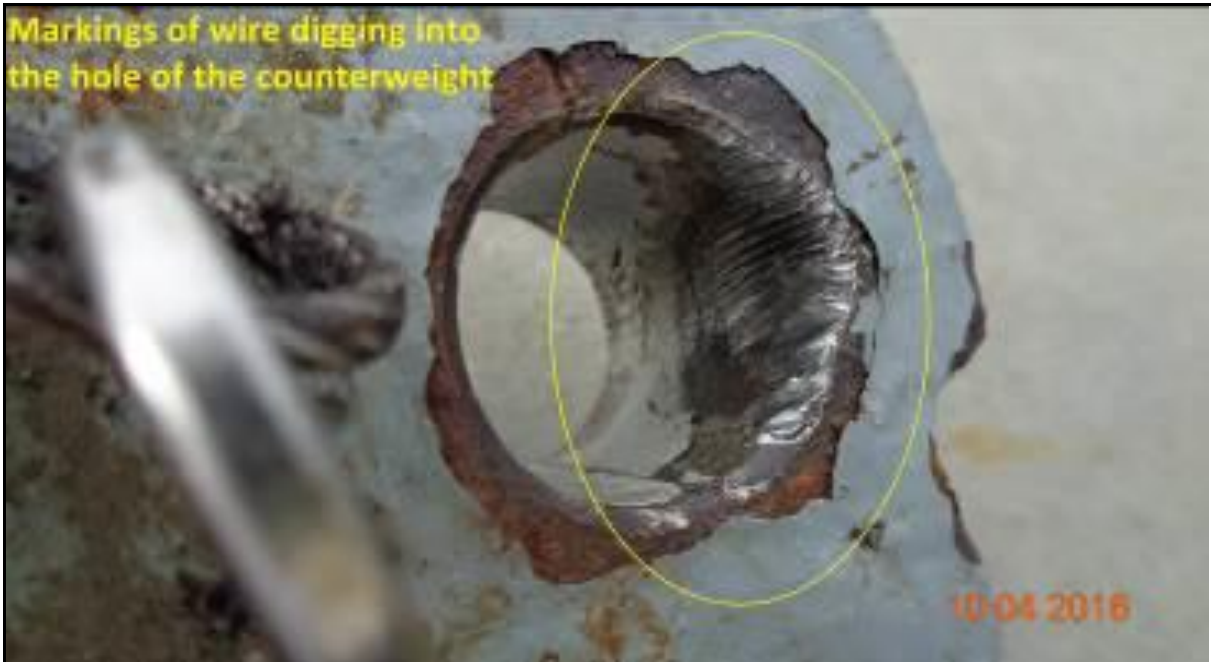
*Figure II-2: Condition of the counterweight hole (picture taken from company investigation report)*

The limit switch for automatic shutdown of the winch motor was not functioning. Even though it was uncertain but there was strong suspicion that the counterweight of the limit switch moved up along with the fall wire then it trapped against the top sheave. And a meanwhile the small wire which was attached to the counterweight without intention was looped over the L-shaped pin, it cause preventing the limit switch to become active.

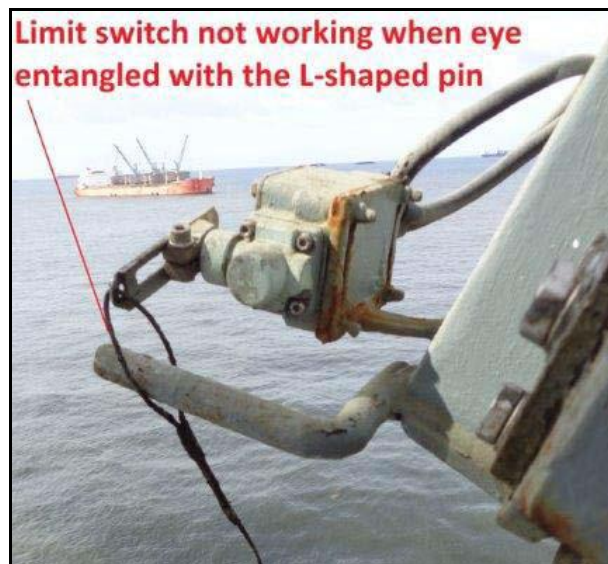
*Figure II-3: Eye string entangled with the L-shaped pin (picture taken from company investigation report)*

Subsequently the fall wire was getting pinched in between the upper of sheave housing and the top sheave as the davit winch continued hoisting. It could have been produce an excessive strain to cut the fall wire.

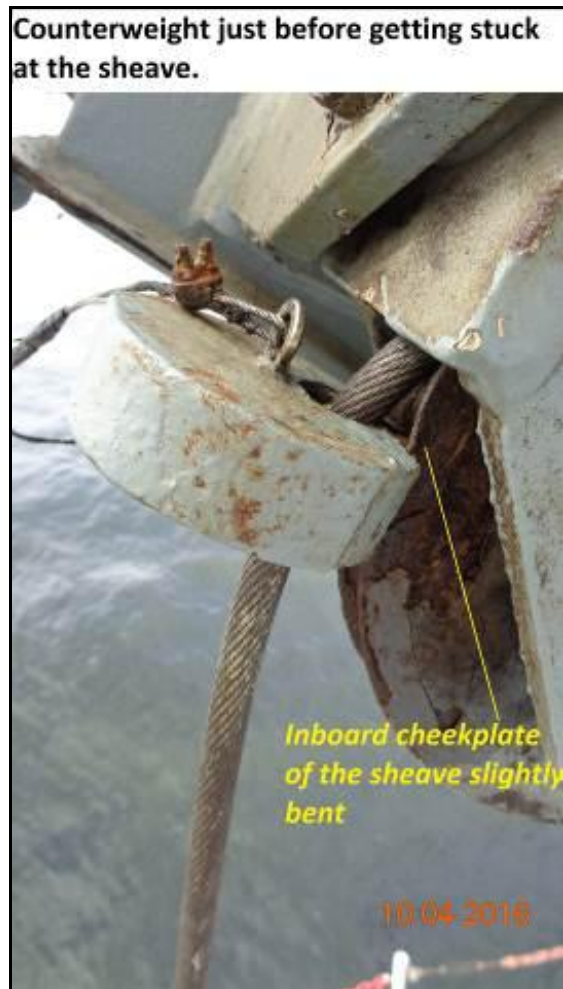
The fall wire has been applied with lubricant oil 'Ceran AD Plus', it was not included in the list of recommendation of lubrication oil as per manual book from the maker. However, it appropriate for the purpose. The lubricant oil has a nature of good adhesion to metal and it

prone to be sticky if the equipment was not cleaned. It could be the reason of how the limit switch counterweight travel up along with the wire while heave in.

Figure II-4: Counterweight trapped against the top sheave (picture taken from company investigation report)

Lowering and hoisting the manned rescue boat when performing a drill can be a potential risk. The limit switch counterweight was unconsciously able to move up along with the fall wire then it trapped against the top sheave. The fall wire was getting pinched in between the upper housing and the top sheave. This condition was a contributing factor for the accident. The failure was facilitated by non-functioning limit switch on the davit system.
