KOMITE NASIONAL KESELAMATAN TRANSPORTASI
REPUBLIC of INDONESIA

FINAL
KNKT-17-12-34-03

Marine casualty investigation report

Fatality on board Singapore registered coal barge

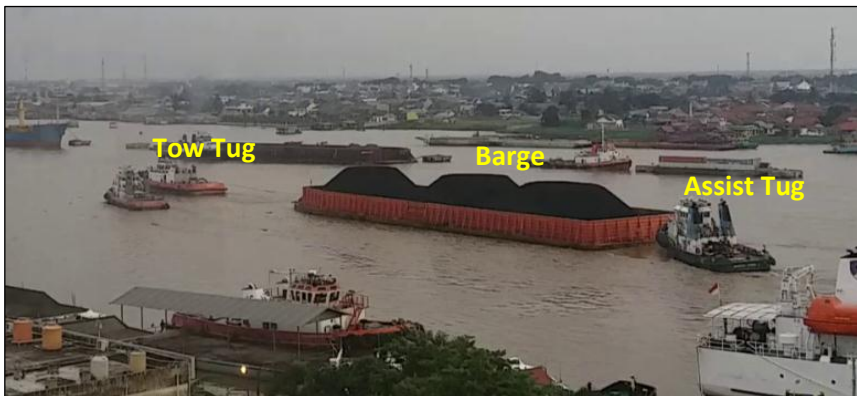
Figure 2: typical towing company configuration

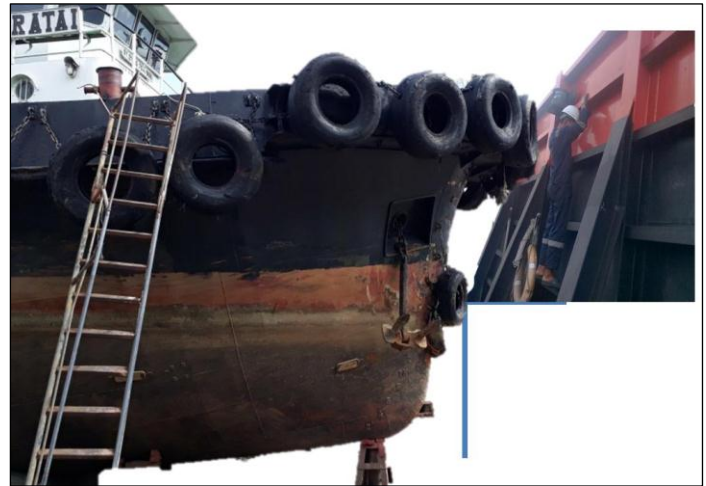
Having released the starboard mooring line, AB-2 climbed over the after end sideboard, in order to move to the *Teratai*. While climbing around the beam, he was facing forward. At about the same time, the *Teratai* came close to the afterend sideboard where the AB-2 still climbing the sideboard (inward). The master of *Teratai* glanced someone’s head which appeared suddenly between the bow tyre fenders and the barge vertical beams. He then quickly reversed the engines by pulling both throttles full astern. Unfortunately, the bow’s fenders tyre of *Teratai* struck AB-2’s back. AB-2 shouted in pain and was heard by the *Teratai* ABs. The *Teratai*’s master reduced the ships speed and saw that AB-2 had attempted to climb over the *Teratai* tyre fender. Two *Teratai* ABs assisted AB-2 and put him down on *Teratai*’s bow deck. *Teratai*’s AB asked AB-2 about his condition and he replied that his chest was in deep pain. After remove the portside mooring line, 2nd officer and AB-1 also rushed to *Teratai* and enquired after AB-2.

Figure 3: reconstruction of event, possible position of the deceased AB while he attempted to climb over the afterend sideboard

The fatal accident of the AB of *Surya Wira 21* occurred while he was attempting to move to the assist tug by climbing over the barge's after end sideboard. The impact to the back of AB-2 resulted in deep pain and presumably damage to his internal organs.

- To establish a procedure of boat transfer for personnel focusing on risk assessment and safety precaution
- Enhancing implementation of safe working practice for mooring and unmooring operation, in particular, for transferring of personnel between vessels and barges
- Providing the crew with proper safe working clothes such high visibility vest
- Re current the crew proficiency in providing first aid treatment

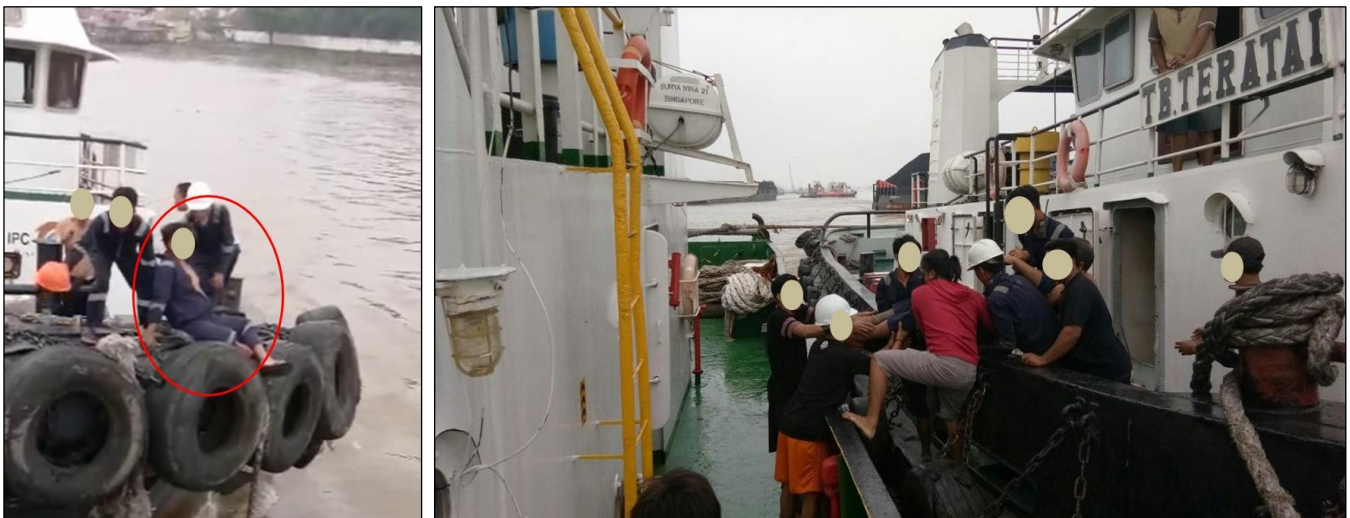
Figure 4: left: position of AB-2 onboard Teratai after the incident. Right: transferring the injured man

With regard to the transferring the injured crew member from the assist tug to the other tug, the investigation found that the action might have worsened the crew members condition. Deep chest pain indicated there was something wrong inside AB-2's body. All life supporting internal organs such as lungs, and heart located inside the chest. Therefore carrying an injured crew member should be done in an extra cautious manner by using proper transport means such as stretcher and applying securing line. Immobilisation of the body should be in place to prevent further damaged.

- Ensure that crews are maintained as current in proficiency in providing first aid treatment
- Review the barge crew transfer process by service and/ or assist tug

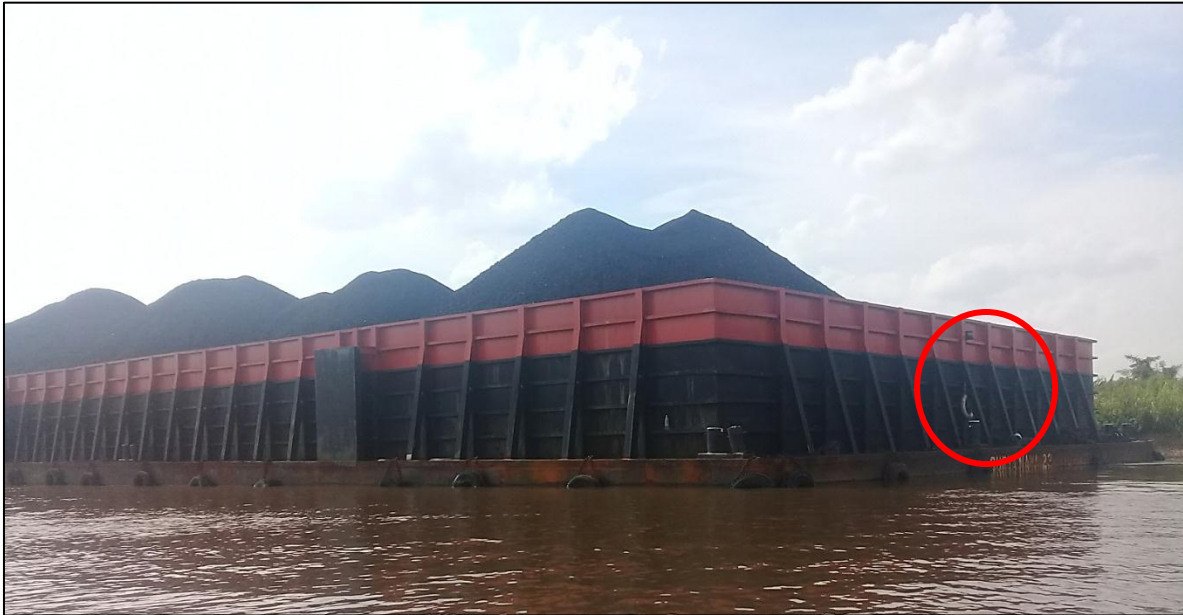
Figure 5: afterend view of *Surya Nawa 23*. Red circle indicating location of AB-2 when the accident happened

At that time of the accident, AB-2 was wearing dark blue overalls the same as other *Surya Nawa 21* crew members. It seems that the overalls were difficult to discern with black painted sideboard of the barge. This might lead to workers movement going unnoticed by the assist tug. The utilization of high visibility vests which has a colour that is easily discernible could enhance all parties' awareness during operations.

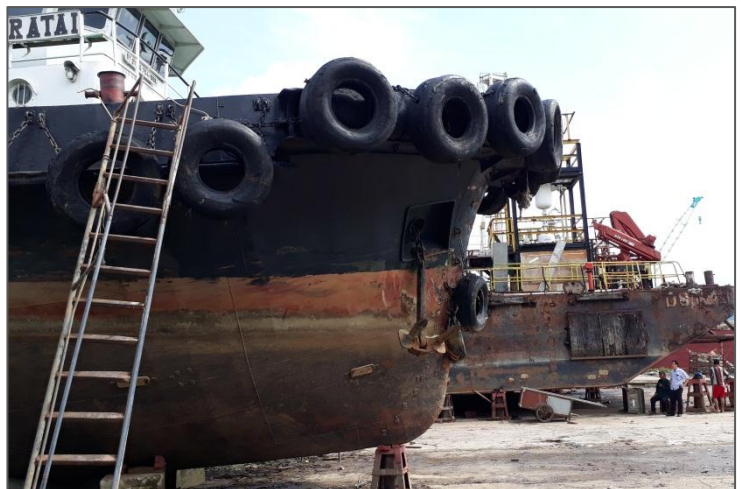
Figure 6: bow shape of *Teratai*

Regardless of no clear information from AB-2 about why he climbed over the sideboard, it is fair to mention that there was no collective safe action to maintain a safe operation among the towing parties. There was no clear information provided by AB-2 to attract attention from the *Teratai* so the master could take sufficient action while tendering the barge. On the other hand, Barge *Surya Nawa 23* was loaded with 7098.922 tons of coal. This created the barge in 'full and down' condition. On the barge after end the freeboard is about 50 cm, whilst the bow of *Teratai* is 'bow-up' as is typical of harbour tugs. The visibility from the *Teratai* conning position has a wide blind spot at a close distance.
