**NATIONAL TRANSPORTATION SAFETY COMMITTEE
REPUBLIC OF INDONESIA**

FINAL
KNKT.18.03.09.03

Marine Accident Investigation Report

**Pipeline Damage and Crude Oil Pollution in Balikpapan Bay
Balikpapan, East Kalimantan
Republic of Indonesia
30 March 2018**

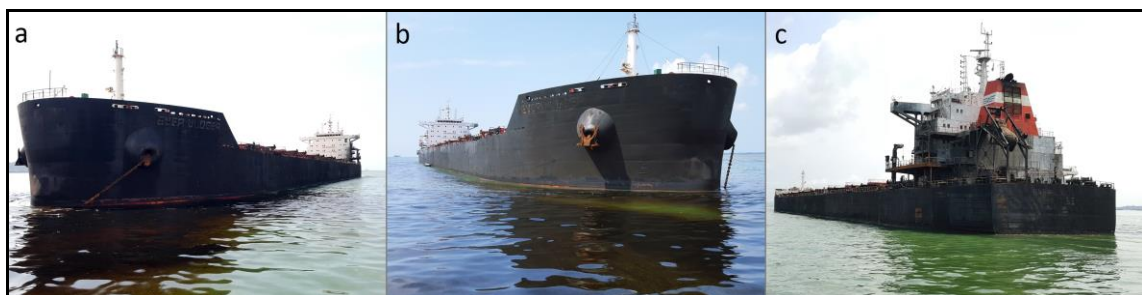
There were three ships impacted by the fire blast on 31 March 2018, namely the Bulk Carrier *Ever Judger* and two wooden vessels. In general, the *Ever Judger* suffered burnt and sooted, particularly on her port side. Her port side was worse than her starboard side because the fire on her port side was much bigger than on another side. Her appliances which made of plastic, composite, aluminium and glass were wrecked and shattered. For example, aft mooring line, lifeboat, portside accommodation ladder, severely burnt, even most of the part became ash. Her port side wall, windows, lights, hydrant hoses, and crane were partially destroyed. Her surrounding hull was smoked black. In addition, the fire and smoke reached the top of the ship's mast on the forecastle deck and port side bridge roof.

Figure I-7: The sooted hull of *Ever Judger* on P/S of her bow (a), S/B of her bow (b) and P/S of her aft

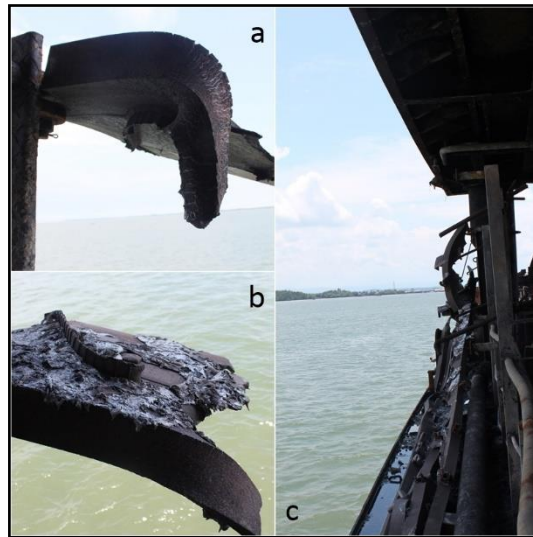
Figure I-8: The burnt port side ladder

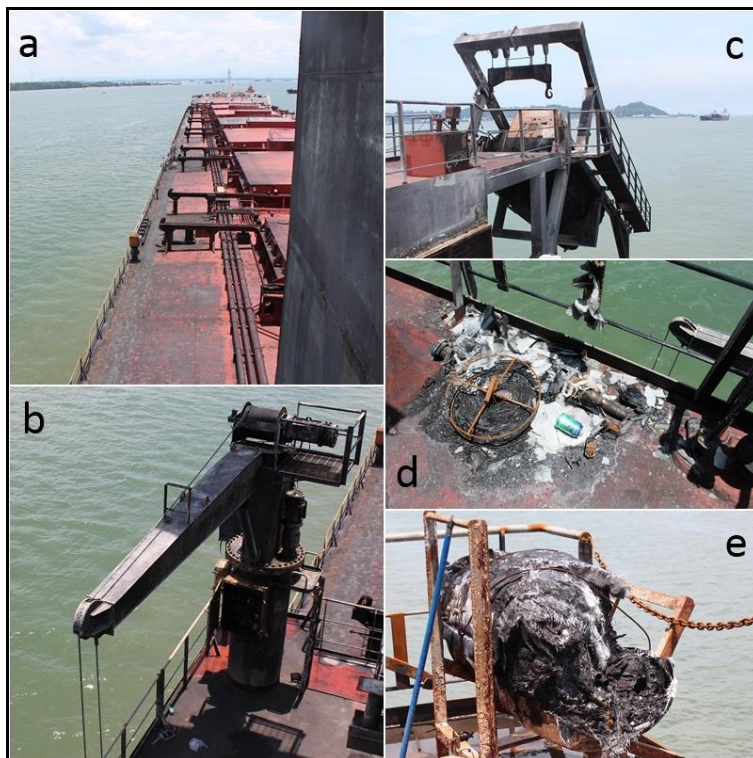
Figure I-9: a) Sooted on port side deck; b) sooted on her crane; c) the burnt lifeboat; d) the burnt fire hydrant hose; e) one of the burnt inflatable life rafts

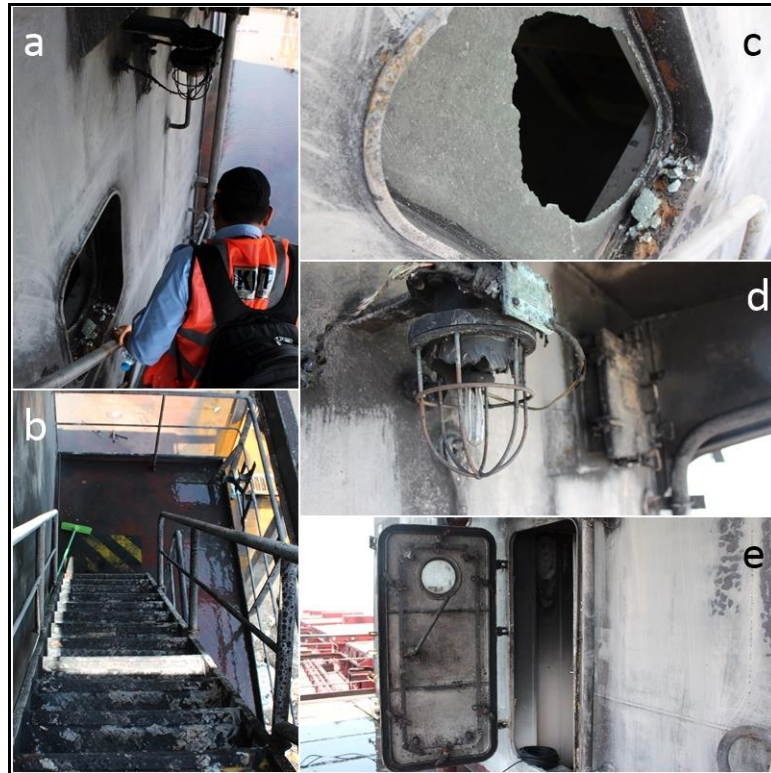
Figure I-10: a) One of the KNKT team members whilst on board; b) the sooted port side ladder; c) broken window; d) broken light; e) the sooted door

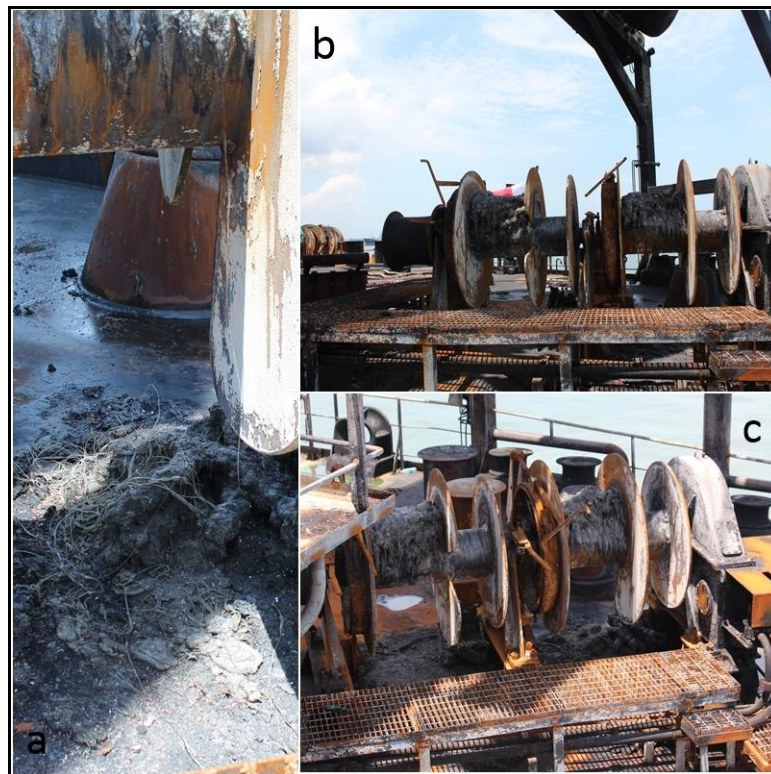
Figure I-11: The burnt windlass on aft port side

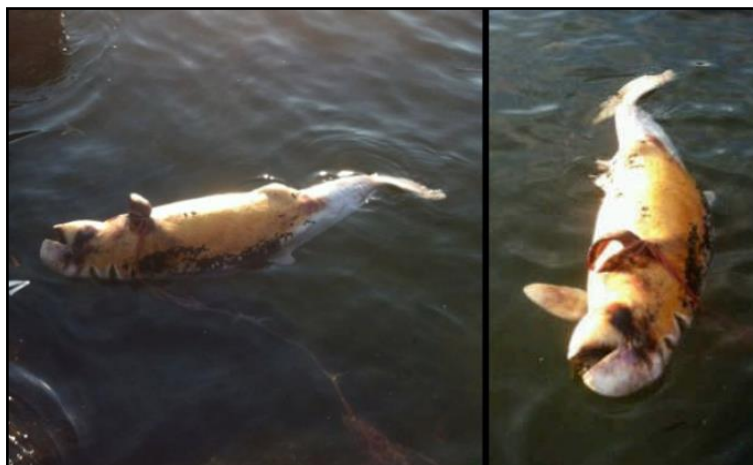
Figure I-13: The death of a Dugong in Balikpapan beach because of oil pollution

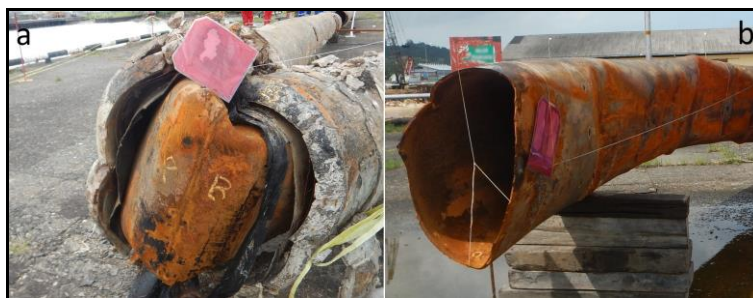
The 20-inch pipe was cut into two parts in the depth of approximately 20-22 m below the sea surface. One of them was folded with V-shape.

Figure I-16: a) A folded; and b) bent and cut subsea 20-inch pipe

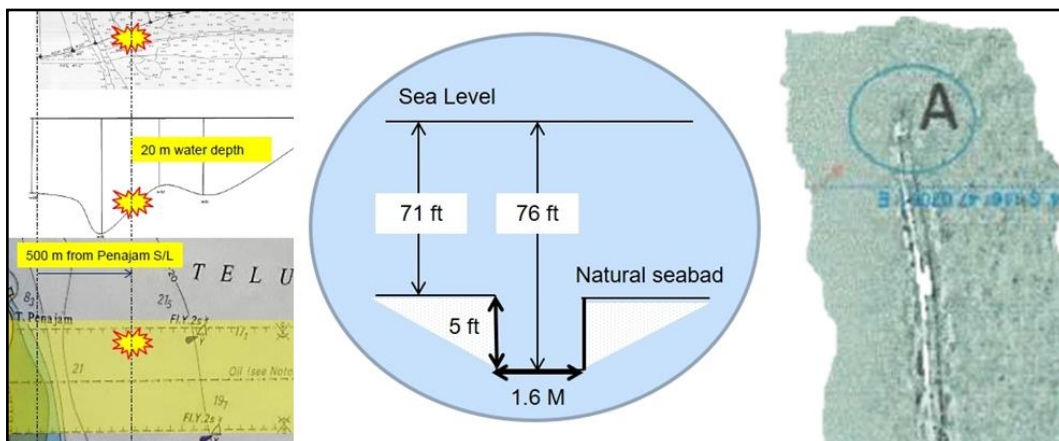
Based on the underwater survey, held by the Pertamina, there was an anchor scar with the approximate depth of 1.5, width of 1.6 and length of 1,000 m. This scar was matched with the location where *Ever Judger's* anchor was dropped and heaved up as well as the *Ever Judger's* anchor size.

Figure I-17: Side Scan Sonar Imagery (source: Pertamina RU V)

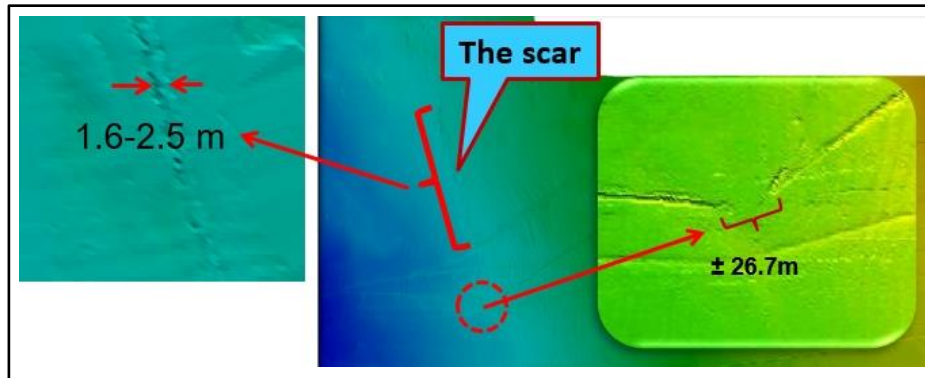
The post-leak survey by the Indonesian Navy (TNI AL) also confirmed this finding. The Multibeam Echosounder caught the scar and wreck of the cut pipe. Then both edges were

separated by more than 25 m away. The location of the damaged pipe was shifted about 120 m from its original location (see Figure I-31).

Figure I-18: Multibeam echosounder image (source: TNI AL)

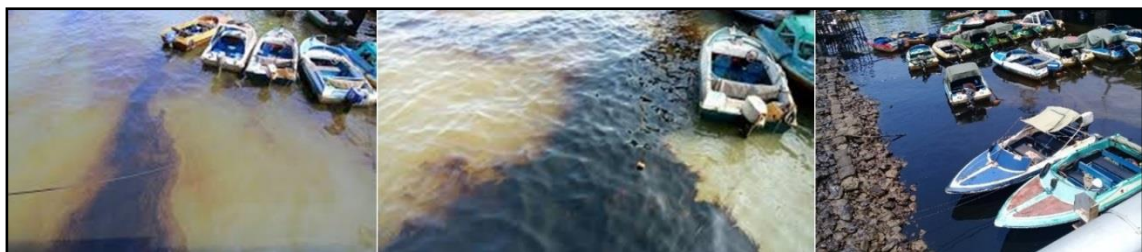
Figure I-19: Pollution impact on the fishermen's properties
