**NATIONAL TRANSPORTATION SAFETY COMMITTEE
REPUBLIC OF INDONESIA**

Marine Accident Investigation Report

The Grounding of *Sea Flyte*

11 October 2018

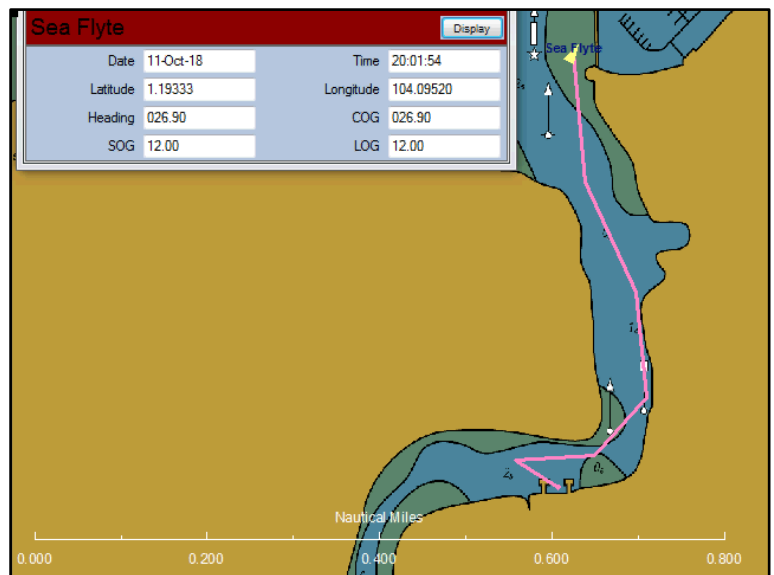
At about 20.04 LT, the Master, Chief Officer and First Engineer felt the ship's bottom hit a hard object beneath the water. The First Engineer immediately pulled the engine throttle to neutral position. At the time, the *Sea Flyte* was still moving until she hit something hard beneath the water for the second time and this made the *Sea Flyte* fully stopped.

Figure 3: The track and grounding location of the *Sea Flyte*

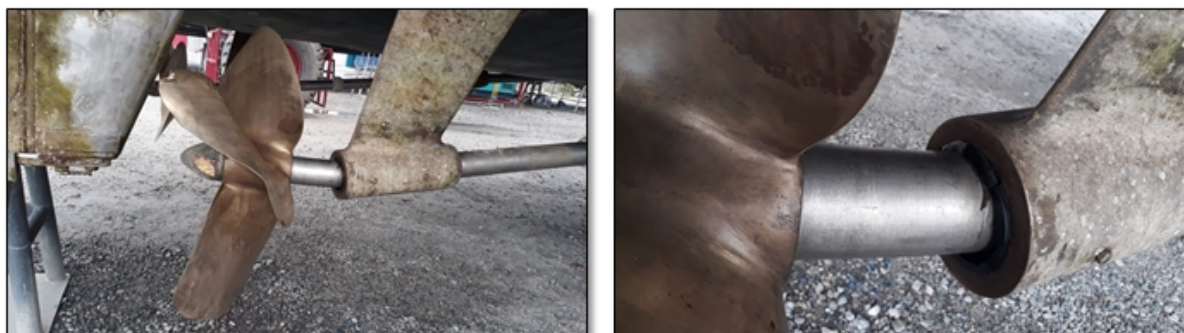
There were no injured passengers or water pollution due to the accident. However, the Sea Flyte suffered major damage on her propellers, propeller shaft as well as plates of keel and bottom.

Figure 7: Starboard shaft condition after the Sea Flyte ran aground

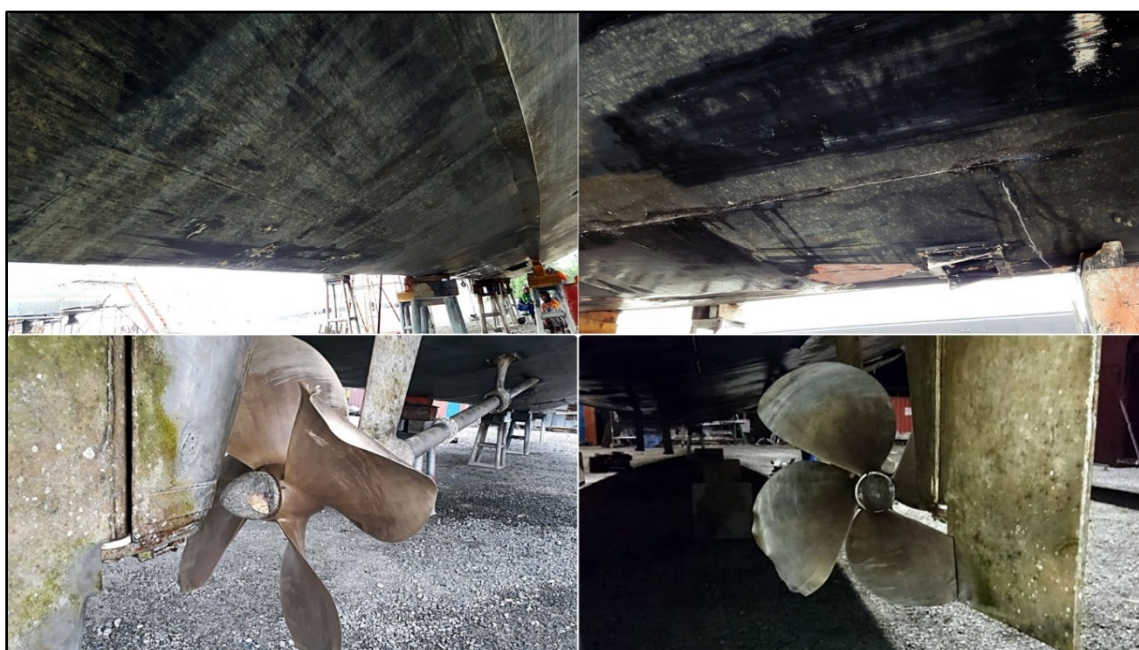
Figure 8: The damage profile of bottom plates and starboard propeller after Sea Flyte ran aground

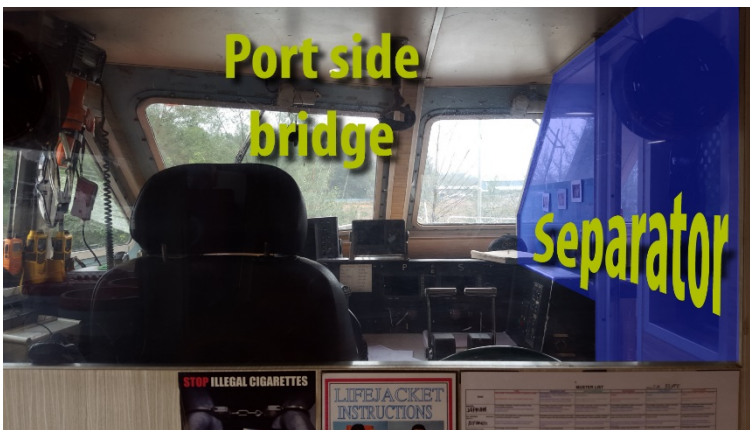
Figure 9: Starboard and port side bridge was separated by a wall

The investigation team found that there was a critical issue regarding the layout of the navigational bridge. The issue was in terms of the physical arrangement of the bridge. The initial layout of the bridge was without a separator. However, the ship had been modified to be separated. There was no clear information about why the separation was in place.

The separated bridge obstructed the cooperation between the left (master and first engineer) and the right bridge crew (chief officer). The communication between each set of crew members could not be transferred smoothly, particularly in a noisy situation such as in the torrential rain and the

vessel's engine noise. In the heavy rain, the difficulty was increased as the master was hardly focusing on the visual outlook, instead they looked at the visual navigation equipment. Therefore, the Master did not pay attention to the *Sea Flyte's* position which gradually drifted to the starboard side, where the water was more shallow than in the middle.

Meanwhile, the chief officer who was observing the channel situation and position of the vessel could not leave his position to remind the left crew. When he was concerned of the vessel's position, he shouted to the left bridge crew with no response.

1. To rearrange the bridge layout to improve the bridge resource performance.
2. To develop guidelines for vessel's departure considering any relevant information and safe operation of the vessel.
3. To develop procedure for the crew in crossing restricted channel in a limited visibility circumstance.

Regarding this recommendation, the PT Batamfast had modify the bridge layout as well as revised the guidelines and procedures.

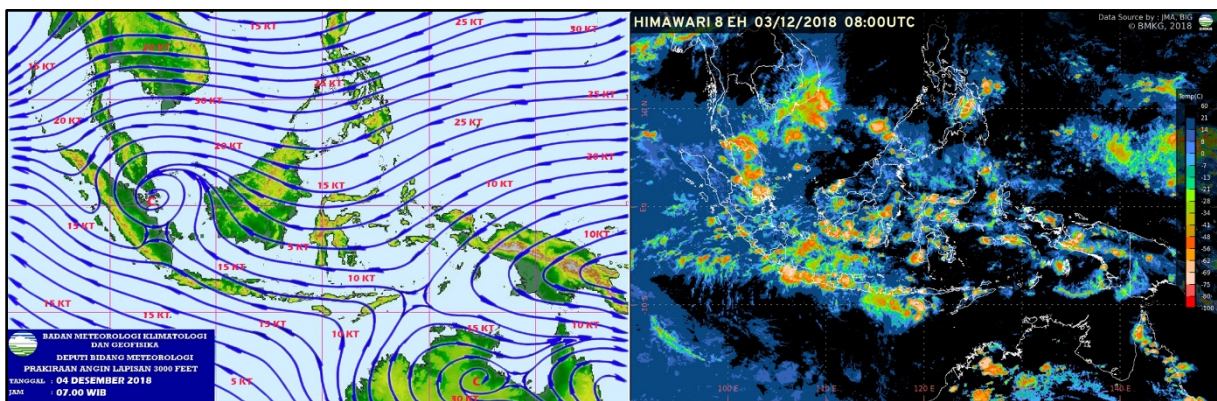
Figure 10: Sample of map of weather forecast issued by the BMKG

Although the controller-on-duty of the NFT had checked the weather forecast prior to giving a depart permit, the staff did not know what would happen after the light shower. In addition, the visibility and weather were deemed relatively good. This depicted that the weather forecast was invaluable as the controller was not a weather forecaster.

1. To provide weather information and monitoring system as well as sensors to support marine operation in the Nongsa River area.
