Marine Casualty Investigation Report

MAIN ENGINE FAILURE OF

***OCEAN PRINCESS* (IMO 8601496)**

29 DECEMBER 2018

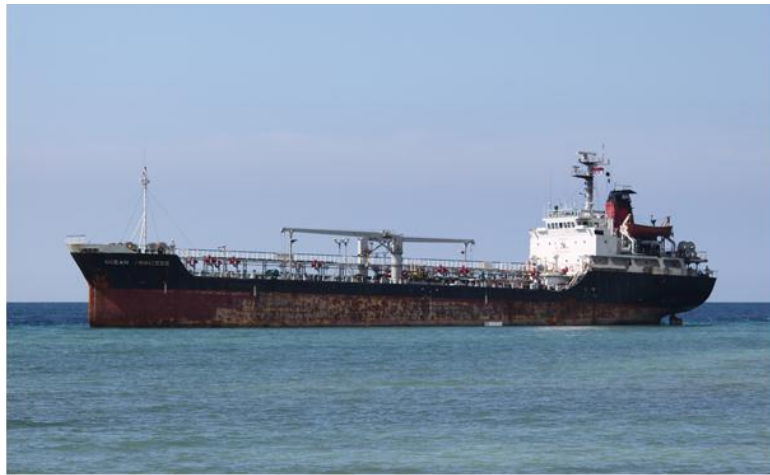
Figure 2: Ocean Princess

There was no leak on the ship when it ran aground. She had a minor scratch due to contact with the coral due to the grounding.

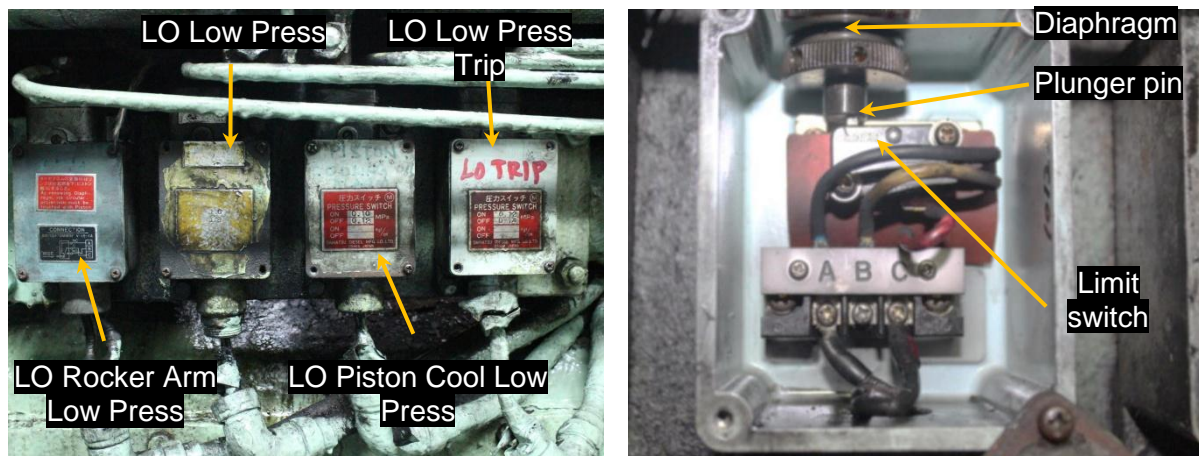
Figure 3: *LO System safety device of starboard M/E (left) and internal pressure switch of LO Piston Cool Lo Press (right)*

At the time of investigation, the PS LOPC LP used Normally Open-'NO' by using a cable in A and C terminals. The condition of PS LOPC LP and LOLP TR without running the LO Stand-by M / E (no pressure) pump shows that the diaphragm PS LOPC LP slightly dropped and slightly pressed the plunger pin compared to the diaphragm PS LOLP TR which only touched the end of the pin. Meanwhile, the diaphragm in PS LORA LP was stuck.

Based on the Daihatsu manual book and information on the pressure set on the PS cover, it was known that the pressure set value for PS LOPC LP was 0.10 MPa² in ON and 0.12 MPa in OFF. Following is the limit safety device LO M/E alarm and trip:

When the engine speed dropped, the LO pump rotation would automatically decrease and then the LO pressure would also decreased. The LOPC LP PS read the LO pressure below the set value. This condition activated the LOPC LP and in a few minutes LOLP TR was also active and directly activated the solenoid valve to cut off the fuel supply.

1. To ensure the crew members are familiar with one engine operation and engine safety device system.
2. To review and revise the main engine operation procedure, especially the procedure for one engine operation.
3. To provide the safety device test procedure on board and maintain a regular test for the LO safety device system.

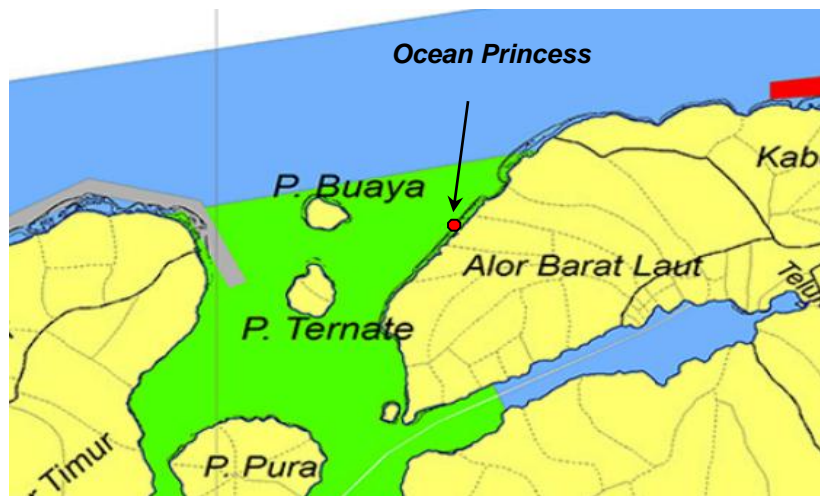
The location of the ship keel whilst she was grounding which was a coral reef area had been damaged.

Based on the ministerial regulation above, the green colour on the map in Figure 3 was a tourism area, while blue was a sustainable fisheries area. The location of the grounding *Ocean Princess* was covered by live soft coral reefs.

Figure 3: Conservation area and the grounding location

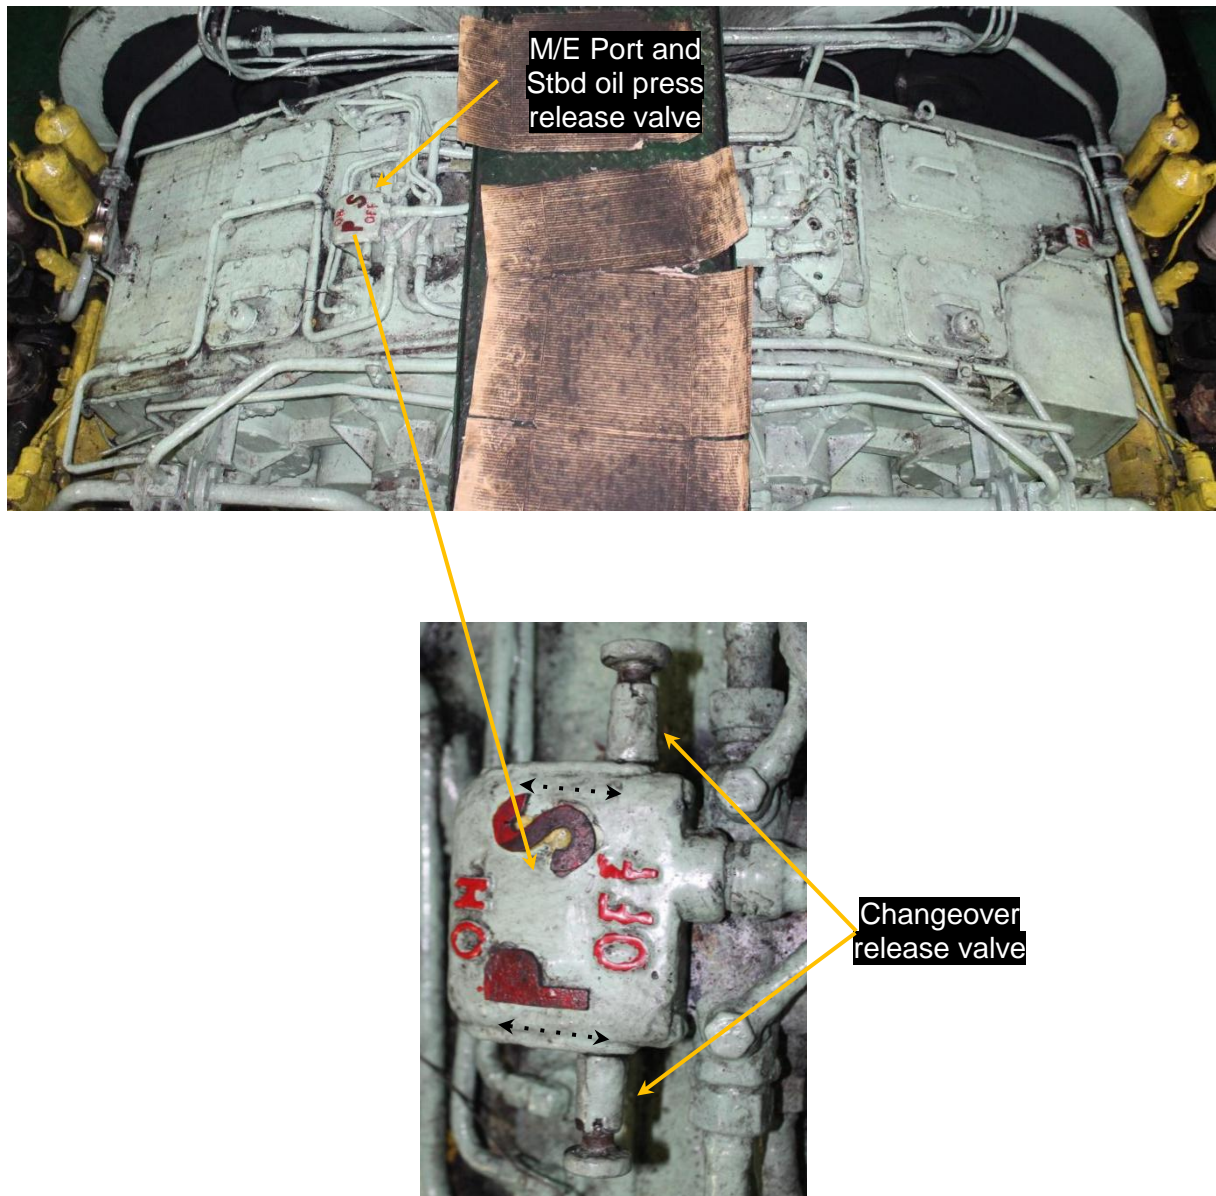
Figure 4: Gear reduction oil pressure release valve changeover

When the Starboard M/E stopped due to the safety device was active, the Port M/E automatically also stopped due to overloading. Right after the engines stopped, the engine crew attempted to restart the Starboard M/E until the ship finally ran aground. There was still about four hours since the engine stopped until the ship run aground. That time was sufficient to restart the Port M/E and the ship could operate with one engine. However, at that time none of the crew members were aware of doing so. As well as from shore management, no one advised to run the ship with a single engine.
