FINAL
KNKT.19.01.03.03

Marine Safety Investigation Report

Collision between *ANTEA* and *STAR CENTURION*

13 January 2019

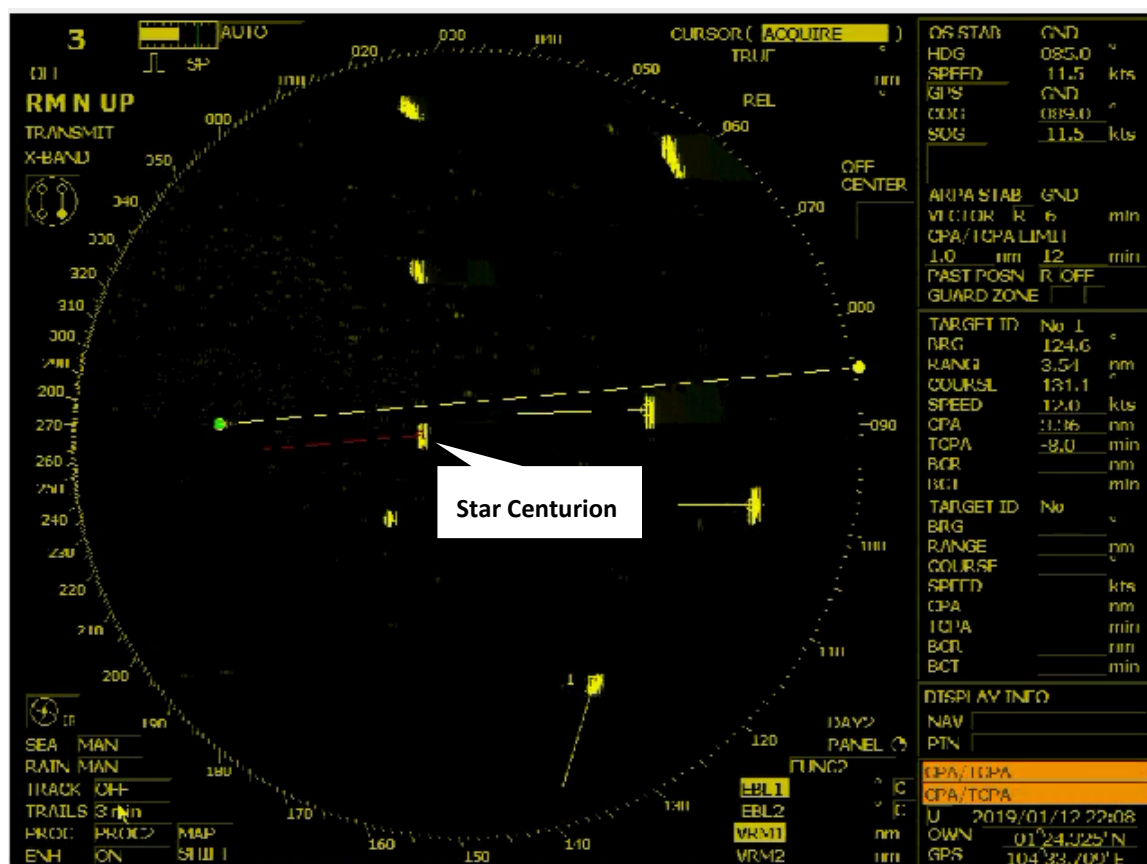
Figure I-8: Extract from X-band radar on Antea at 06:08:36 hours. CPA/TCPA alarmed to Star Centurion

At 0608:36 hours, a CPA/TCPA alarm on the X-band radar sounded in relation to *Star Centurion*. The officer on watch acknowledged the alarm. He examined the target by the X-band radar and changed the radar trails to 3 minutes. He moved to ECDIS² unit to see where *Star Centurion* in relation to *Antea* navigation course tracks.

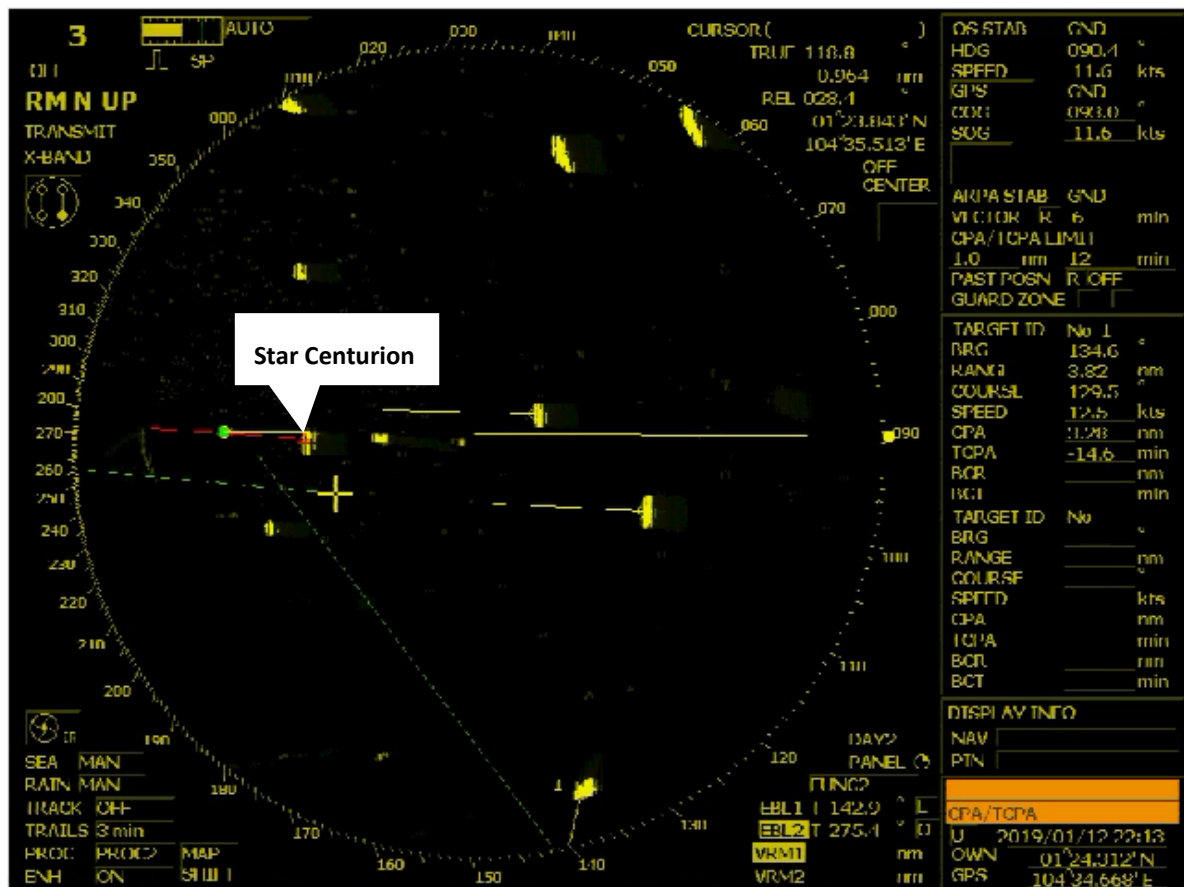
At 0613:46 hours, the helmsman informed the officer on watch again that there was no steerage after the steering wheel applied to hard starboard. The officer on watch immediately took over the wheel and put helm to hard starboard again, however the ship's heading did not pay off to starboard.

Figure I-10: Extract from X-band radar on Antea at 06:13:46 hours. Again, the AB inform to the OOW that there was no steerage after he applied to hard starboard

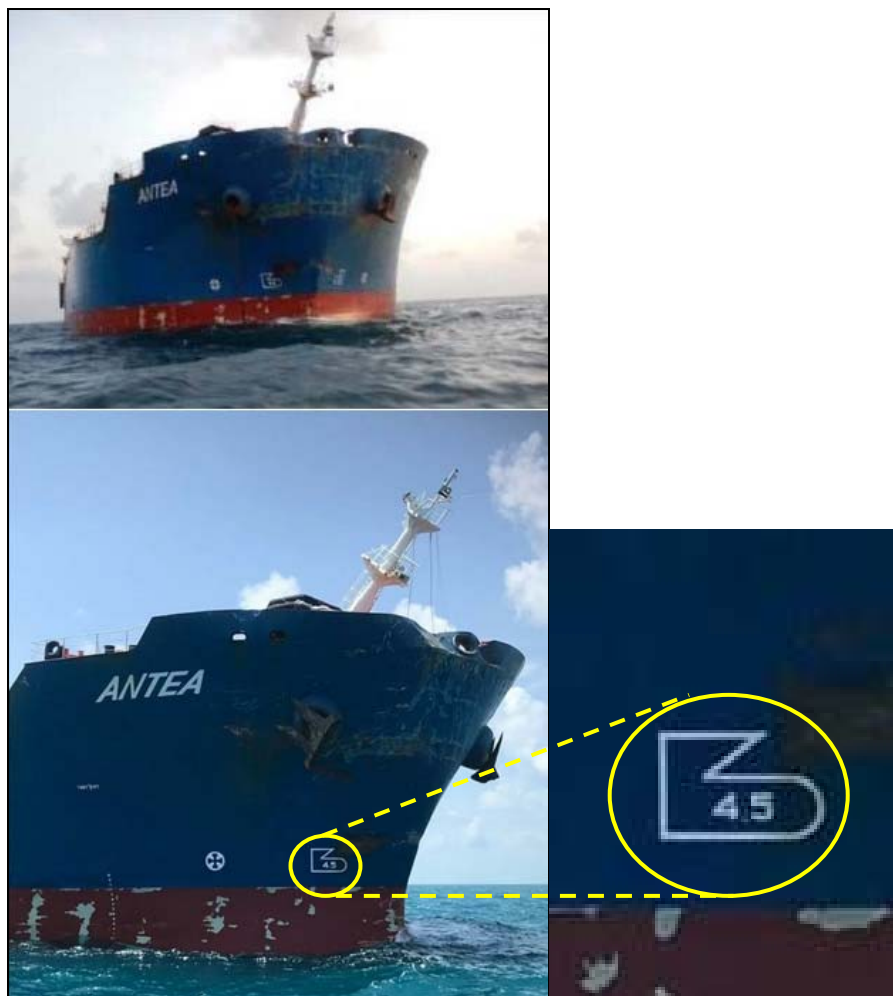
Figure I-17: Bow damage. Antea afloat following the collision

Reportedly on *Antea* that no crewmembers were injured as a result of the collision and there was no pollution of the environment. The consequences for *Antea* was lost time with the vessel out of service to carry through and complete repairs.

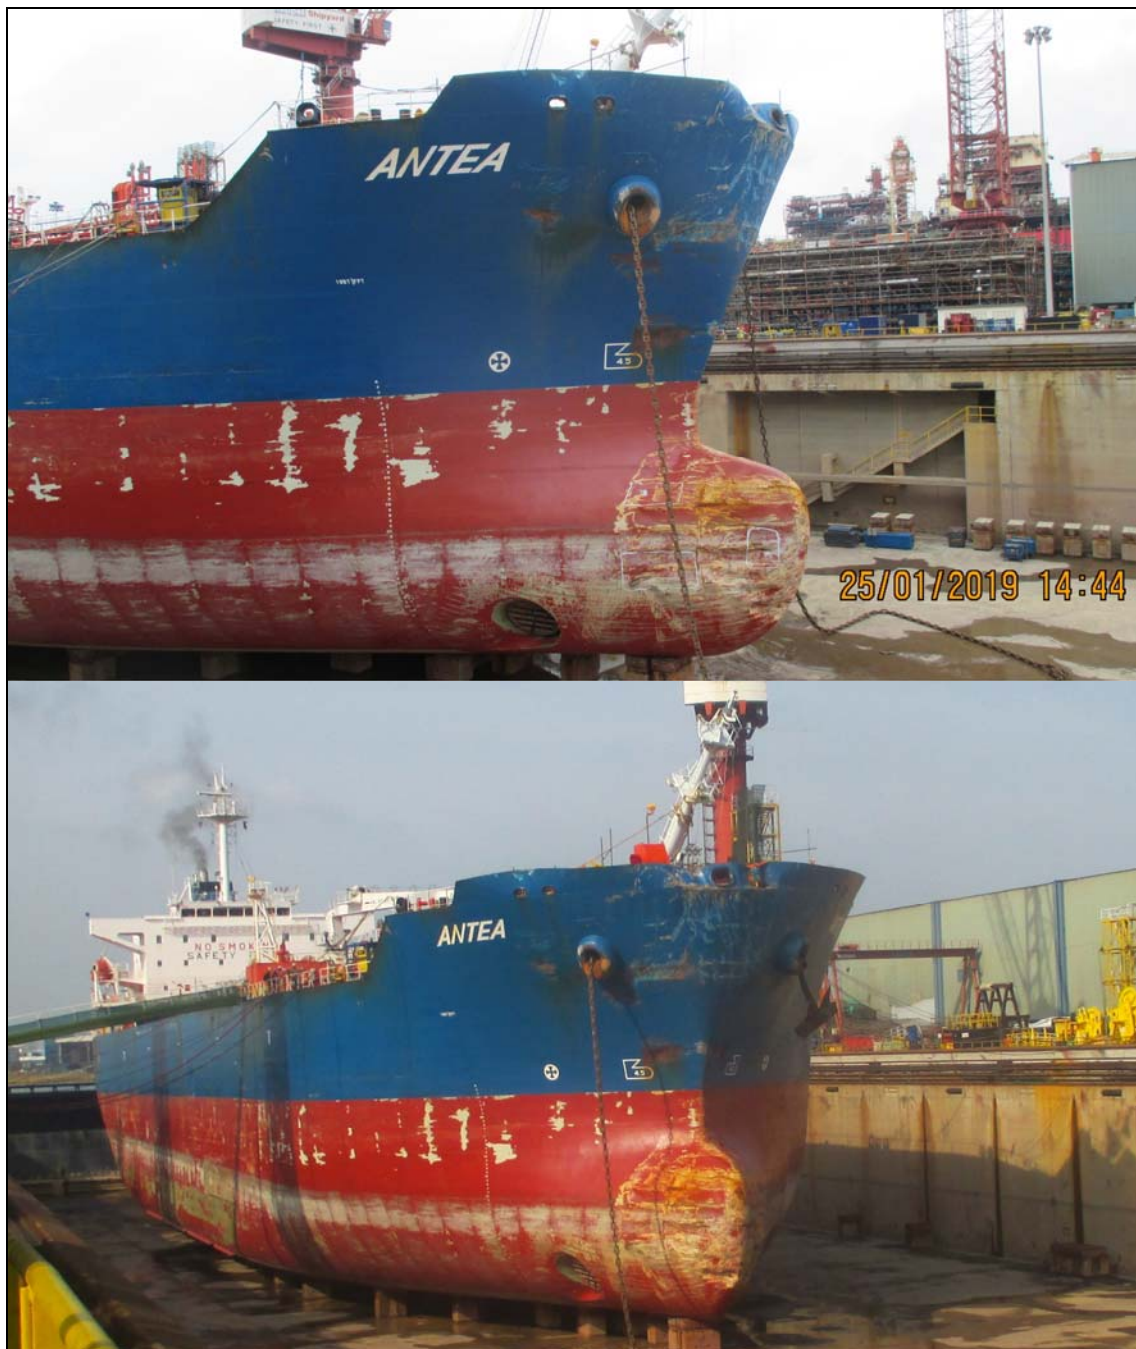
Figure I-18: Bow damage. Antea in Keppel dry dock

Antea is constructed with bulbous bow and protruding anchor hawse pipe. *Antea's* bulbous bow protrudes 4.5 metres forward from the intersection of the stem and design waterline. Considering the bulbous bow construction and the extent of scratching to the forecastle topside area, it is estimated the *Antea* bow penetrated the *Star Centurion* to a maximum distance of 9 metres.

- Multiple locations at bulbous bow on both sides
- Internal structural members of forepeak tank
- Forecastle (Bosun) store – forward ship side plating and frames
- Bosun store davit detached from forecastle deck
- Forecastle deck bulwark at multiple locations
- Foremast half detached from deck towards forward
- Ship side plating dent at no.3 starboard water ballast tank
- Port side anchor bell mouth casing cracked

- Both anchors deformed. Port side anchor beyond repairs
- Hand rails and fitting on the compass deck at the starboard side forward corner and deck buckled down
- Damage to bow thruster anodes

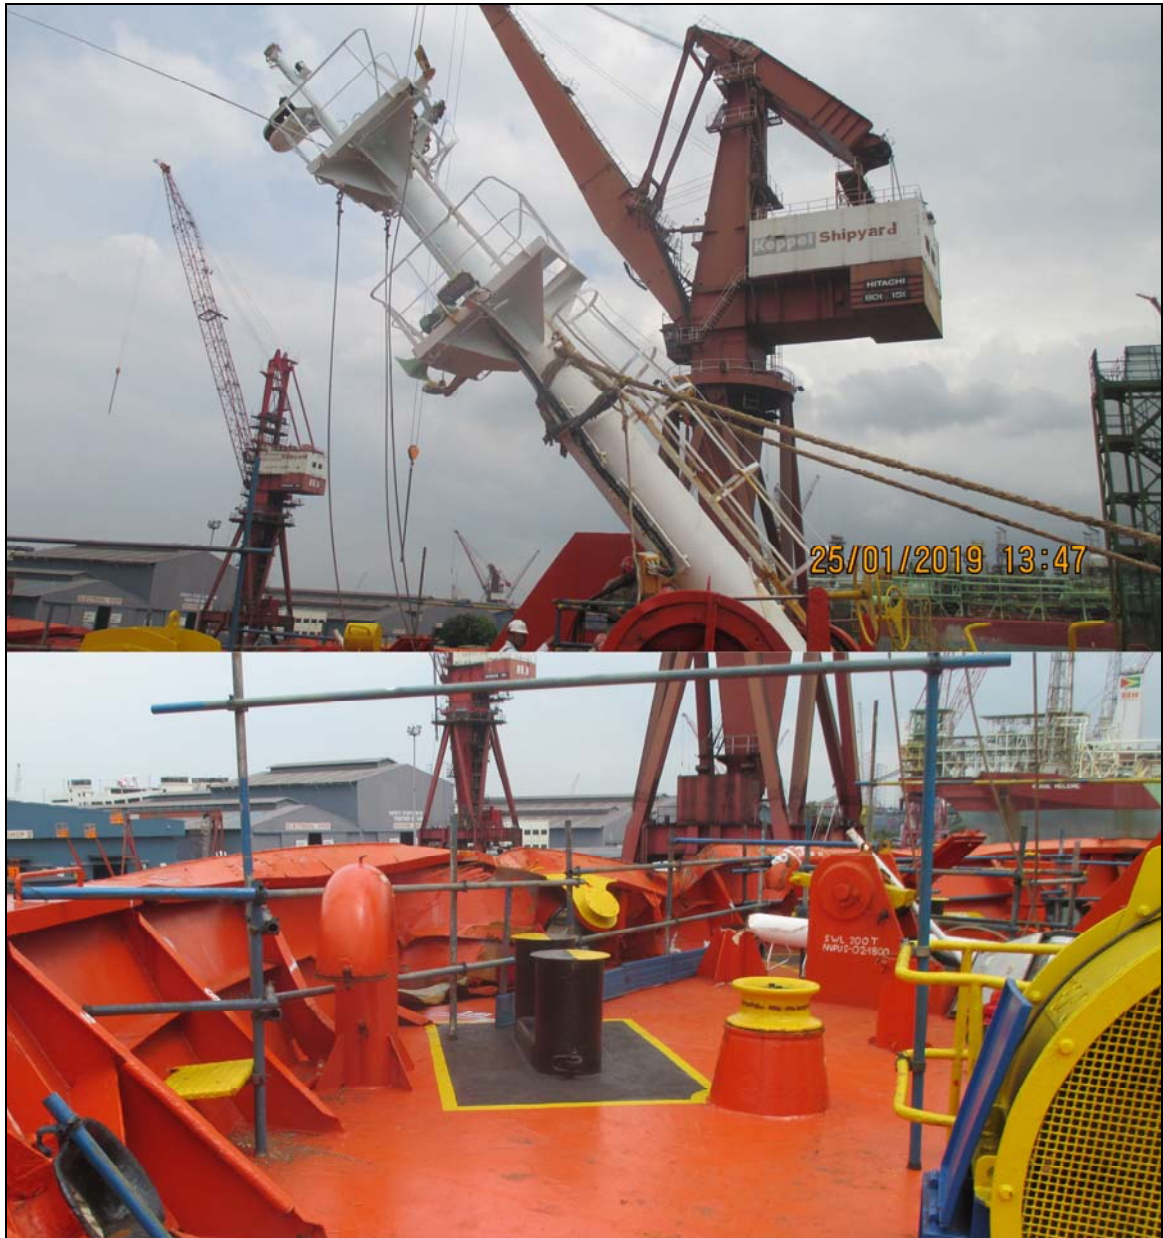
Figure I-19: Forecastle damage. Antea in Keppel dry dock

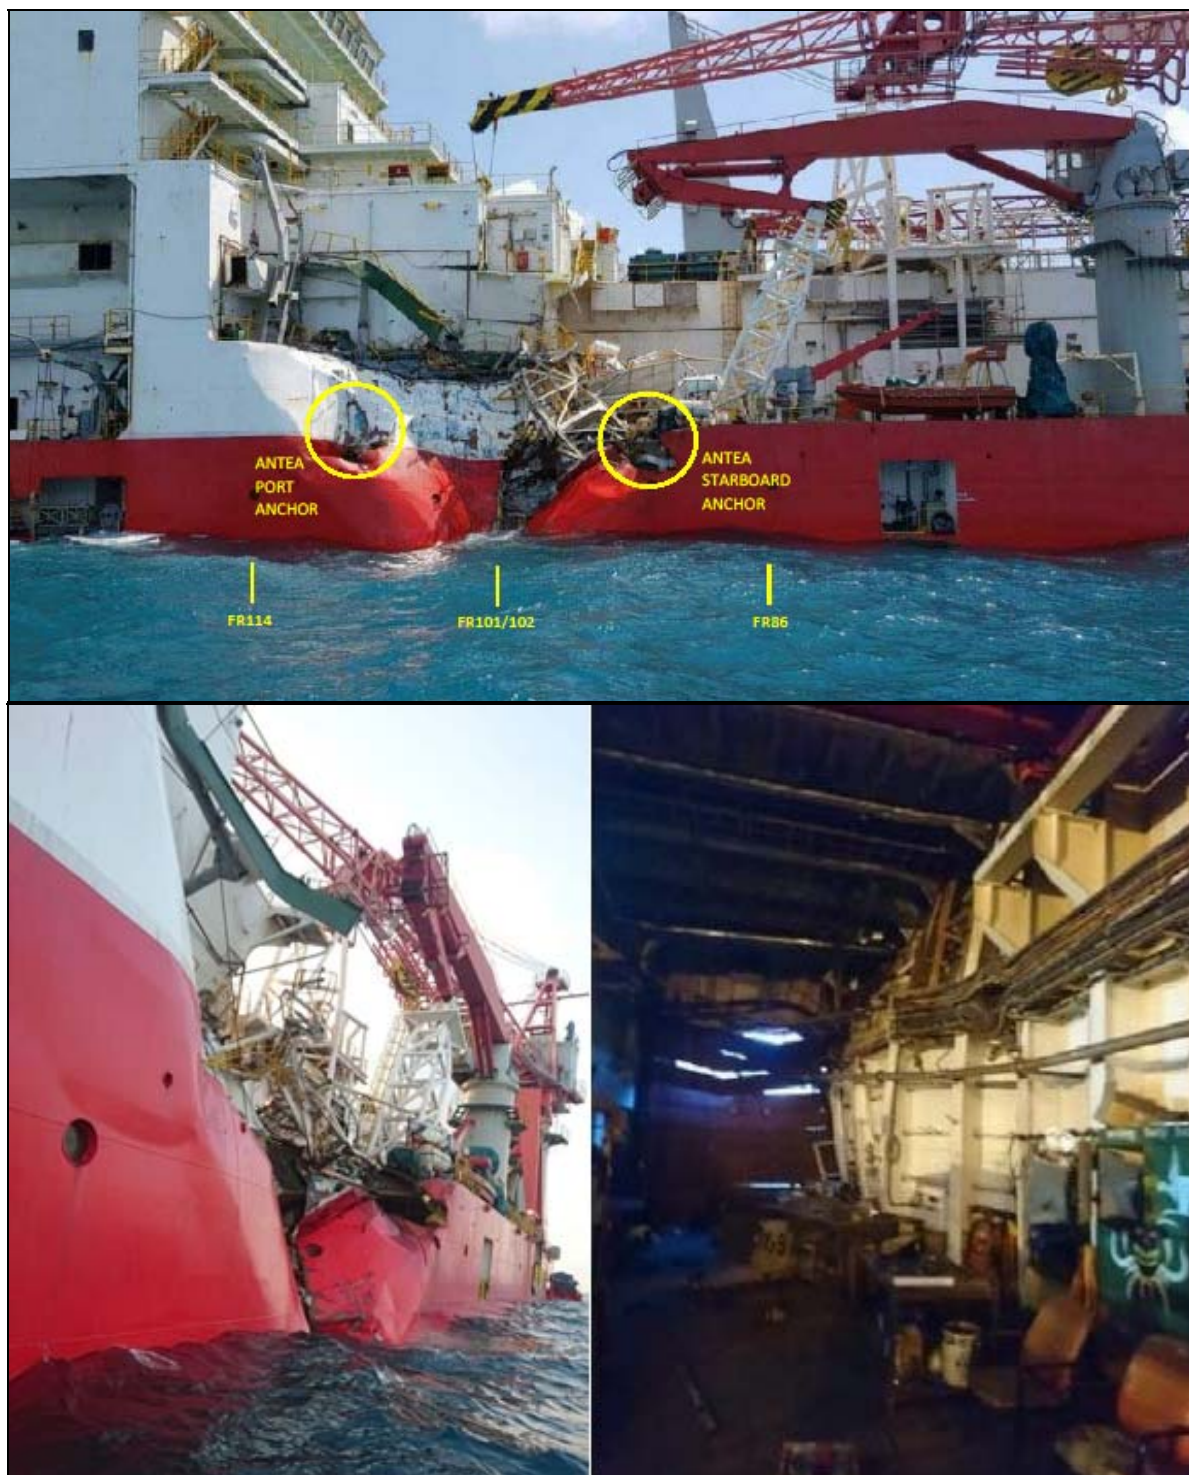
Figure I-20: External damage on port side (above and left) and internal damage seen from construction shop (right)

An estimation from reported observation shortly after the collision that the impact of *Antea* on the port side of *Star Centurion* was located across frame 86 to frame 114 with a length of about 21 metres. A wide tear damage on port side shell as the primary impact point was located approximately at frame 101/102.

The two secondary impact points at one either side of the primary point, just below the production deck. These are come from the anchors of the *Antea* which secured in their stowed position, giving an initial indication of the bow penetration into the *Star Centurion*.

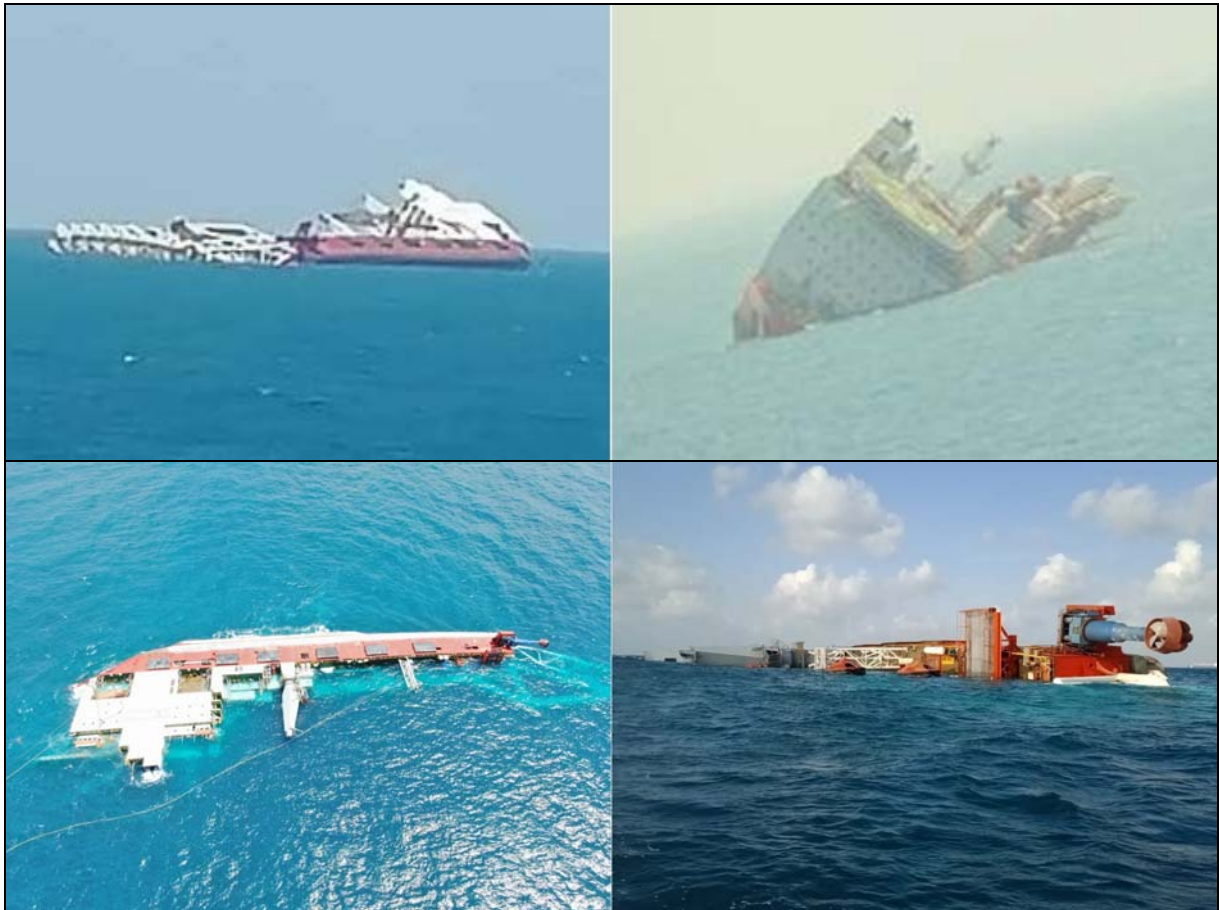
Star Centurion had severe damaged in the hull on the port side. The vessel watertight integrity compromised and it commenced taking on water then capsized due to a loss of stability and eventually it sank in the collision location.

Figure I-21: Capsizing and sinking Star Centurion

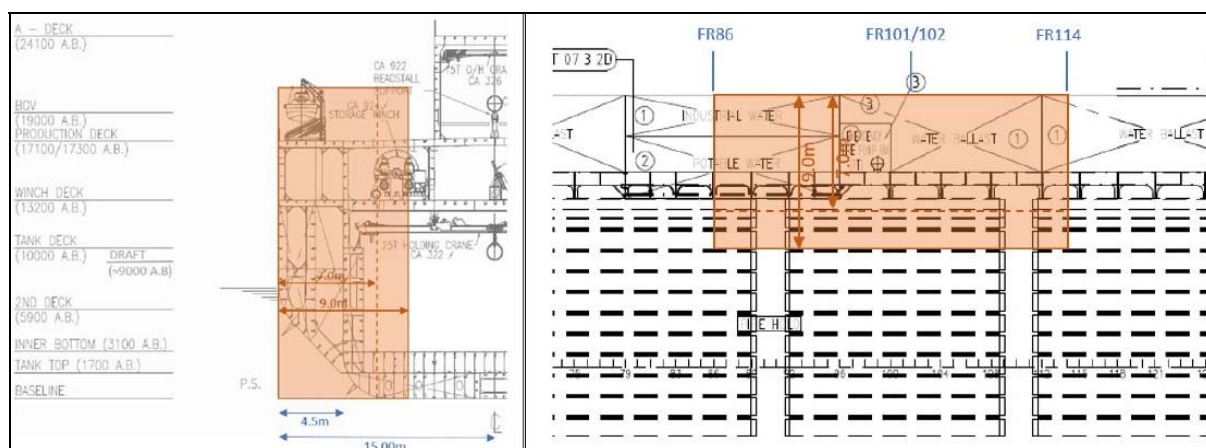
Antea on departure had an observed fore draft of 8.40 metres. Prior to collision *Antea* was making speed of 11.5 knots which created a squat in open waters about 1 metre based on ship's squat calculation, and therefore fore draft at the time of impact about 9.40 metres. This is similar draft to *Star Centurion* when at anchor about 9 metres. It is fair to assume that the vertical extent of damage to the *Star Centurion* is the full depth of the vessel from the production deck down.

Having observed *Antea* bow damage to an estimated 9 metres of penetration this can be seen in the transverse section and deck plan view, it shown with respect to vessel structure and internal subdivisions. The key subdivision to identify here is that between the wing tanks, within the sponson, and the pipe cargo hold, where this longitudinal bulkhead is 4.5 metres inboard of the side shell. It is therefore evident that the transverse extent of damage has resulted in the loss of the pipe cargo holds watertight integrity.

Figure I-22: Transverse section (left) and 2nd deck plan view (right) showing estimated damage penetration (height and length)

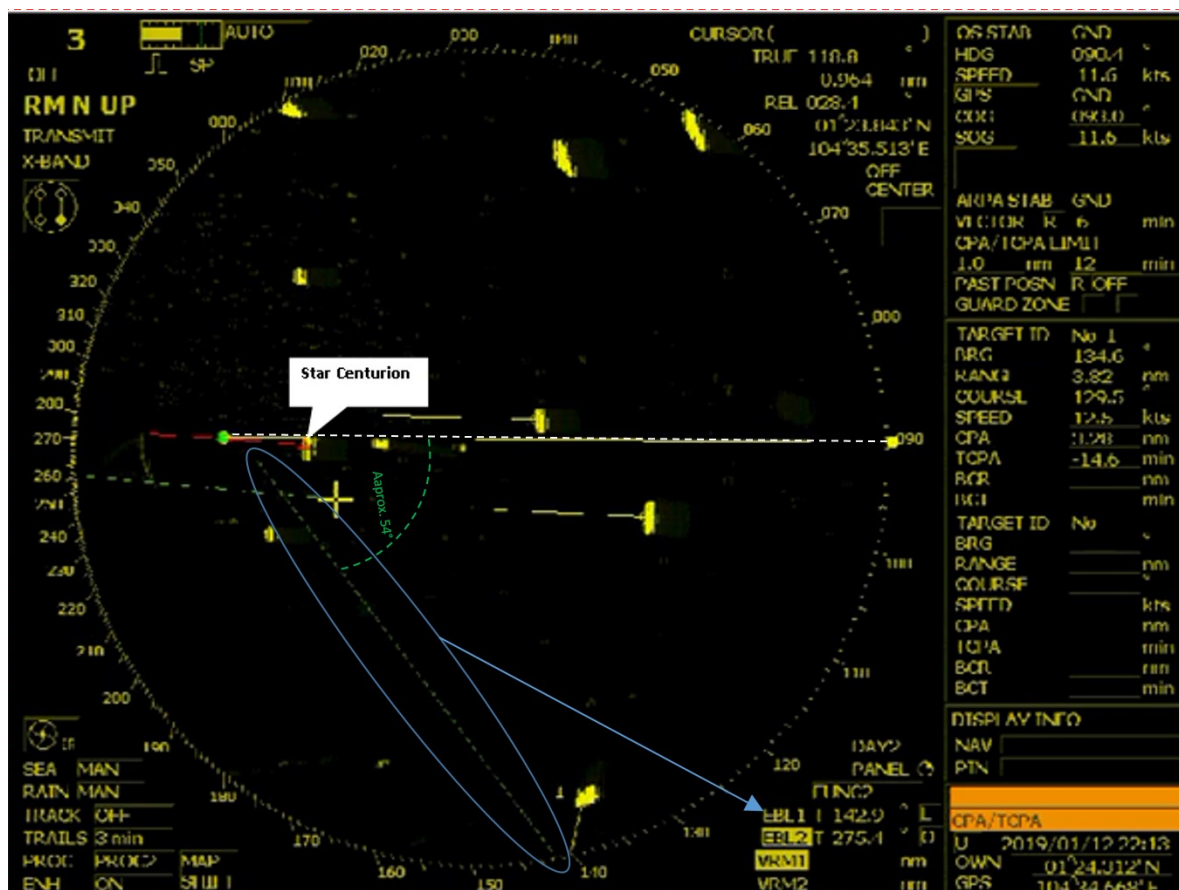
Figure II-1: Extract from X-band radar on Antea at 06:13:37 hours. The AB inform to the OOW that there was no response after he applied the steering to starboard
