**NATIONAL TRANSPORTATION SAFETY COMMITTEE  
REPUBLIC OF INDONESIA**

**FINAL**  
**KNKT.19.01.06.03**

**Marine Accident Investigation Report**  
**Barelang 2 Bridge contacted by *Eastern Glory***  
**(IMO 8508228)**  
**Barelang Waters, Riau Islands**  
**Republic of Indonesia**  
**23 January 2019**

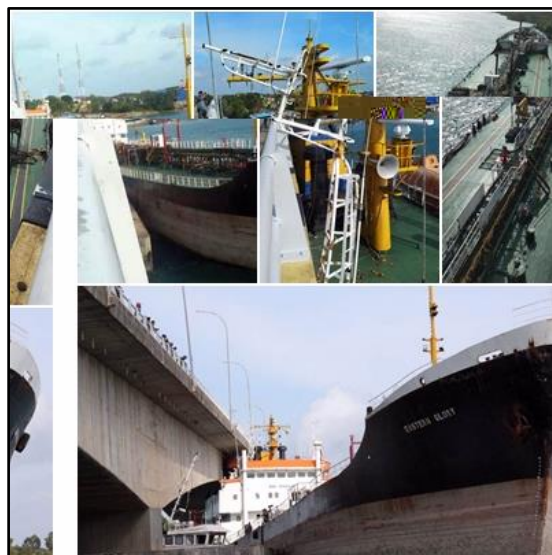
As the result of the contact between the *Eastern Glory* and the Barelang 2 Bridge, her upper structure had a major damage. Some parts of the upper structure were underneath of the bridge.

At the initial of the occurrence, the *Multi Sahabat 7* was in between the *Eastern Glory* and the bridge pillar. Luckily, the *Multi Sahabat 7* did not have any serious damage because the upper structure of the *Eastern Glory* held her in position, so that the *Multi Sahabat 7* was not pressed by the *Eastern Glory* towards the pillar.

**Figure 2: Eastern Glory hit middle pillar of Barelang 2 Bridge**

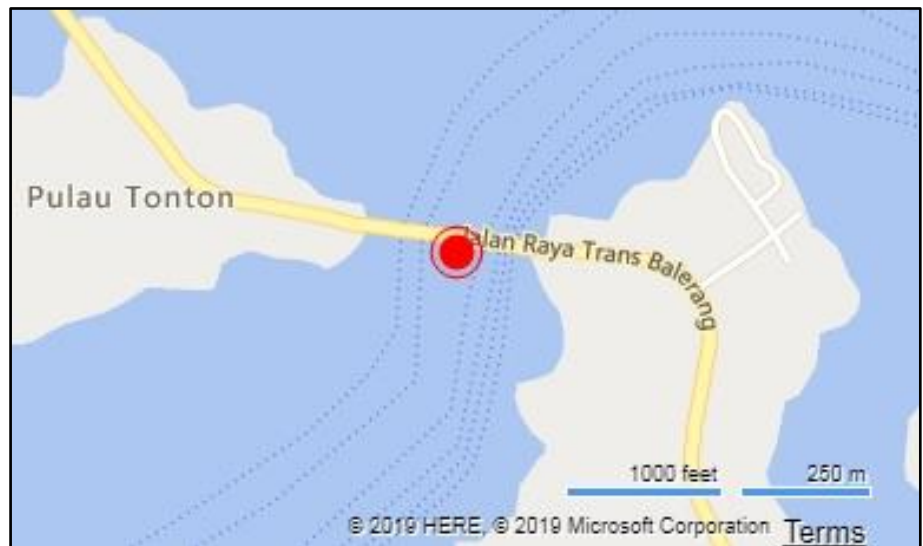
**Figure 4: Barelang 2 Bridge (Image: HERE)**

As the initial design, all bridges have no protection from the risk of ship collision, such as bridge fenders. Compared to the Musi Bridges in Palembang, the marine traffic in Palembang is higher than in the surrounding of Barelang Bridges.

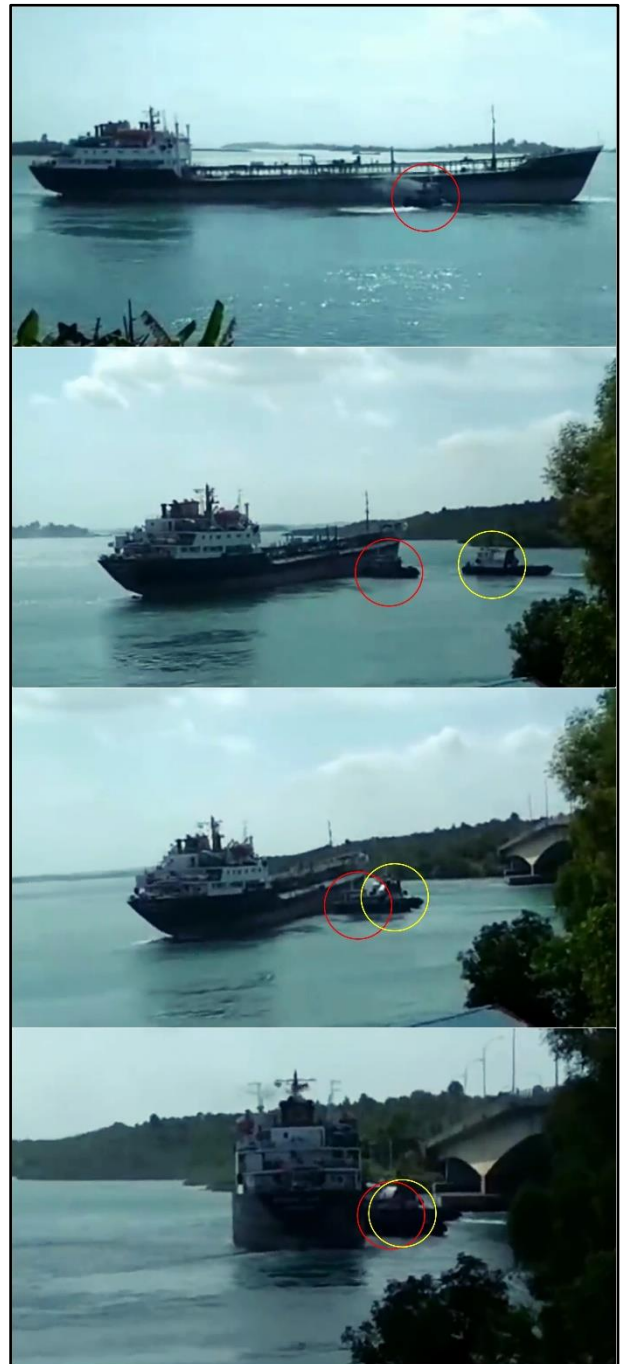
At the time of accident, the *Eastern Glory* was assisted by two tug boats. However, both tugs only produced the total power of 1,400 HP. None of them had the power more than 2,000 HP in towing works as required by the Minister of Transport regulation No. 57 Year of 2015. This insufficient power then led to the failure of towing whilst the the *Eastern Glory* was pushed by the current.

To manoeuvre the ship safely, the Master of the *Eastern Glory* should consider a couple of things. First, the Master should ensure that the current was not flowing towards the bridge. Second, all of the tugs were attached on the *Eastern Glory* to ensure they could push in time. Based on an amateur video as seen in Figure 5, there was only one tug assisted the *Eastern Glory* at the beginning of the shifting. Another tug appeared late when the situation became worse.

Figure 5: Multi Sahabat 6 (red circle) Multi Sahabat 7 (yellow circle)

1. To ensure the crew members conduct the pre-departure briefing correctly with sufficient information.
2. To ensure that the Master always checks the adequate power and readiness of tug boats in shifting assisted by using tug boats.
3. To ensure the voyage data recorder (VDR) on the international voyage vessel is fitted and works properly.
