**NATIONAL TRANSPORTATION SAFETY COMMITTEE
REPUBLIC OF INDONESIA**

FINAL
KNKT.19.07.16.03

Marine Accident Investigation Report

*Allision of **Soul Of Luck** with Container Gantry Crane*

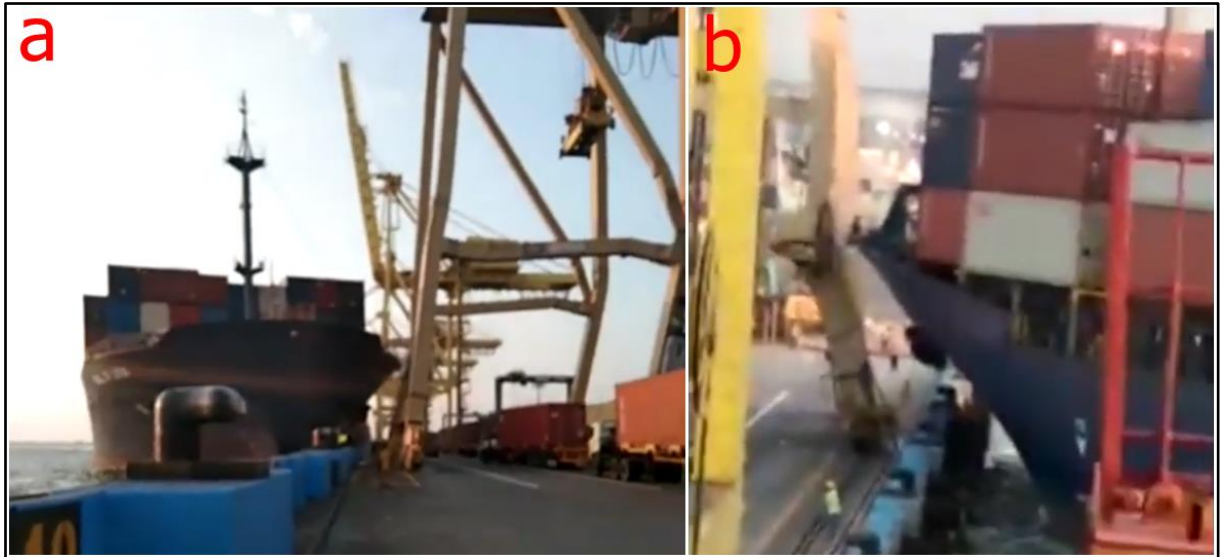
A few seconds later, the fore of *Soul Of Luck* hit the container gantry crane No 03. As a result, the gantry rapidly collapsed. Some trucks and containers underneath the gantry crushed by the crane.

Figure I-12: Photos taken by port workers from the wharf (a) and Kanway Galaxy (b) whilst the Soul Of Luck hit the container gantry crane No 03

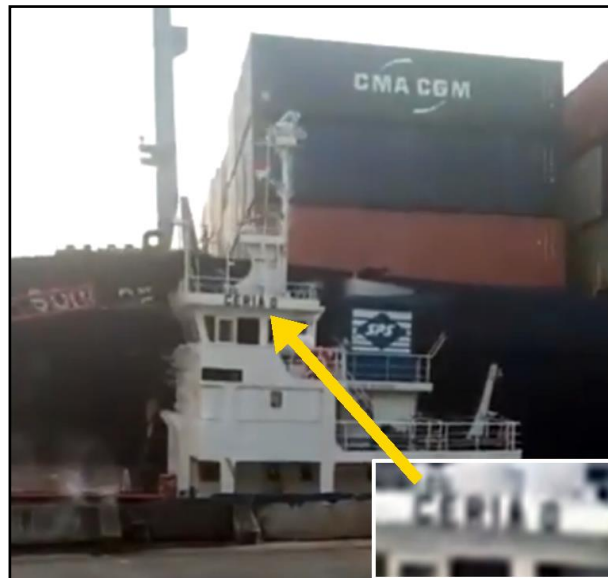
The Master ordered the helmsman to steer the *Soul Of Luck* hard to starboard. Her heading slightly changed. As the consequence, the *Soul Of Luck* grazed the port side hull and railings of the *Ceria 8*. This cut off all of the berthing lines of the *Ceria 8*. Afterwards, the *Ceria 8* dragged by *Soul Of Luck* towards south. They were approaching an oil tanker vessel, named *Heng Xin*.

Figure I-14: The *Soul Of Luck* wilst contacted the *Ceria 8*

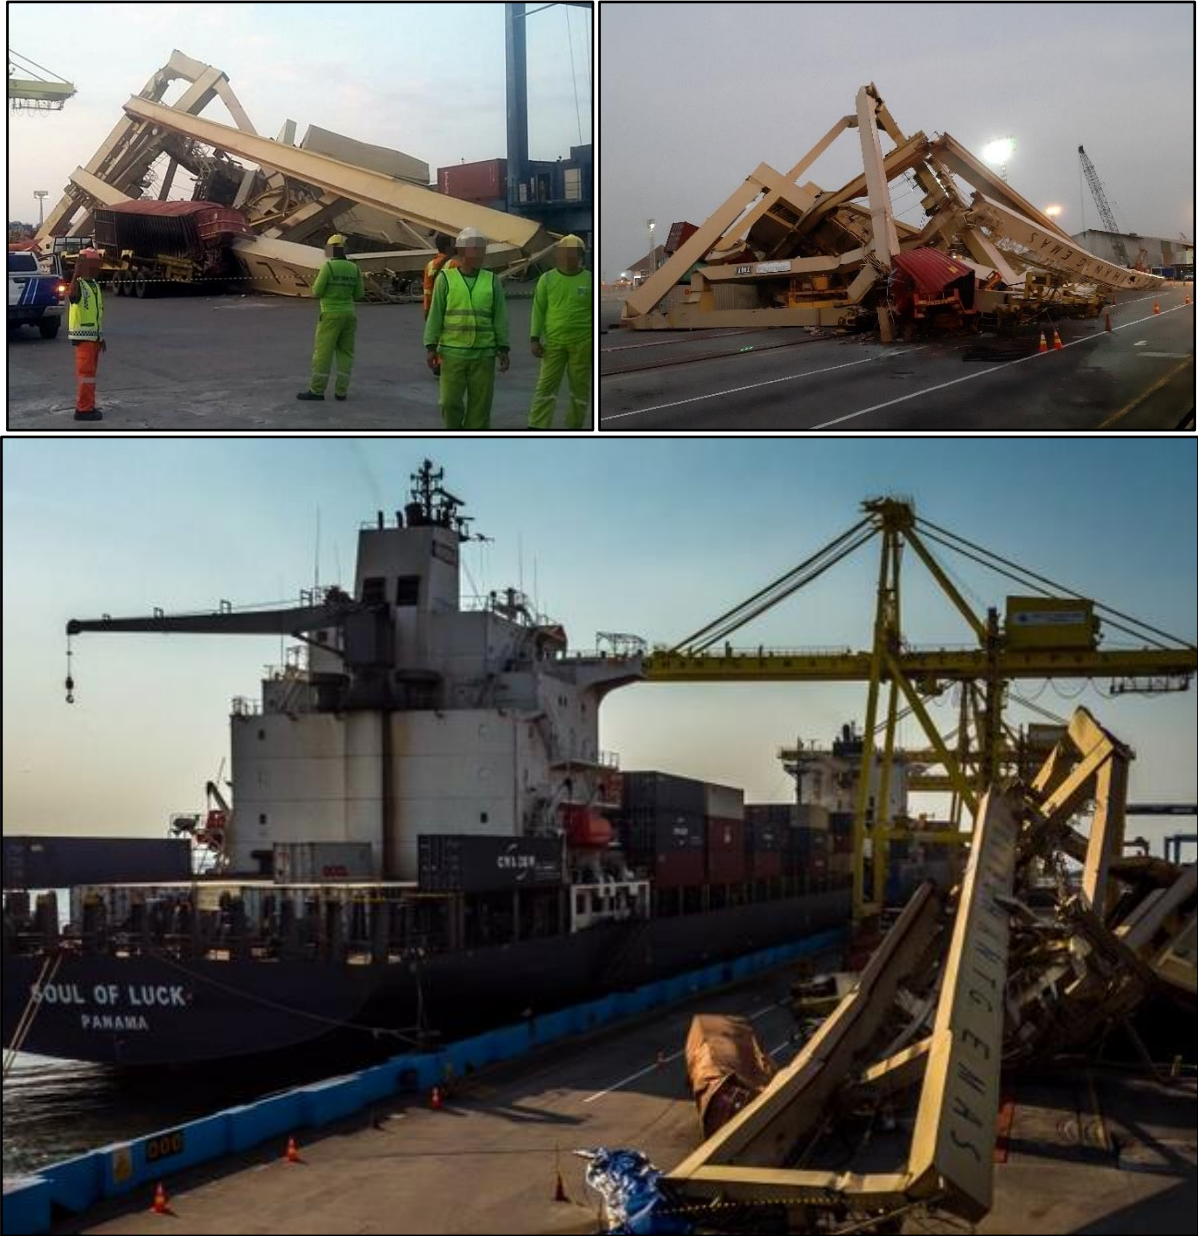
The massive destructions were seen on the container gantry crane No 03, a few container trucks and several stacks of containers nearby the collapsed gantry. There were no reports related to the crack of the wharf construction due to the incident.

Figure I-15: The ruined container gantry crane No 03

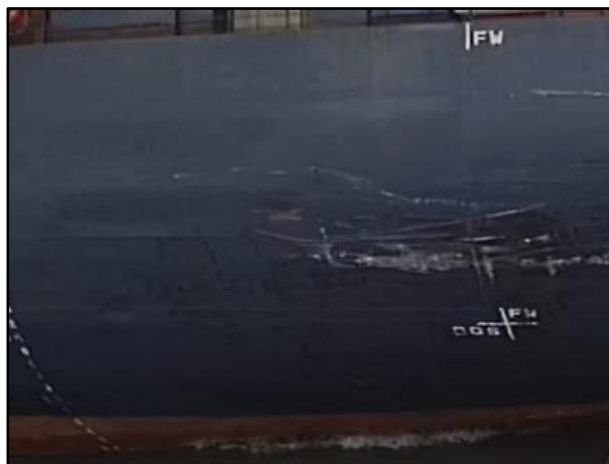
There were two ships suffered damage due to hit by the *Soul Of Luck*. The port side of *Ceria 8* had an extensive damage on the hull, railing, and construction. Her berth lines were cut off. The astern was also damaged after contact with the *Heng Xin*. Meanwhile the *Heng Xin* only had a light damage on her railings which required repainting. Whereas, the *Soul Of Luck* had a damage on her port side hull.

Figure I-16: Scratch on the Soul Of Luck's aft port side hull

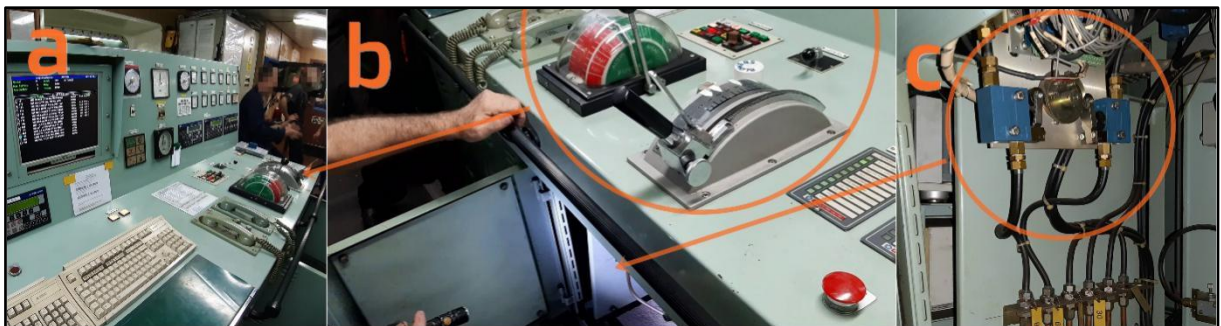
The witness interview also confirmed that the valve was broken in the pneumatic system. This part was responsible to deliver the air to control the engine. The failure of this part meant the engine could not be controlled as intended by the engine crew.

Figure II-1: The panel controls in the engine room (a); the engine control (b); the pneumatic valves

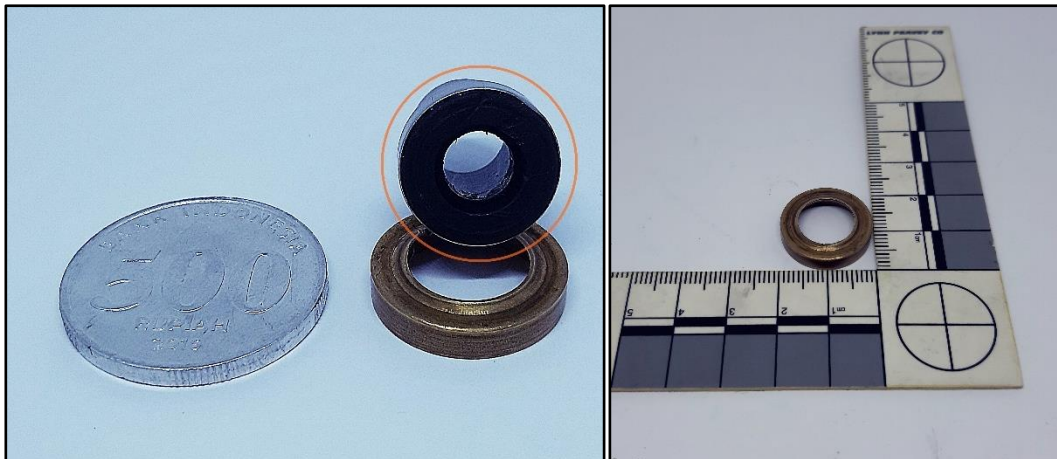
At the accident of *Soul Of Luck*, when the handle of manoeuvring system was positioned to astern, the control system did not work. The engine crew found that the pilot valve of manoeuvring system for astern had a leakage. Therefore, the air was wasted out of the system. The leakage made the system had insufficient power to switch the engine to the astern position.

mode, despite some attempts had been made. None of the trial made a positive result. Taking into account the function of the rings, the valve system should be airtight at a certain bar of the working pressure.

Figure II-2: The broken rubber ring in the pneumatic valve (orange circle, left) and the broken brass ring (right)

After the accident, the engine crew switched the engine control from ECR side to the engine side. The testing used the replacement of pneumatic valve was successfully done.

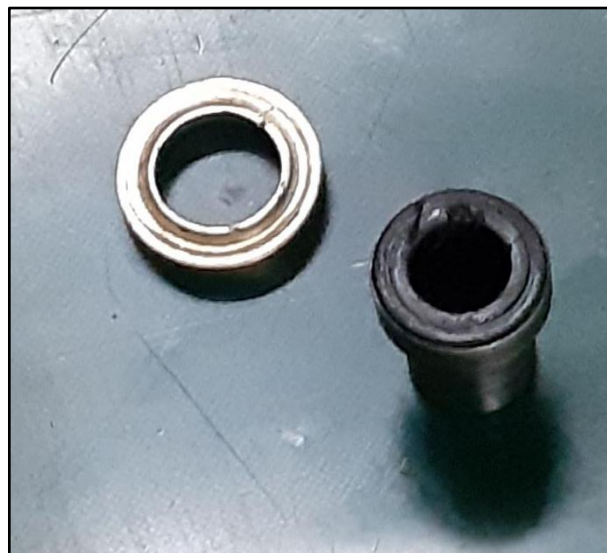
The investigation team could not retrieve any records related to the broken parts. The replacement of the pneumatic valve was unknown and it was predicted occurred before all engine crew went onboard the *Soul Of Luck*. Thus, the performance of the valve was not recorded in details as the main engine performance.

Figure II-3: The close-up view of broken rubber and brass parts
