**NATIONAL TRANSPORTATION SAFETY COMMITTEE  
REPUBLIC OF INDONESIA**

**Marine Accident Investigation Report**

**Grounding of Container Ship *Tina I***

**22 November 2020**

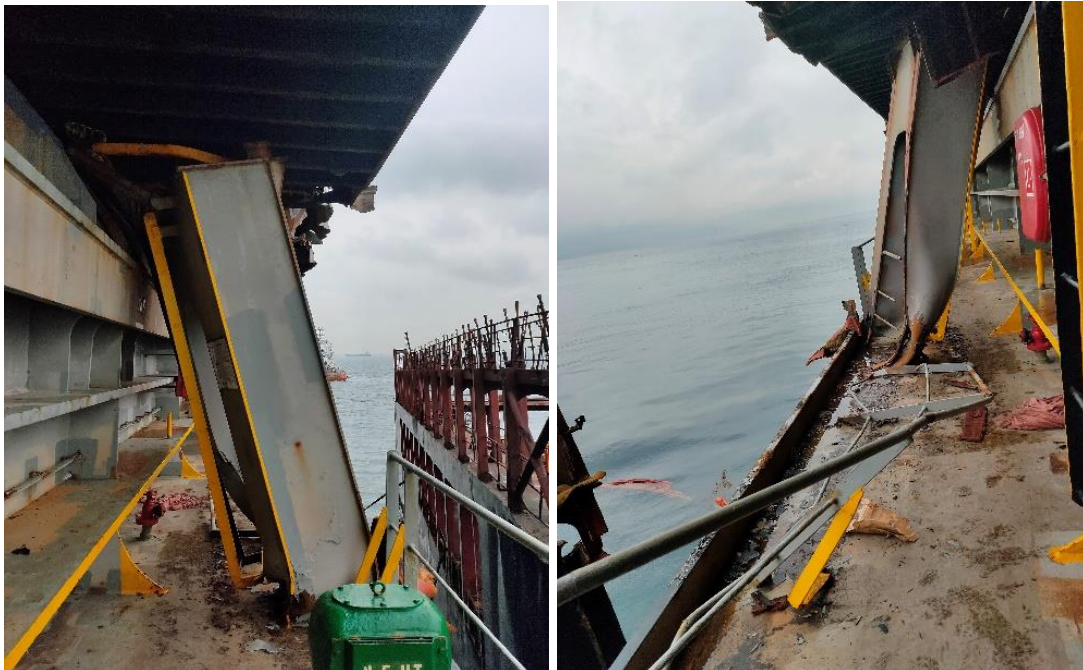
There was no report of fatalities or injuries on the ship's crew in this incident, but there are several damages to the ship occurred. And also, there was one ship suffered damage due to slightly contact made by the *Tina I*. The starboard quarter of *Shahraz* had a slight damage on the hull, railing, and construction. Whereas the *Tina I* had damage on her keel and port side hull and railing.

*Figure I-2: The damage on the port side of Tina I*

As a result of the accident occurred, the following damages have been thorough examination by company internal inspection and diving survey carried out in the damaged area and the following has been ascertained:

- a. IWO Forepeak Tank
  - Found indented at stbd bottom plate including internal members in way of Fr.116 – Fr.135, damage area approx.13500 mm (L) x 900 mm (B) with max depth 980 mm.
  - Found indented at stbd bottom plate including internal members in way of Fr.133 – 134, damage area approx.400 mm (L) x 260 mm (B) with max depth 80 mm and 560 mm (L) x 300 MM (B) with maximum depth 50 mm.

- Found indented at port bottom plate including internal members in way of Fr.129 – 133, damage area approx.2500 mm (L) x 1300 mm (B) with max depth 800 mm;
- b. IWO Bow Thruster Area
  - Found indented at bottom port side plate including internal members in way of Fr.108 - 109, damage area approx. 590 mm (L) x 600 mm (B) with max depth 180 mm;
- c. No.1 WBT (C)
  - Found indented at stbd bottom plate in way of Fr.101 - 103, damage area approx. 500 mm (L) x 500 mm (B) with max depth 100 mm.
  - -Found indented at stbd bottom plate in way of Fr.104 - 105, damage area approx. 250 mm (L) x 400 mm (B) with max depth 100 mm, followed with crack on the bottom plate approx.300 mm (L) x 70 mm (B)
  - Found indented at stbd bottom plate in way of Fr.104 - 105, damage area approx. 500 mm (L) x 350 mm (B) with max depth 150 mm, followed with crack on the bottom plate approx.100 mm (L) x 20 mm (B);

- d. IWO Passageway (Port)
  - Stringer no.1 Fr.60 – Fr.62 found dented 1500 mm (L) x 1000 mm (B) max depth approx.50 mm. Several detached detected on fillet joint welding between deck stringer to side shell iwo Fr.61 approx. 100 mm;
- e. IWO Healing Tank No.5 (Port)
  - Found indented Side shell and long. side shell stiffener no.1 & no.2 counting from main deck Fr.60 – Fr.62 approx. size 1500 mm x 2000 mm, max. depth 50 mm approx, and no crack detected;

- f. IWO Upper Deck (Port)
  - Port railing approx. 8000 mm in length and 1(one) pc H beam with adjacent structure found damage and detached iwo Bay 36 (P);
- h. Bilge Keel Plate (Port)
  - Found damage at portside bilge keel plate (P) between Fr.61 – Fr.64, damage area approx. 4500 mm (L);

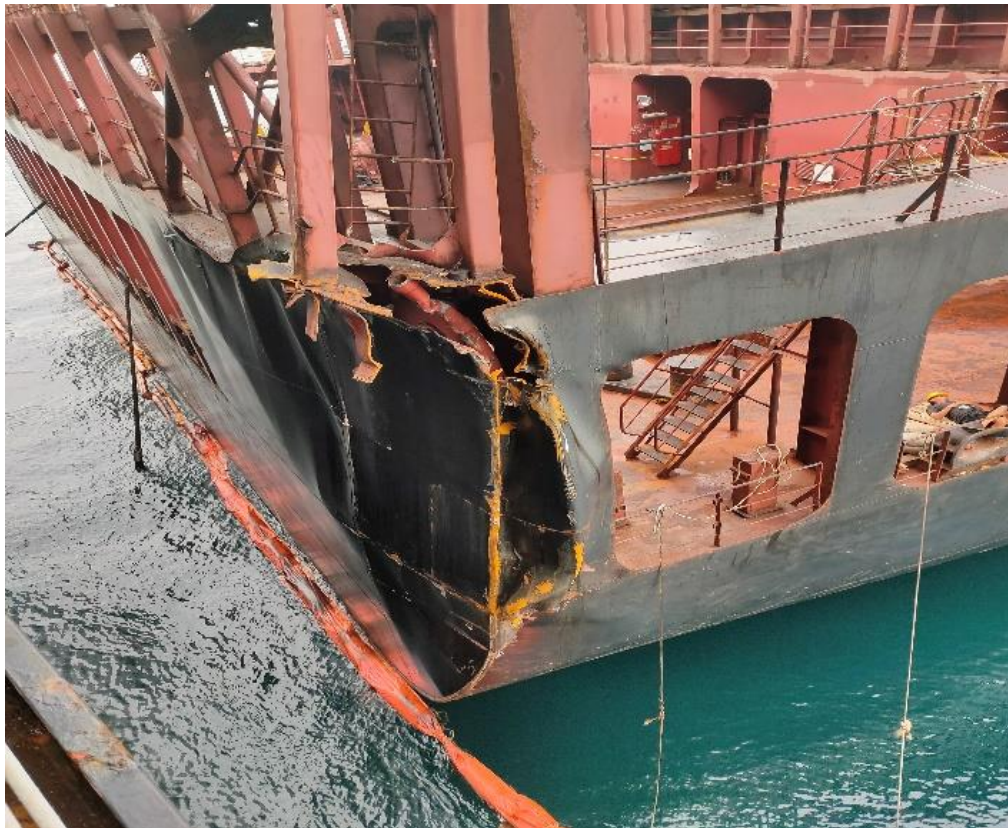
*Figure I-3: The Damage of Shahraz at the stern starboard side hull*

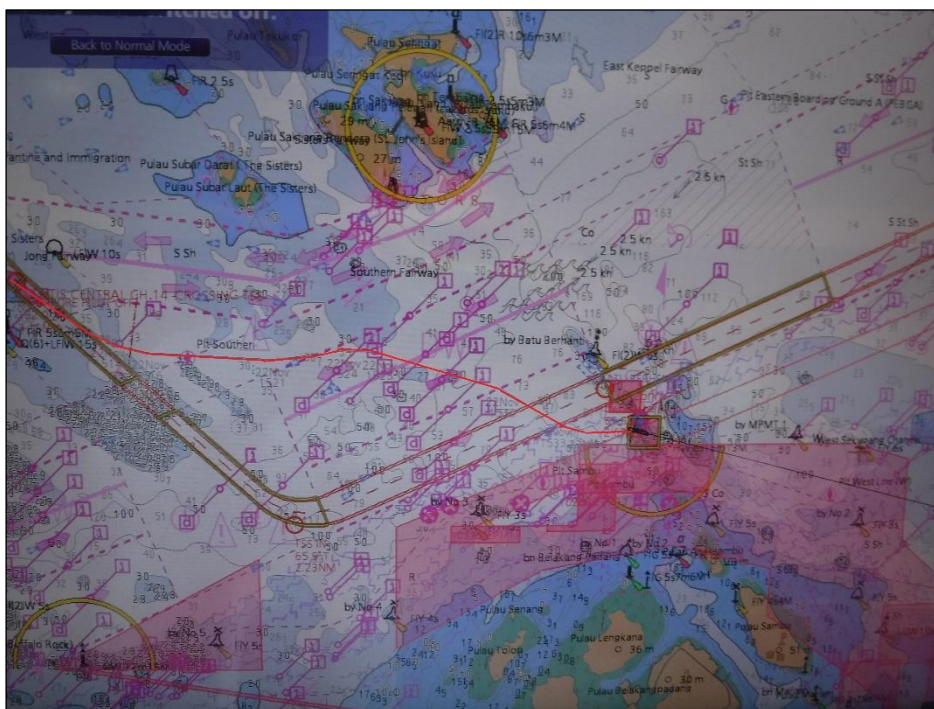
Figure II-1: The *Tina I*'s real track on ECDIS (red)

The ECDIS was meant to be used as a secondary aid to navigation. However, the passage plan entered in it was incomplete (Figure II-1) and did not utilise in-built safety features such as danger areas, safety depths, look ahead and predicted vessel movement. Both the master and third officer had attended an ECDIS course and should have been aware of the advantage of using these features; they should have checked to see that the equipment was correctly set up.

The passage plans referred to the maximum speed the vessel was required to transit each leg, but it failed to take into account confined water transits and contingency planning such as areas of expected increased traffic volume where speed may have to be reduced and other precautionary measures taken. For the passage through the Singapore Strait consideration should have been given to:

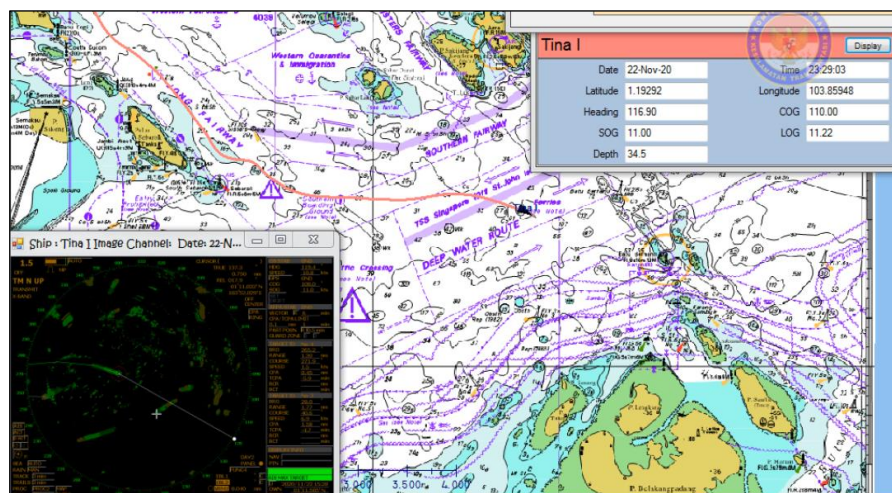
Figure II-2: Range of radar used on 1.5 NM (source:VDR)

Since *Tina I* commenced crossing TSS to the time of grounding, the bridge team monitored the vessel's progress on ECDIS and Radar. However, the Radar was inappropriately set up. The master used a range 3 NM when crossing the westbound lane before changing to 1.5 NM (Figure II-2). While there are good reasons for using a large scale, in this case it probably contributed to the master losing positional awareness as the tug and tow would not have appeared on the display until shortly before the vessel grounded. In addition, ECDIS feature has no danger areas were
