**NATIONAL TRANSPORT SAFETY COMMITTEE  
REPUBLIC OF INDONESIA**

**KNKT.20.11.11.03**

**Marine Casualty Investigation Report**

*Cape Kallia (IMO 9447160)*

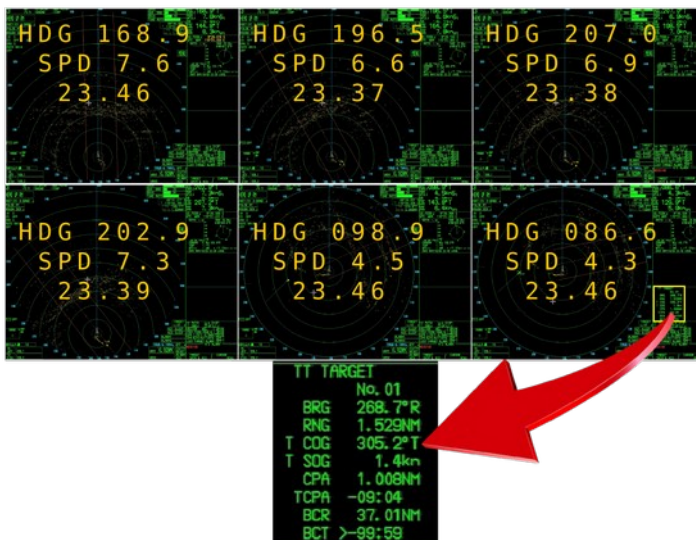
Figure 4: The *Kerinci Indah 02* was set as target (image: VDR *Cape Kallia*; radar time)

At around 03.46 LT, the 2/O set the *Kerinci Indah 02* as the target on the RADAR view for the first time. The range between them was around 1.4 NM (see Figure 4).

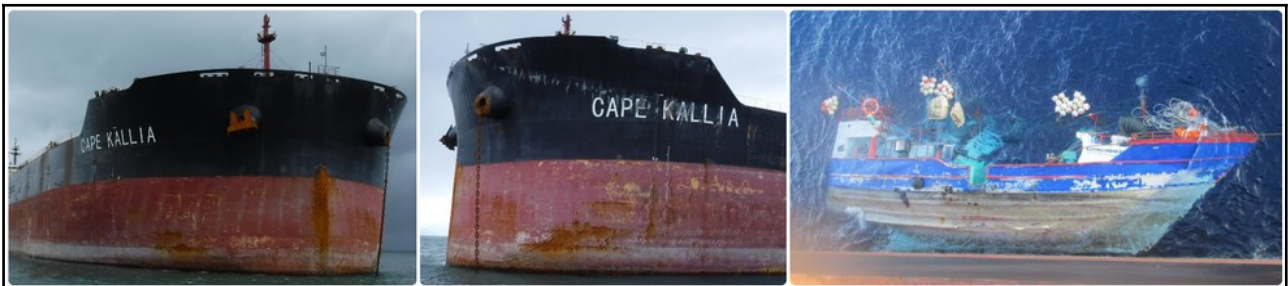
Figure 12: The condition of both vessels after the occurrence

The photos of latest condition of fishing vessel taken by a crew of *Cape Kallia* shown that the condition of the *Kerinci Indah 02* was not broken, only capsized to port side. If it was a collision, the fishing vessel would have been broken up into some pieces. Also, if it was a contact between both hulls, there should be an exchange of paint. Nonetheless, there was no paint of *Kerinci Indah 02* found on *Cape Kallia*.

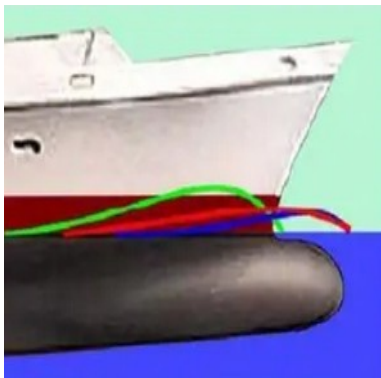
Figure 13: Illustration of impact of bow wave with and without bulbous bow

Another hypothesis was about the bow wave. The *Cape Kallia* has no bulbous bow. The impact on movement of non-bulbous bow vessel is a big wave created during her sailing (Bui, et. al. 2021). The bow wave created a greater resistance for the ship due to the pressure difference of water while vessel moves ahead in a certain speed.

In contrast, a vessel equipped with bulbous bow will have a relatively smaller bow wave. The bulbous bow works to break the bow wave before the wave comes to the hull. Without the bulbous bow, the brake wave along the hull will create a bigger wave as well as speed reduction.

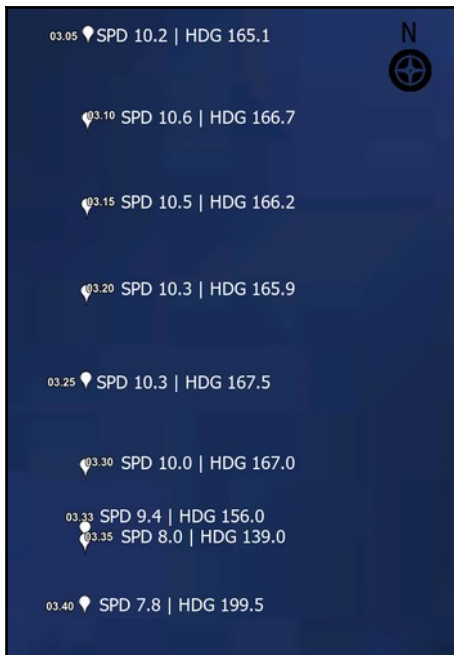
Figure 15: Timeline of Cape Kallia's position

Recognising an object in further was a good action took by the OOW in the beginning of appearance of the unknown object. This situation meant the fishing vessel should alter the direction, instead of the bulk carrier. However, the bulk carrier noticed that the fishing vessel kept

on her direction in an insufficient time. Referring to the Rule 8 COLREGs, when the give way vessel did not change the direction, the stand on vessel should take an immediate action to avoid collision. This action was also covered by the Rule 15 COLREGs which allows any action taken as long as the result is to avoid collision.

Referring to the Rule 7 of COLREGs, when the OOW were not sure whether the unknown object was moving approaching them or stay (e.g. catching sea products) and whether the object was power driven or not, they should deem the worst possibility exists. By applying this worst case scenario, the OOW would make decision to take much wider gap whilst passing it, instead of relying the object to move away from its position/direction. Further, the Rule 5 of COLREGs also requires the OOW to apply all appropriate and significant action to the prevailing circumstances and conditions to determine if risk of collision exists or deemed exists.

1. To ensure the crew members treat an uncertain hazard as exists and to take precautionary actions in an ample time.

Regarding this recommendation, the Transmed Maritime, Ltd. has done the safety action by revising the navigation procedures, specifically at the Bridge Standing Orders and the Collision Avoidance.

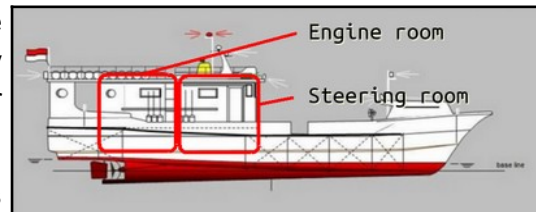
*Figure 16: An example layout of typical fishing vessel*

Based on the layout of engine and steering rooms was really poor. In the typical vessels, usually both rooms only separated by a few metres and most of them area located adjacent. The door used had no requirement to reduce the loud of engine noise. The very loud noise from both main and auxiliary engines made the Skipper unable to hear clearly the sound of the wave and whistle of vessel approaching.

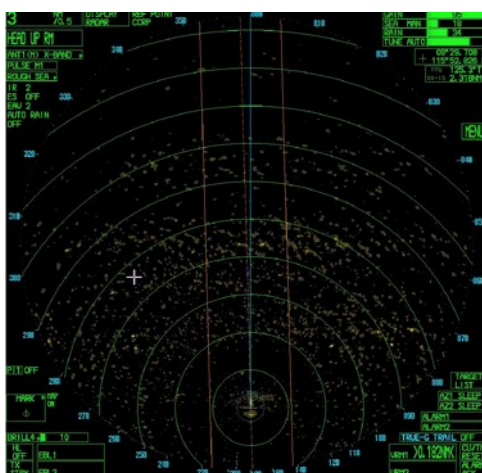
Figure 17: An example of difficulty in checking fishing vessel on RADAR

The absence of AIS on board the wooden fishing vessel means the vessel was hard to be spotted by RADAR. The other vessels in the night will need a time to ensure about something with the lighting on board. The Ministry of Fisheries actually had developed a lite version of AIS, named AIS Wakatobi. Although the capability has been reduced, but if it is installed on board a fishing vessel, the other vessels would be able to see the data transmitted by the lite AIS. This function would clearly enhance the safety with an affordable cost for the fishermen. However, the device has not come to the market until this report has been completed.

1. To coordinate with the Directorate General of Sea Transportation, Minister of Transportation in in providing a transmitter of locator and vessel data with affordable conditions for most fishermen to support the Vessel Monitoring System (VMS) for fishing vessels under GT 30.
