**NATIONAL TRANSPORT SAFETY COMMITTEE
REPUBLIC OF INDONESIA**

FINAL REPORT

Marine Casualty Investigation Report

***ASIAN CHAMPION* (IMO 9474656)**

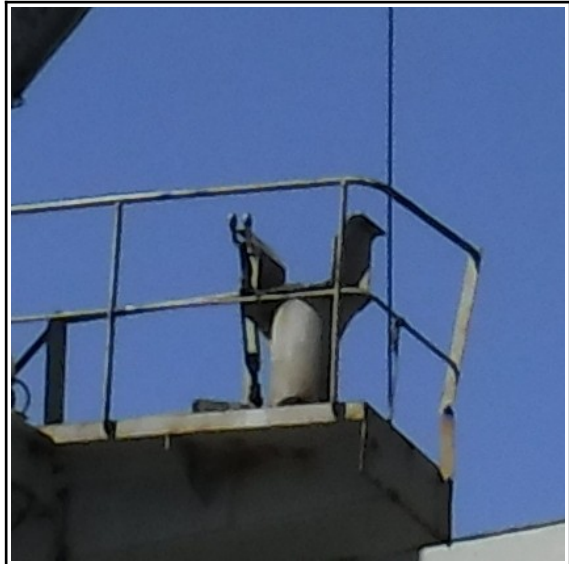
At around 08.06 LT, when the Bosun was sitting in the cabin of Crane No. 3, he could not see both cadets in the vicinity of the jib, unless for one of those. The Bosun thought that both Cadets had already completed securing the chain and electric wire and were standing clear the head of the crane boom. The Bosun then began to lift up the crane boom. When the boom just out of the crane resting point, the tail (extra tip down part) of the boom swung into the right direction immediately (about 10 cm), that swing rightly hit the back of Cadet B. He immediately collapsed on the resting platform and remained unconscious.

Figure 2: A resting platform of Asian Champion

- The Cadet B was declared death on arrival.
- The Crane No. 3 had no issue or damage before and after the accident.
- The visual from crane cabin to the resting platform was partly obstructed by the crane.
- The Cadet A had no visual issue with the brightness of sunlight.

1. To revise the existing procedure of crane works to be more detailed, particularly in regards to the safety of workers on the resting platform, how to communicate between workers on the platform and the crane operator as well as releasing the crane tension.

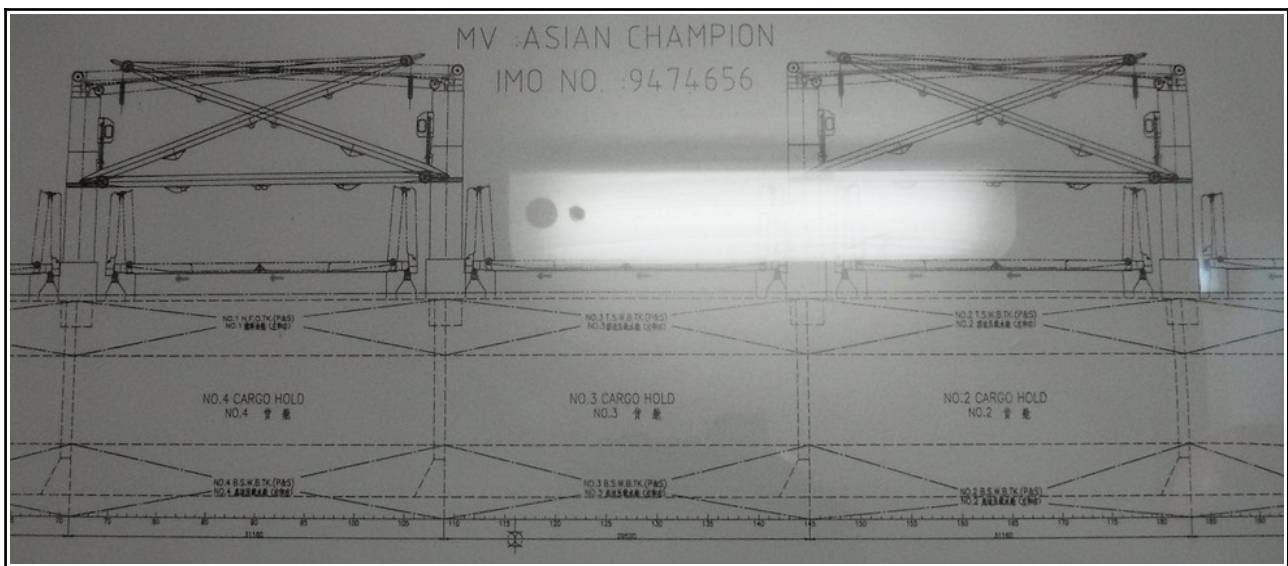
Figure 3: Cranes of Asian Champion

The *Asian Champion* has four cranes to un/load cargo in her five cargo holds. The resting point of Crane No. 1 is located at the Crane No. 2, while the resting point of Crane No. 2 is located at the Crane No. 1. The same relation also happens to the Crane No. 3 and No. 4.

There was no modification recorded on the Crane No. 3 and its resting point. The only change was in terms of maintenance of the Crane No. 3, such as the renewal of luffing wire in June 2019 and the hoisting wire in December 2020. Since November 2020, all ship's cargo cranes have been operated about eight times without any issues.

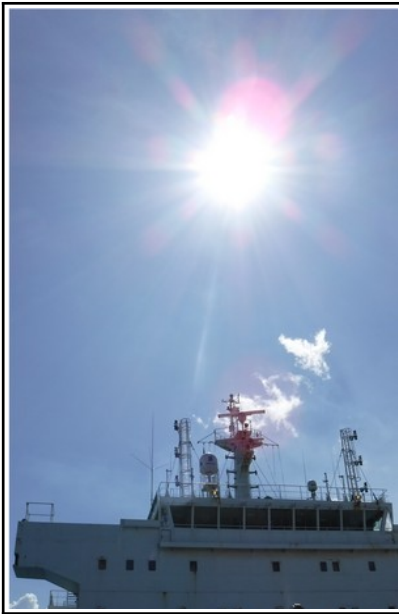
Figure 4: Sunlight at around 09.00
LT

After completing the berthing works, the Bosun did not feel any tiredness, sleepy or unwellness. He felt the everything was as normal as usually, including when he was sitting in the crane cabin. At the accident time, the Bosun did not feel the sunlight was too hot or too bright for him (see Figure 4).

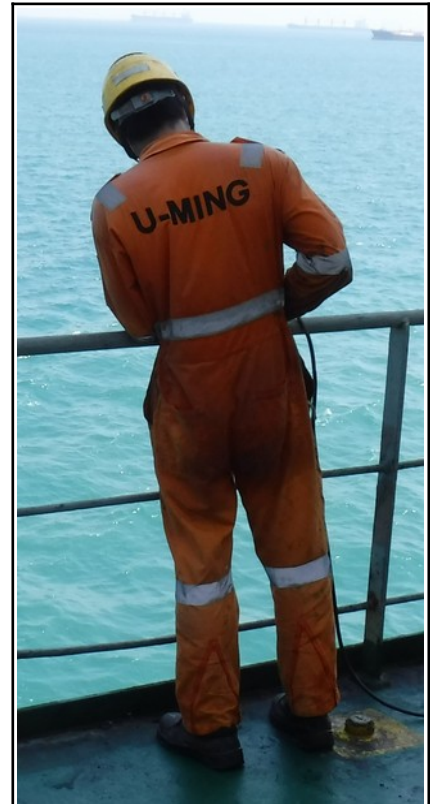
Based on interview with the medical staff of hospital and several crew members, the Cadet B wore the usual safety gear at the time of the accident. The safety gear comprised of boots, overall and helmet.

Figure 5: Sample of the safety
gear wore by Cadet B
