KNKT.07.05.10.04

Aircraft Accident Investigation Report

Indonesia AirAsia

Boeing 737-300, PK-AWP

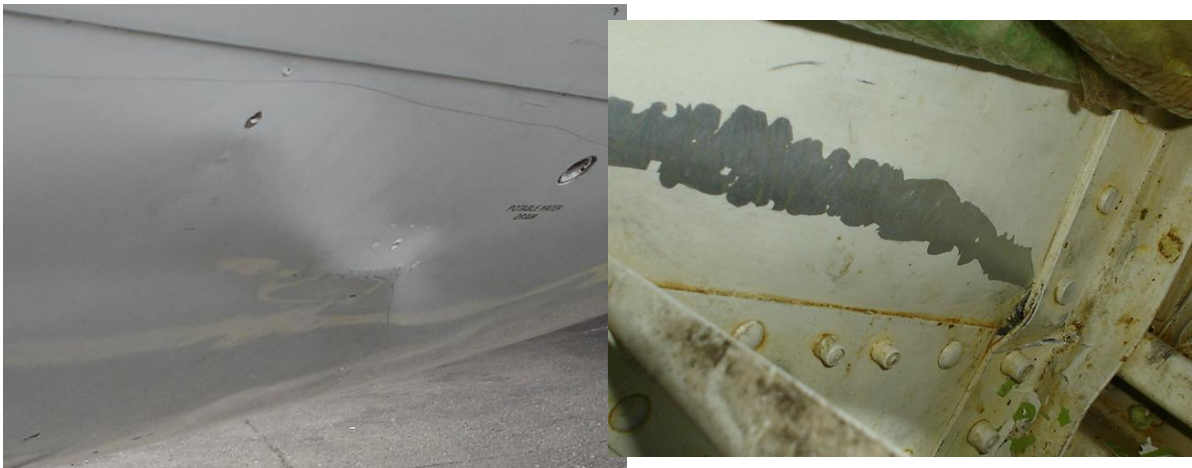
The Flight Data Recorder (FDR) recorded that during touchdown the indicated airspeed was 190 knots while the target landing speed was approximately 130 knots and the vertical acceleration was 4.8 g.

During turn around check found 14 tie bolts of the left nose wheel detached which one of the tie bolt could not be found, the left nose wheel tire deflated. Fuselage skin above the nose wheel wrinkled and deformation was also found on this section. The left main landing gear bearing and axle were found to be damaged.

Figure 1: wrinkle of the fuselage skin and structure damage on the nose landing gear area

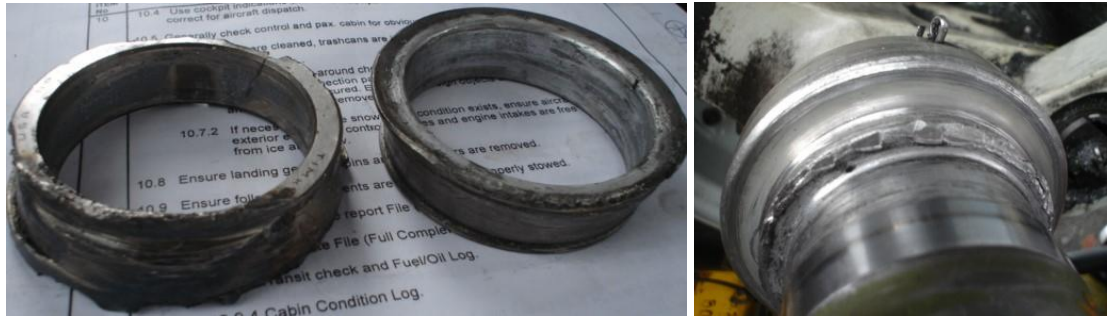
Figure 2: damage on the left main landing gear axle and bearing
