**Aircraft Accident Investigation Report**

**PT. AVIASTAR MANDIRI (Pty Ltd)**

**PK-BRM ; CASA 212-200**

**11 January 2007**

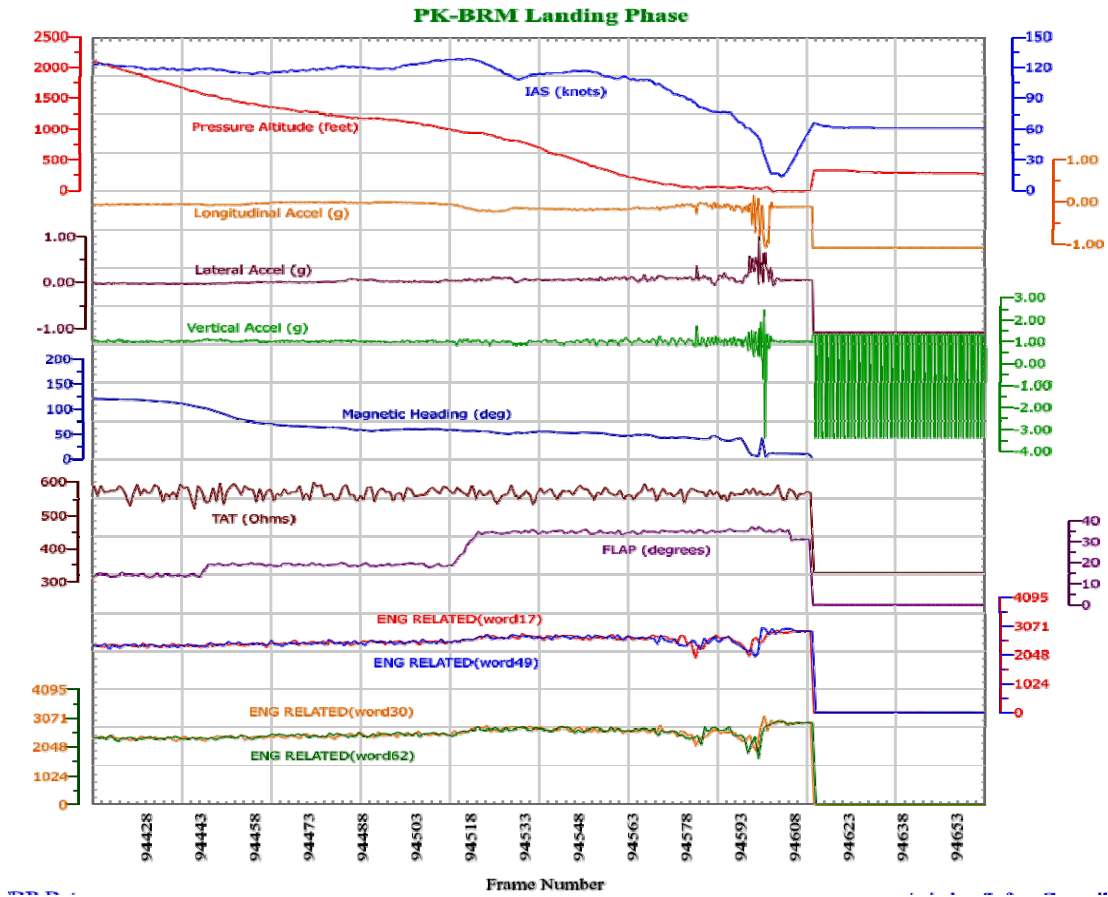
Figure 1: Results of the FDR Readout

The Reading of the FDR was carried out at the FDR readout facility of the Aviation Safety Council, Taiwan.

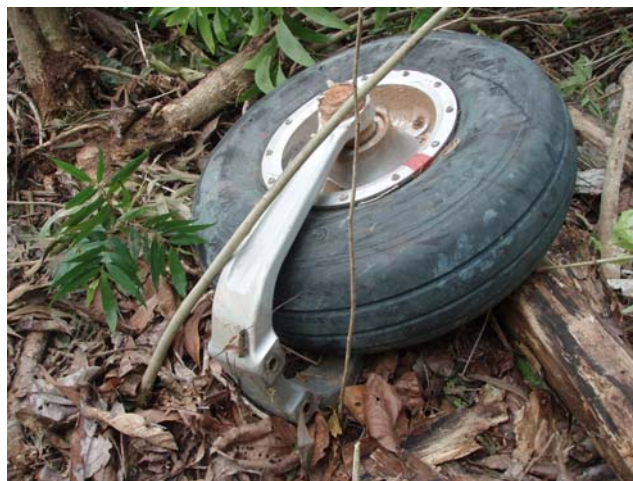
The nose landing gear separated from the aircraft and the lower part of the nose section including the radome, and the cabin floor were substantially damaged. The leading edges of both wings were substantially damaged.

The nose landing gear separated from the aircraft during the impact with an embankment. The aircraft came to rest amongst trees, with the wings and lower fuselage substantially damaged.

**Figure 2: Severed nose landing gear**

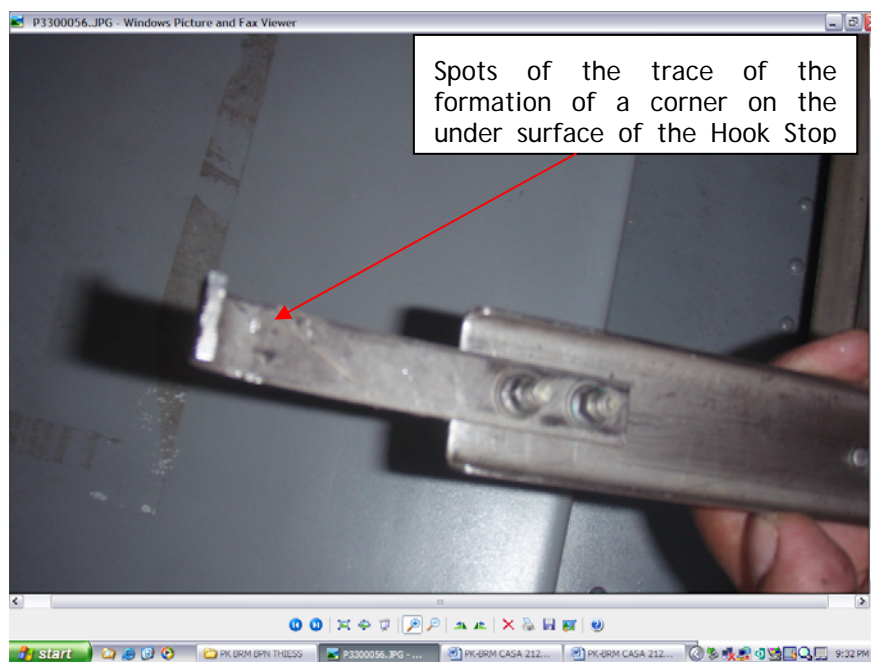
The investigation found that the power-lever, anti-reverse locking system showed signs of wear to the lower surface. However, there was no evidence that this contributed to the accident.

**Figure 3: Hook Stop of the Anti Reverse System**

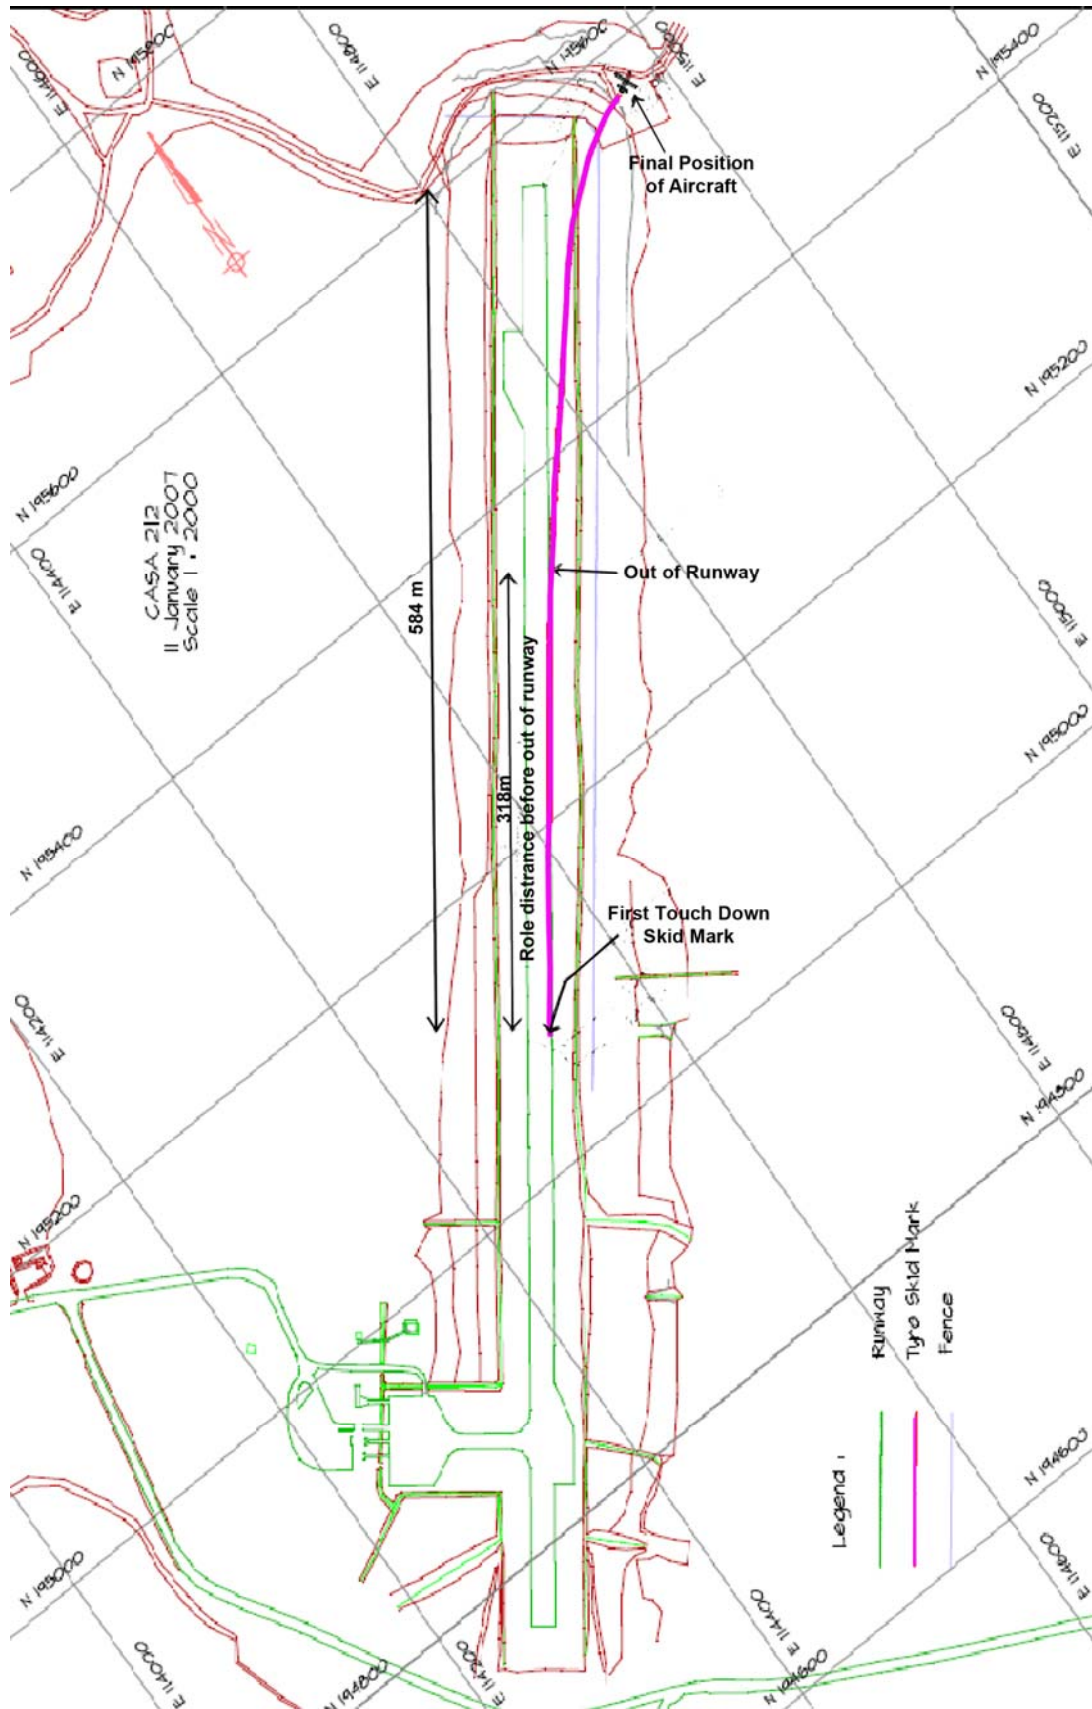
Figure 4: Sketch of the accident location for PK-BRM (not to scale)

An imprint of the left main landing gear was found 400 meters from the end of runway 04, and 2 meters to the right of the verge of the runway at an angle of approximately 10 degrees from the runway.

The first imprint of the right main landing gear was found about 150 meters further on from that imprint of the left main landing gear. Further right main landing gear imprints indicated that the aircraft bounced three times. The aircraft touched down with the right main landing gear settling on the grass and sank into the soft wet ground. The right main landing gear subsequently left a heavy continuous imprint in the soft ground providing evidence of an abrupt turn to the right before the aircraft impacted the embankment.
