# **NATIONAL TRANSPORTATION SAFETY COMMITTEE**

**Aircraft Accident Investigation Report**

**Piper Seneca PA-34  
PK-JKS; PT. Air Transport Service**

**Kasiguncu Aerodrome  
Central Sulawesi  
Republic of Indonesia**

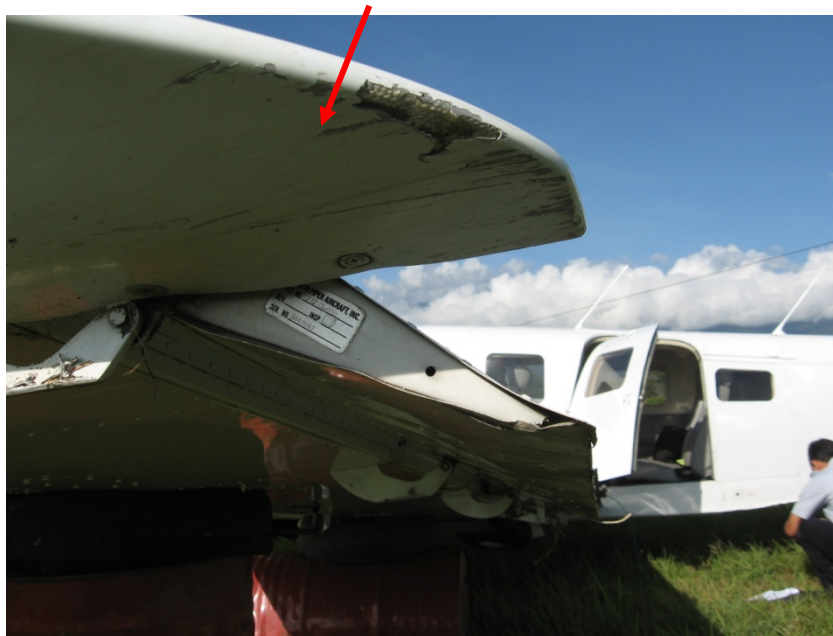
- The wing tip had scrape abrasion marks and was cracked in several places.
- The two (outer and inner) aileron hinges had abrasion marks from dragging along the runway.
- The aileron was wrinkled on the trailing edge.
- The Flap trailing edge and flap trim tab sustained significant abrasion damage.

Figure 1: The Wing tip was partly scored and cracked.

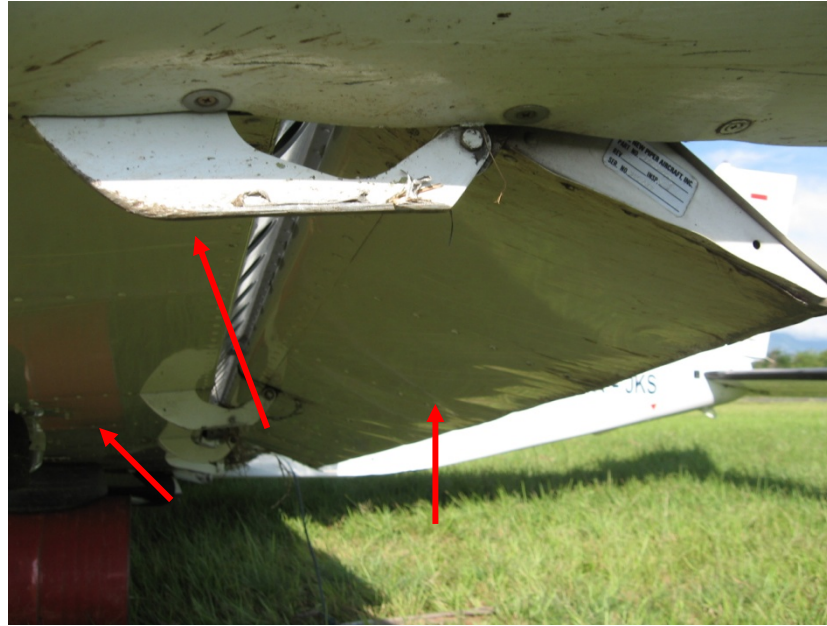
Figure 2 : The 2 (outer and inner) aileron bracket hinges were scraped on the runway surface.

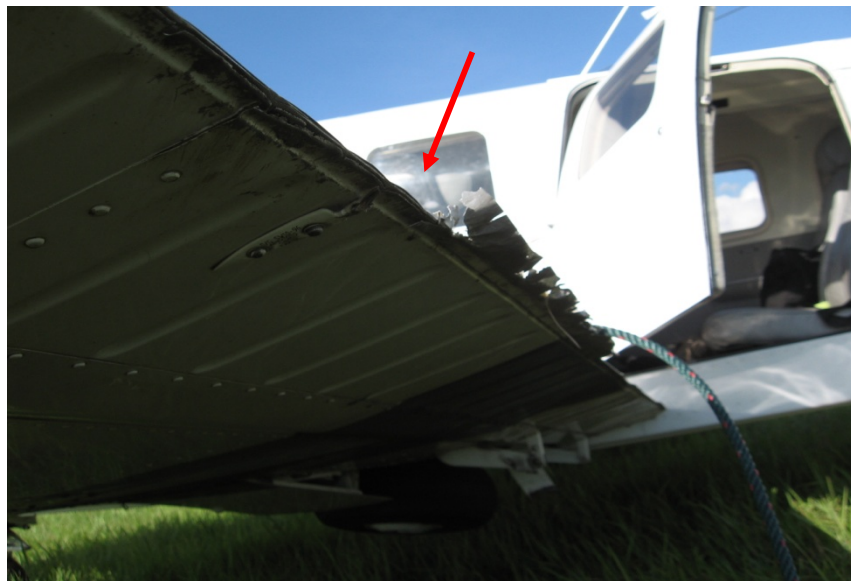
Figure 3 : Damaged Flaps on the trailing edge .

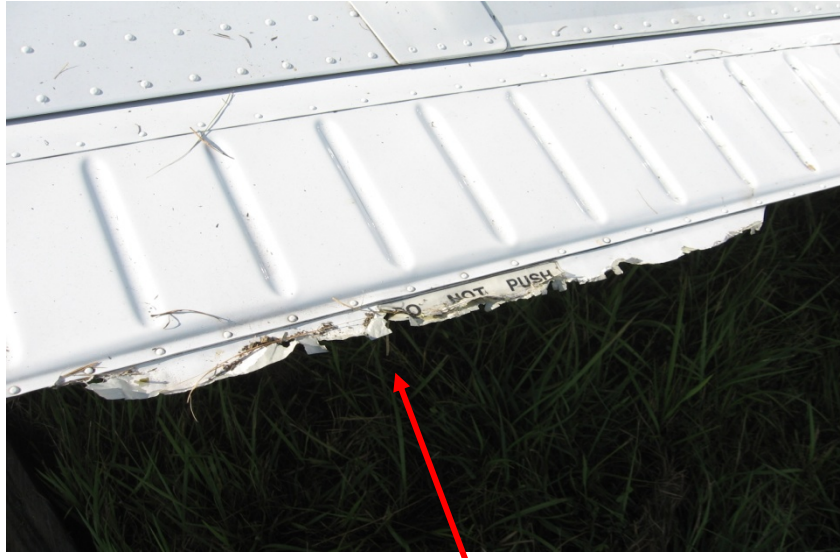
Figure 4 : Flap Trim Tab damaged from runway scraping

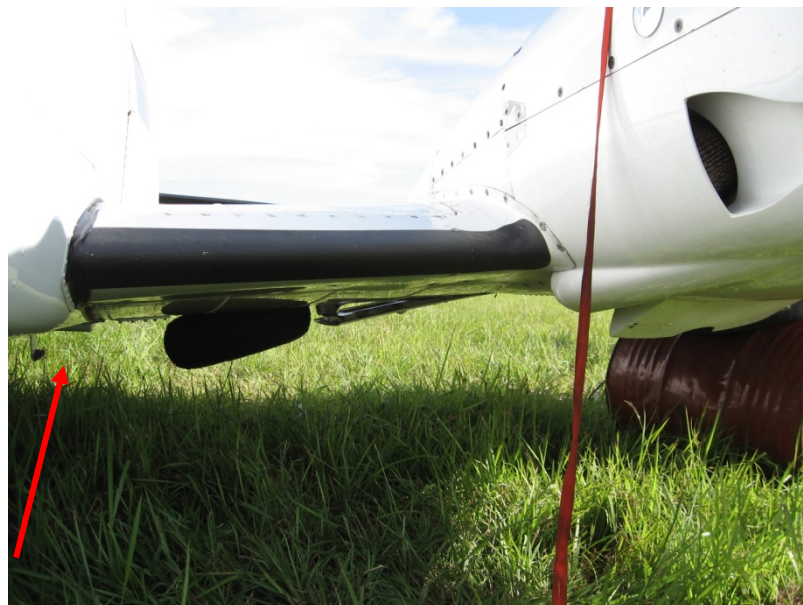
The Left main landing gear was in the retracted position. The tire only sustained minor scuff damage as a result of scraping on the runway.

Figure 5 : The Left MLG in its folded stored position

The investigation determined that there was no evidence of any defect with the landing gear micro switches, or hydraulic system. The left main landing gear had evidence of some movement in the area of the down lock. The landing gear was only 2,592 hours since new. The investigation was not able to conclusively determine that the noted movement could be linked to the landing gear unlocking and subsequently retracting. The manufacturer's time between overhaul for the landing gear is 10,000 hours.

The investigation was not able to determine why the landing gear retracted during the landing roll.

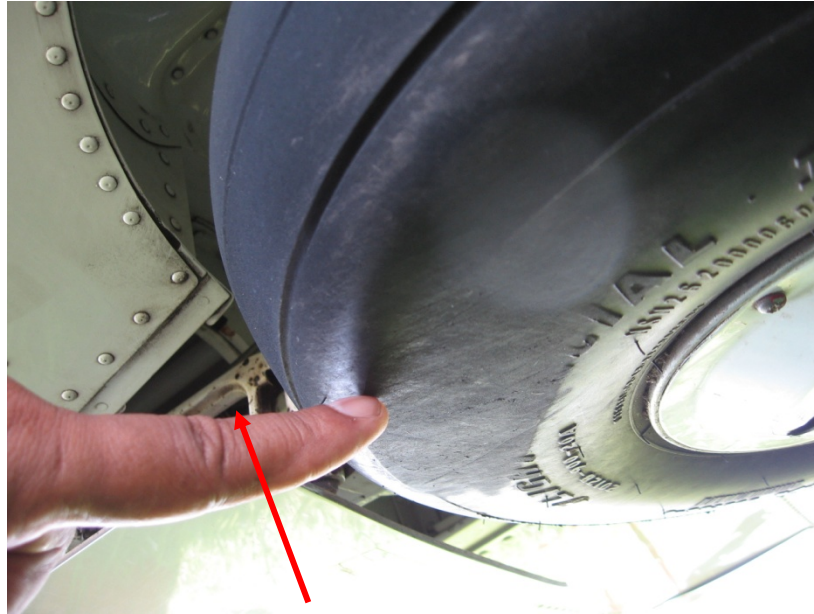
Figure 6 : The Left Tire, the outside of which scraped on the runway

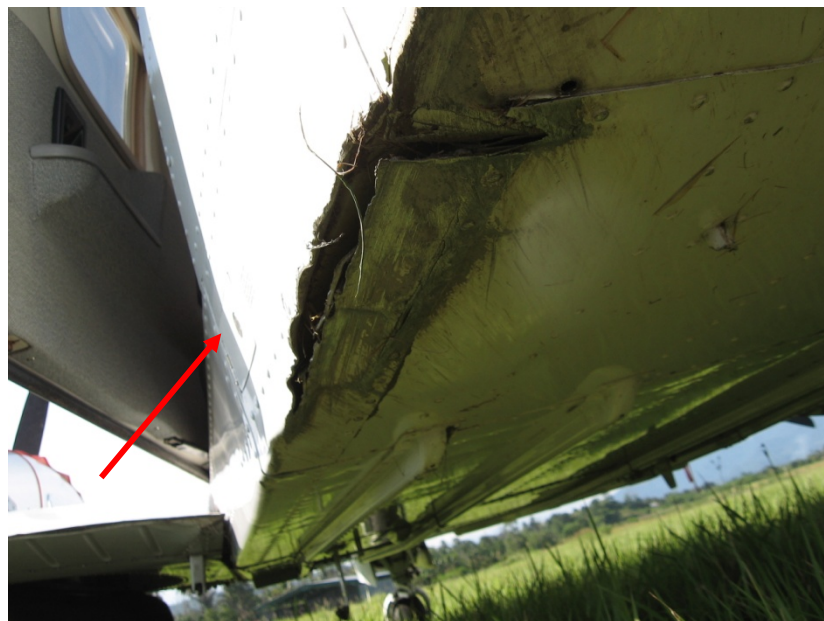
The fuselage under the rear left cabin door sustained damage to skins and frames; 60 centimeters in length. The ADF Antenna was significantly damaged due to scraping on the runway.

Figure 7 : The Cabin Skin Former underneath the passenger door

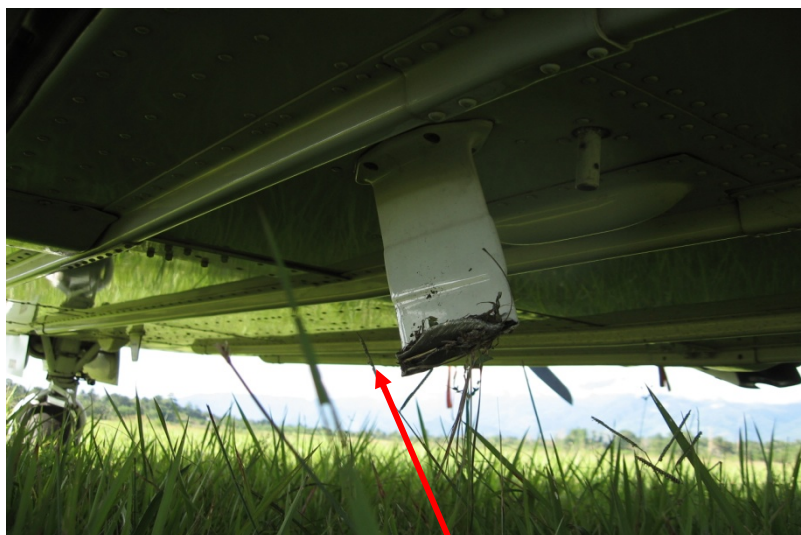
Figure 8 : The ADF antenna damaged at the end

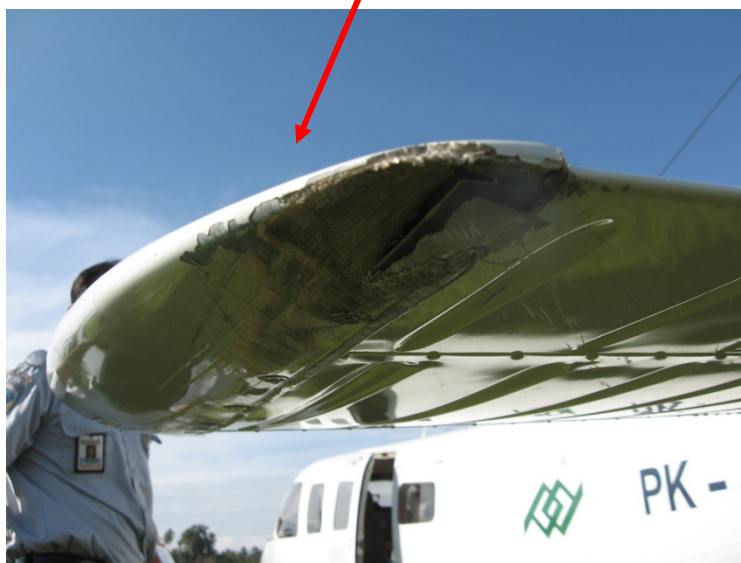
The left Elevator Tip Cover (Fiberglass) was damaged on its lower trailing section.

Figure 9 : Damage to the tip cover of the left Elevator (Fiberglass)

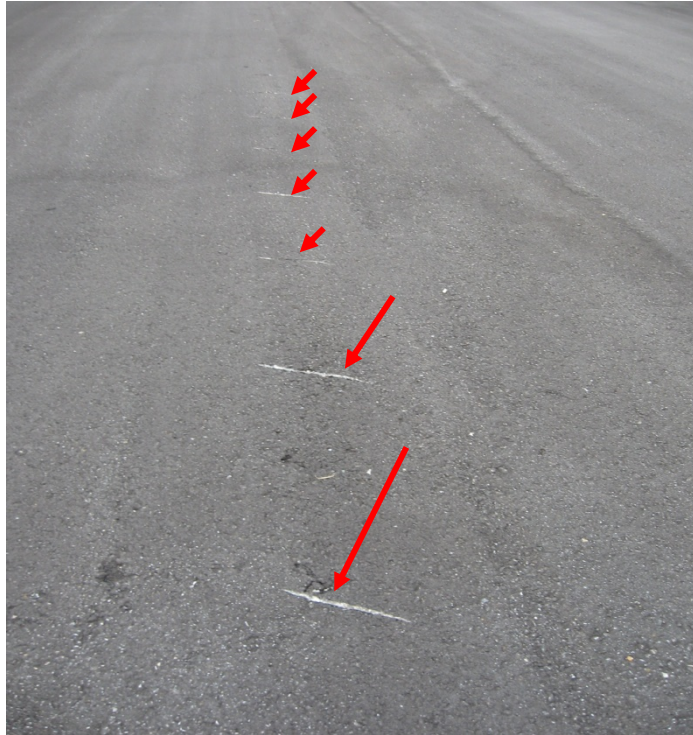
Slash marks from the left propeller were found for 100 meters on the surface of runway. The indentations were 5 mm in depth.

Figure 10 : Propeller blade marks which struck the runway

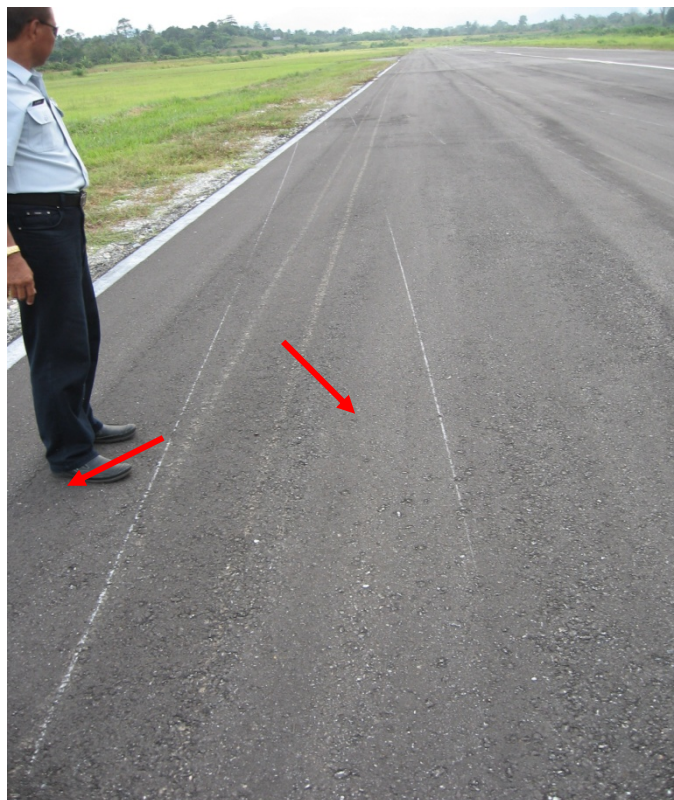
Figure 11 : Marks left by the aileron bracket hinges

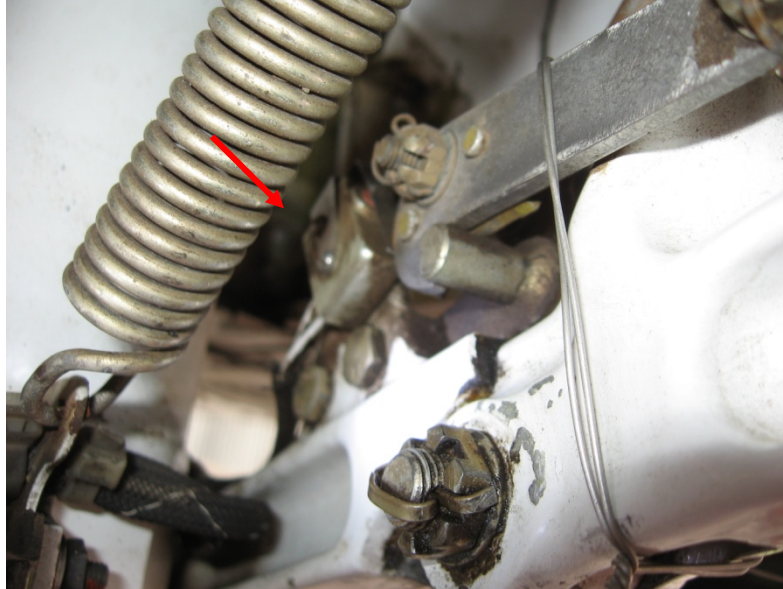
Figure 13 : The micro-switch for the main landing gear down lock was not damaged

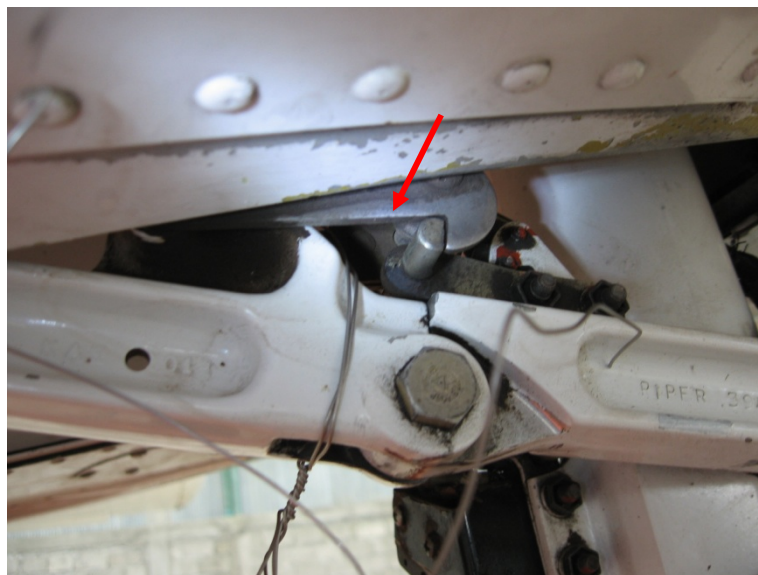
Figure 14 : The position of locking devices was normal
