**FINAL**  
KNKT.07.05.12.04

# NATIONAL TRANSPORTATION SAFETY COMMITTEE

*Aircraft Accident Investigation Report*

**PT. Perkebunan Nusantara II  
Piper Pawnee PA 25-235; PK-PNM  
Klumpang Tobacco Plantation, Deli Serdang,  
Medan, North Sumatra  
Republic of Indonesia**

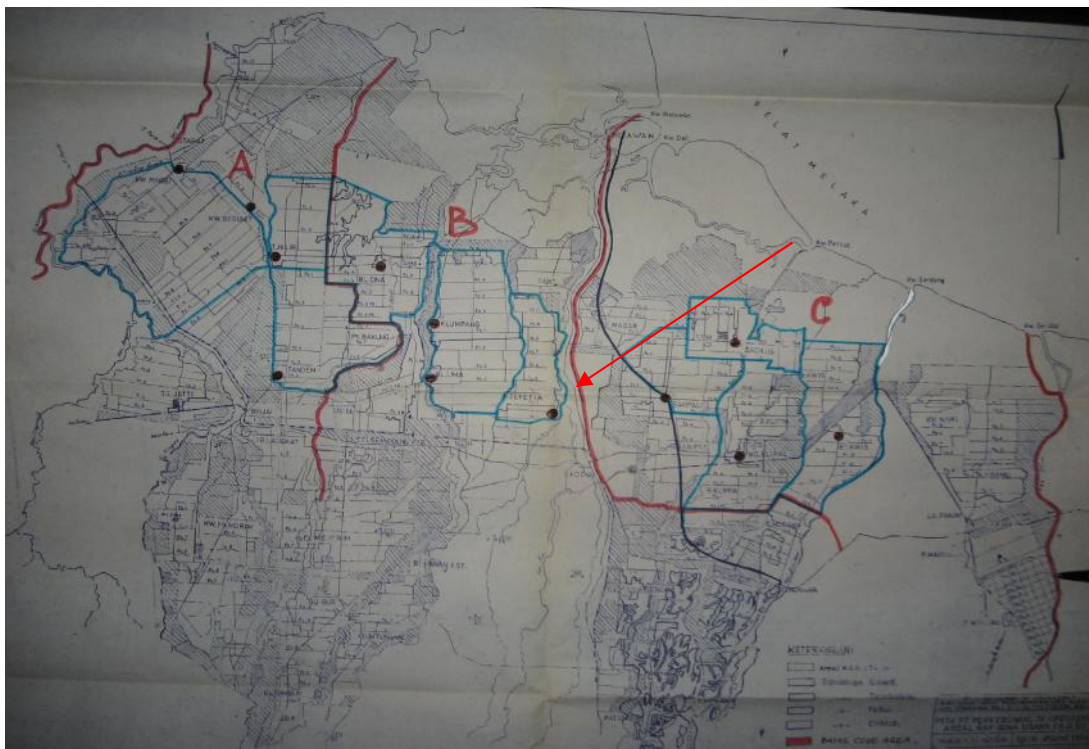
Figure 1: The occurrence site on the tobacco plantation area

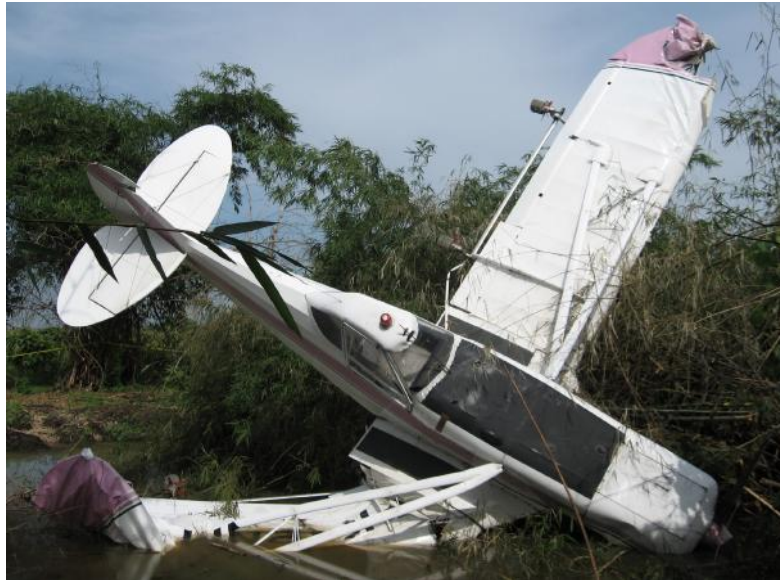
**Figure 2: The aircraft last position**

The aircraft stopped at about 50 meters from the impacted bamboo trees with left wing on top at an angle about 90° and fuselage at an angle about 45° relative to the ground (see Figure 2)

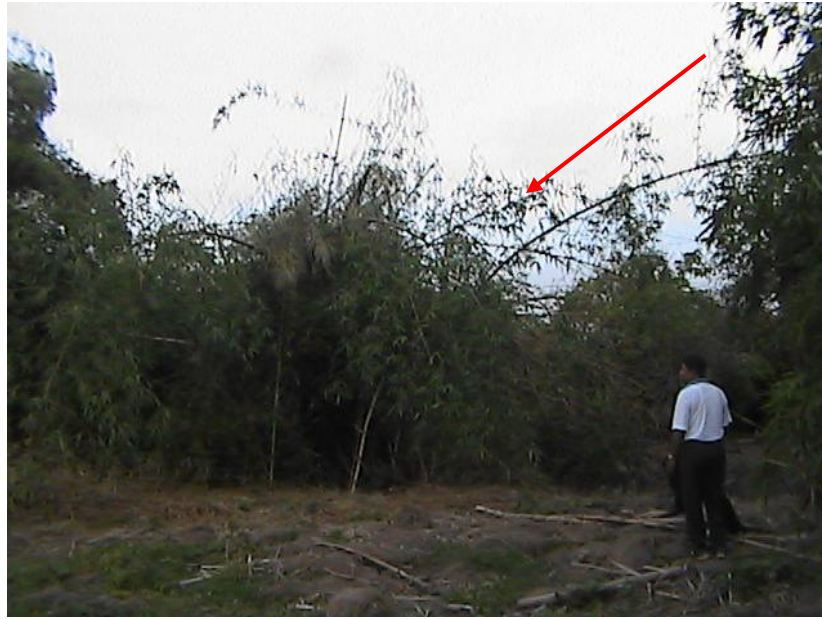
The right wing, left wing and wing strut was broken and damaged.

The left wing tip was hit a top of the bamboo trees and then impacted with ground (see Figure 3).

**Figure 3: The bamboo trees affected by the aircraft wing**

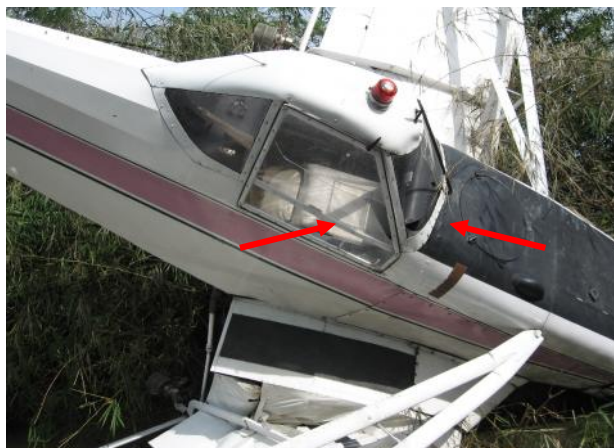
The aircraft windshield was broken.

**Figure 4: The broken windshield**

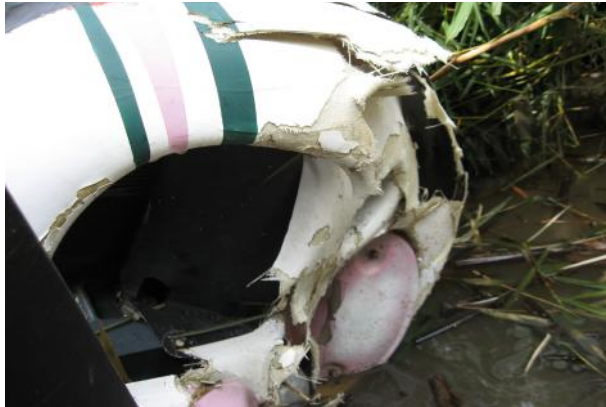
The aircraft engine cowling was broken. The lower engine cowling was broken and bamboo pieces in the engine cowling.

**Figure 5: Bamboo pieces in the engine cowling**

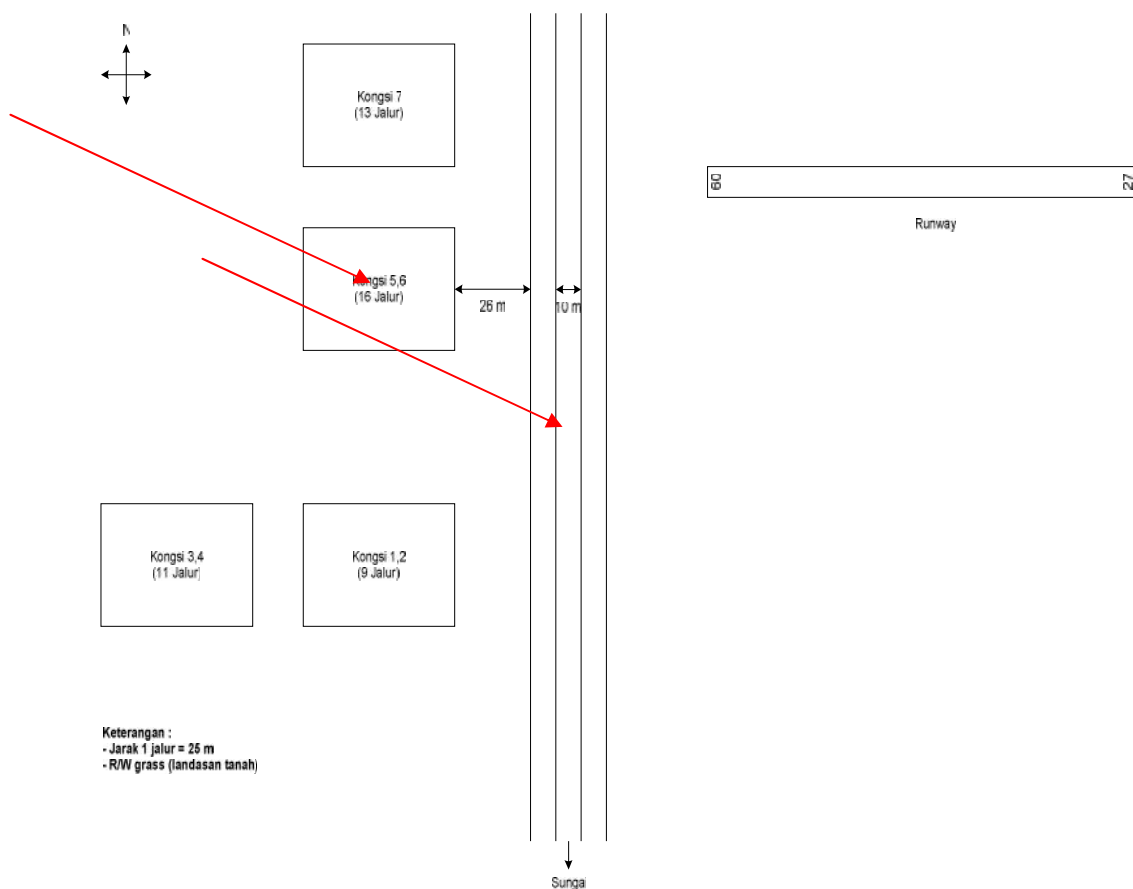
At the time the accident, the witness who is an aircraft maintenance engineer informed that the wind blow extremely and the aircraft most likely lost of control. The wind came from direction about 300 degrees sporadically; meteorology data informed wind direction 120 degrees and speed 8 knots.

Figure 6: The wind direction scheme

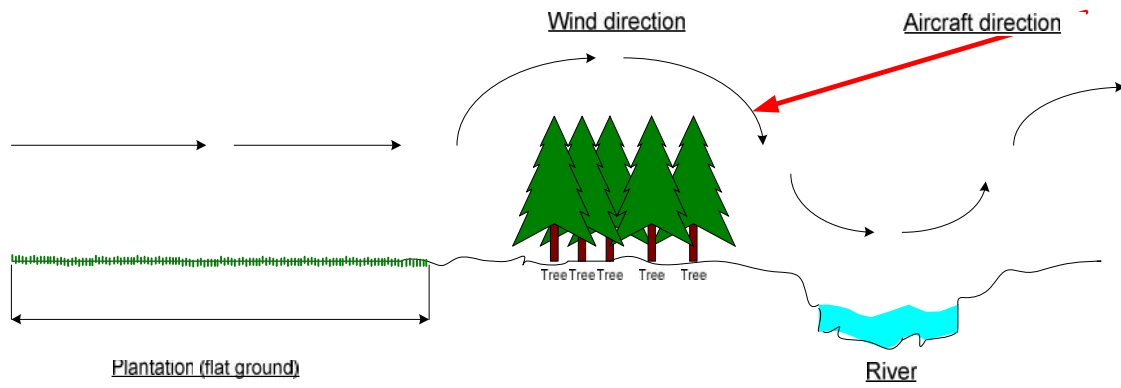
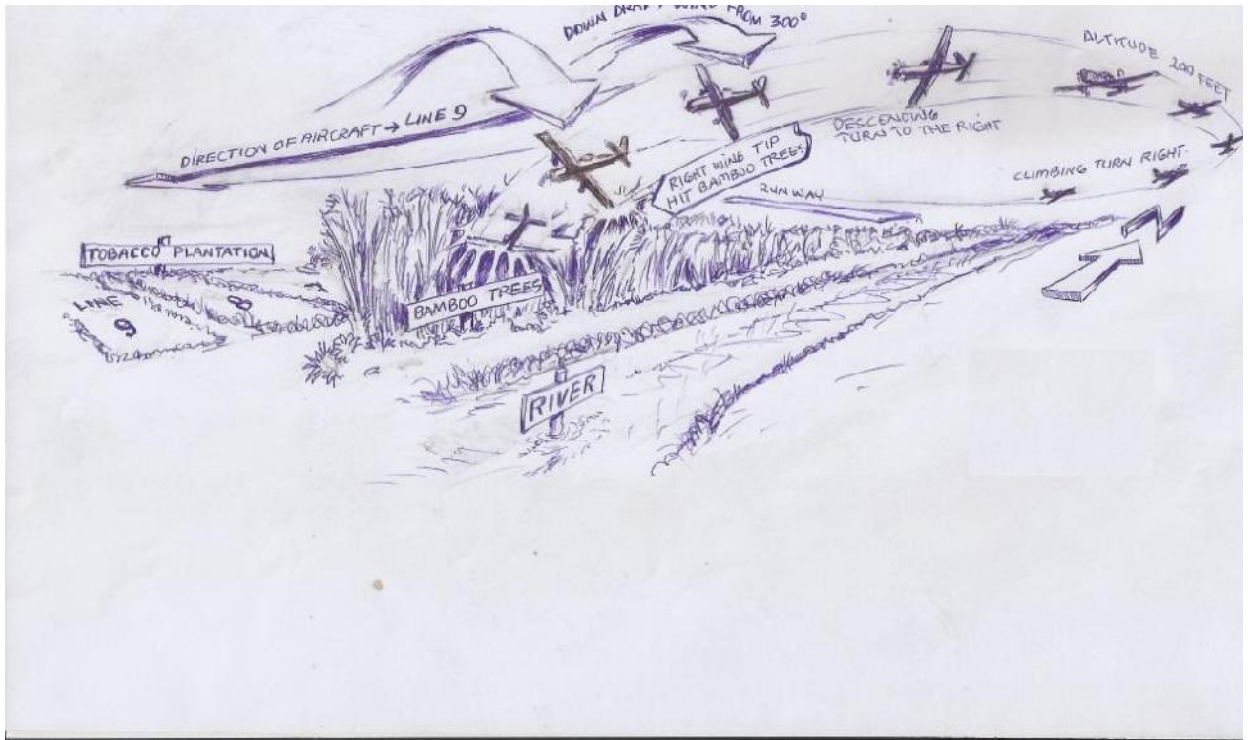
The aircraft departure from the airstrip and then the aircraft climb turned to the right to chose the area plantation. After the aircraft reach altitude 200 feet, the aircraft descend and turn to the right to line 9 area plantations. While the aircraft descend over the river, the aircraft has experience of down draft and the right wing hit the bamboo trees, then the aircraft un-controlled and crash.

It might indicate that the aircraft was full load operating weight and entering the turbulence at the low altitude caused the aircraft lost of altituded and uncontrolled

Figure 7: accident illustration (not scale)
