FINAL
KNKT.07.14.06.04

Aircraft Accident Investigation Report

**Trigana Air Service
de Havilland DHC 6-300 Twin Otter; PK-YRU
Mulia Airstrip, Papua
Republic of Indonesia**

1 June 2007

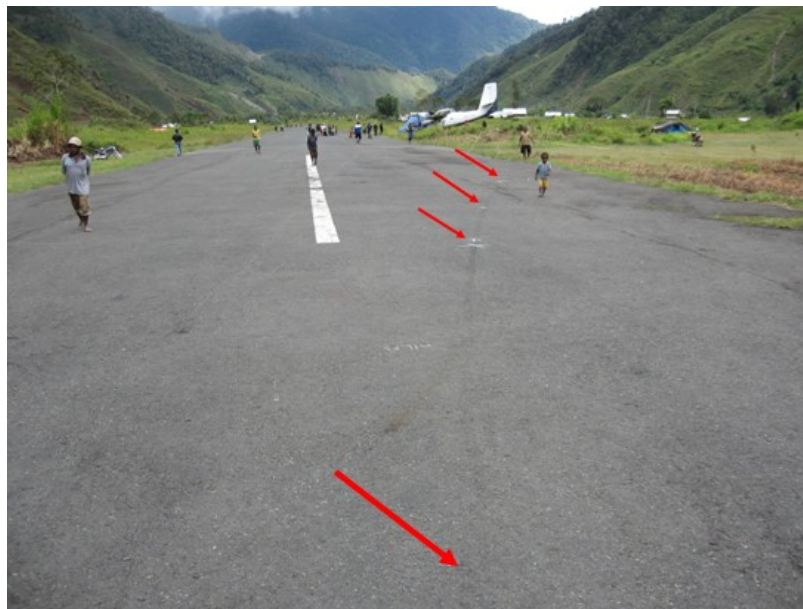
On Friday 1 June 2007, a de Havilland Twin Otter DHC 6-300, registered PK-YRU overran the right side of the runway during the take-off roll. The aircraft left the runway and impacted a ditch and rocks on the right shoulder of the runway. Main-wheel tire marks for more than 65 meters on the runway indicated that heavy braking action was being applied to the left brake.

Figure 1: Left main wheel track showing runway excursion to the right

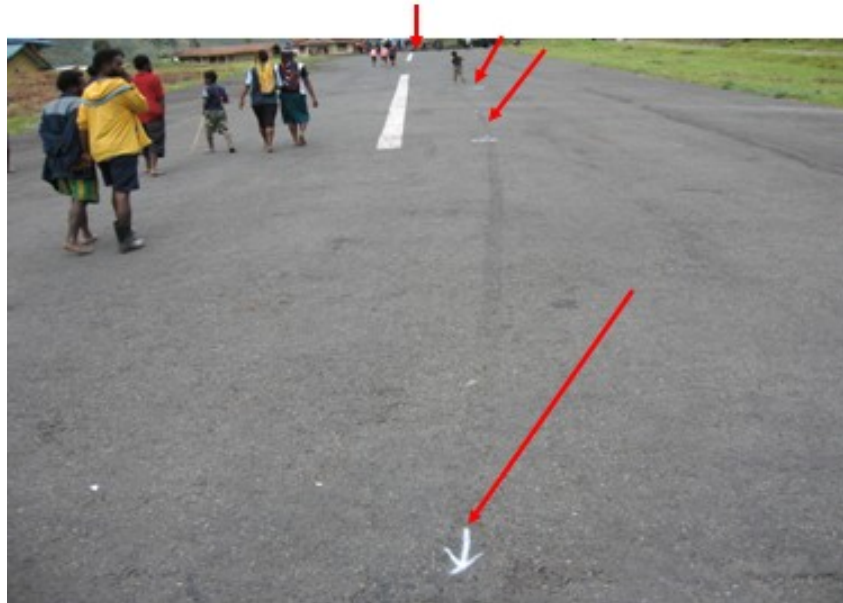
Figure 2 : View looking up slope back along the take-off track

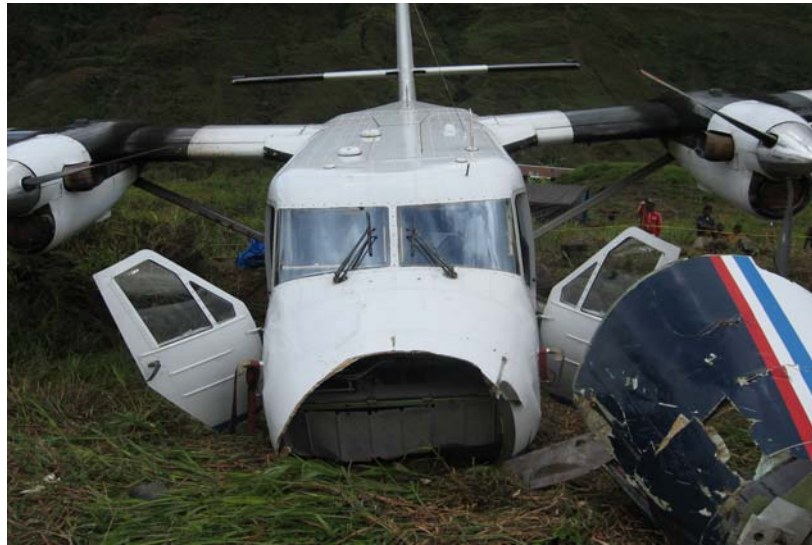
Figure 3 : Forward fuselage substantially damaged

The nose section, including the radome and the nose landing gear housing, was substantially damaged.

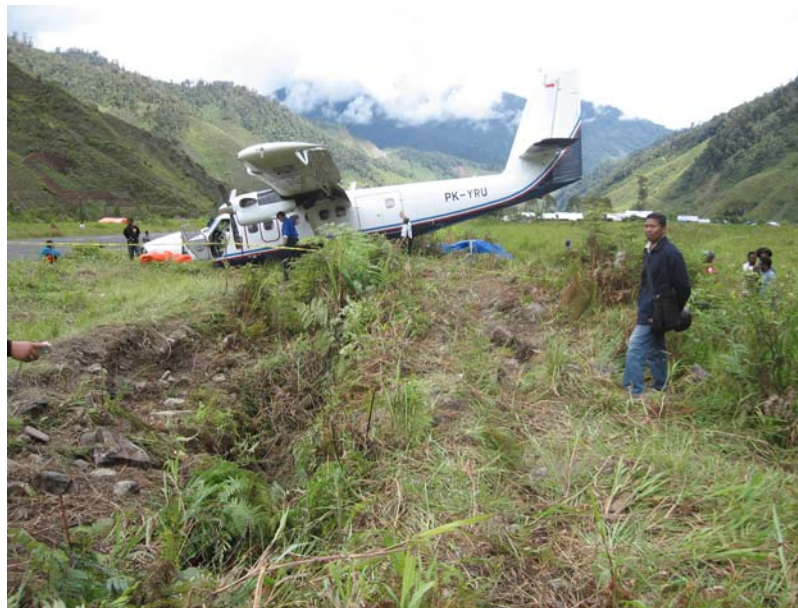
Figure 4 : The right shoulder of runway 27 showing rocks and ditch

The aircraft subsequently entered the runway shoulder, which had a ditch and was covered with slippery grass and large rocks.

The National Transportation Safety Committee recommends that the Directorate General of Civil Aviation review the safety of the Mulia runway shoulder area and require the airport operator to ensure that there are no obstacles to safety, such as ditches and rocks, to prevent an aircraft from safely negotiating the runway shoulder in the event of a runway excursion.

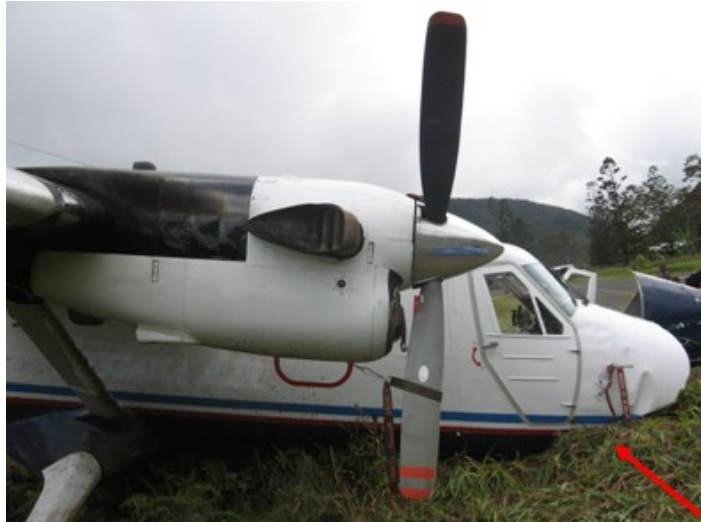
The nose landing gear was fractured, the struts were separated from their housing, and the nose wheel was damaged. The nose landing gear strut was damaged as result of impacting rocks and a ditch.

Figure 5 : Nose landing gear area indicated by arrow

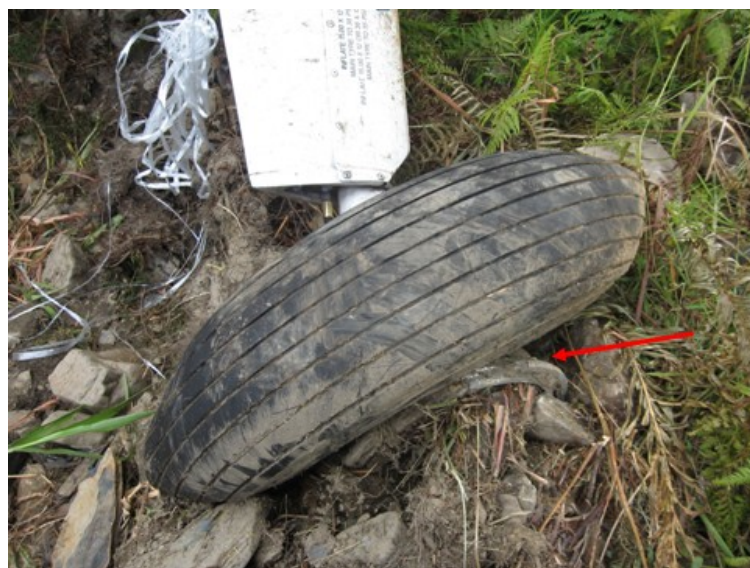
Figure 7 : The damaged right main landing gear wheel

The right main landing gear wheel was damaged as a result of its collision with rocks on the shoulder of the runway.

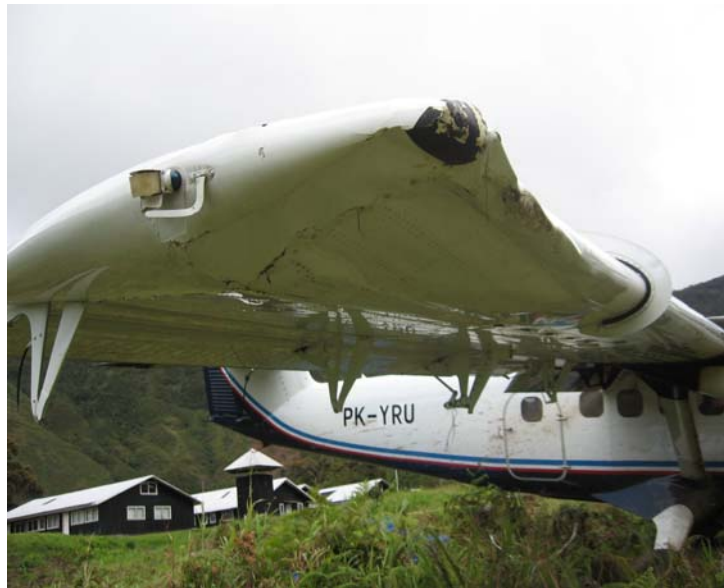
Figure 8 : Right wing substantially damaged

The outboard section of the right wing was substantially damaged as a result of ground impact. This occurred when the aircraft swung to the left as a result of the left main landing gear being stuck in a ditch. The aircraft then swung further left through 90 degrees, resulting in the right wing impacting the ground.

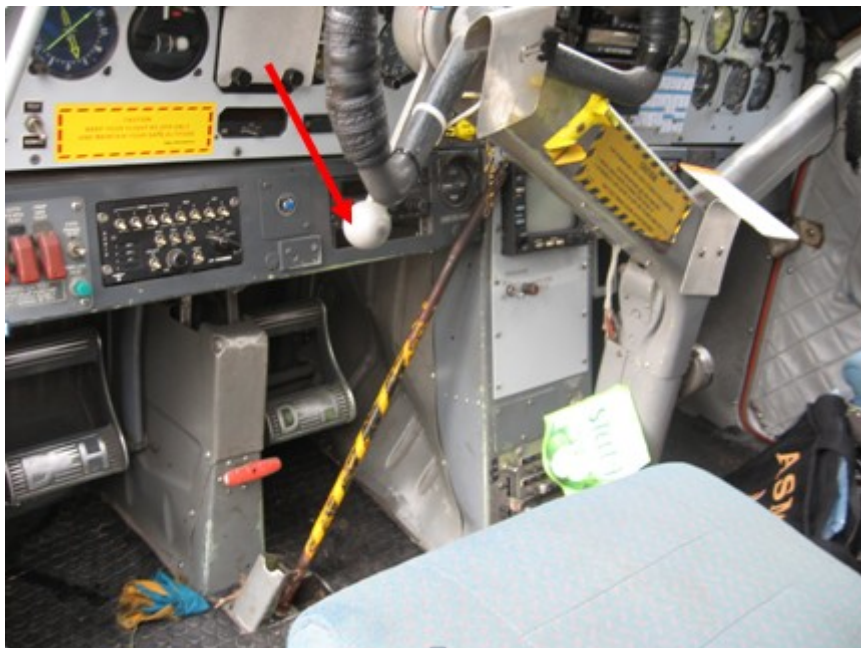
Figure 9 : Arrow pointing to the nose-wheel steering lever

The final position of the nose-wheel steering lever was down (indicating that the nose-wheel steering was selected to the left). That may indicate that the pilot under training attempted to steer the aircraft to the left using nose-wheel steering. However, the investigation could not conclusively determine if the steering lever had been moved after the accident.

The investigation considered that it was possible that the nose-wheel steering was not centred before commencing the take-off roll and that the pilot under training may have been unaware that he was holding an inappropriate nose-wheel steering position during the take-off roll.

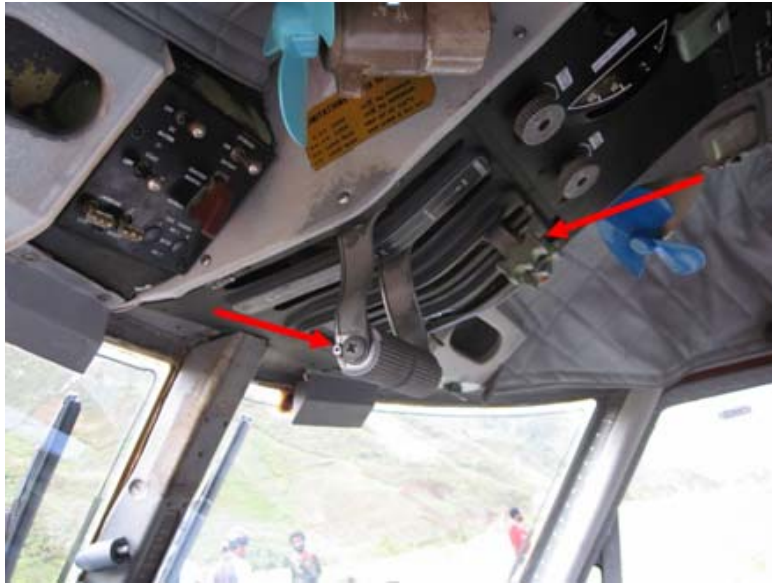
Figure 10 : Left arrow Power Levers and right arrow Propeller Levers

The investigation determined that the power-lever position also did not necessarily indicate the position of the power lever at the time of the accident, because the pilot had shut the engines down after the aircraft came to a stop.
