**NATIONAL
TRANSPORTATION
SAFETY
COMMITTEE**

Aircraft Serious Incident Investigation

**PT. Metro Batavia Airline
PK-YTU
Boeing Company 737-300
Depati Amir Airport, Pangkal Pinang
Republic of Indonesia**

7 January 2007

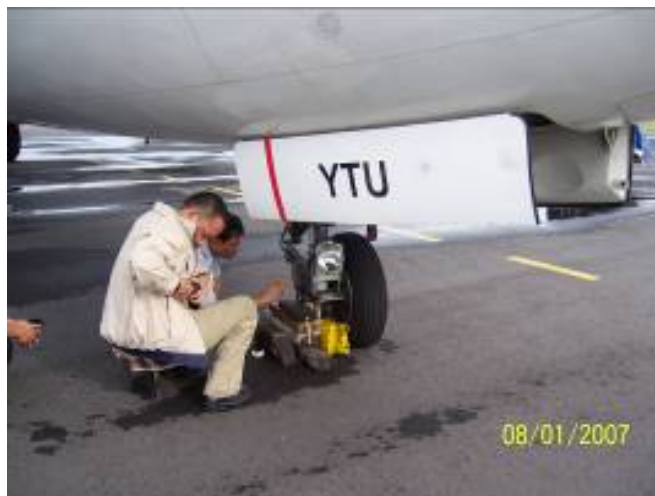
After inspection, it was found that right nose wheel axle shaft was broken and right nose wheel was missing.

Figure 1: The Boeing B737-300 aircraft Reg. PK-YTU after occurrence

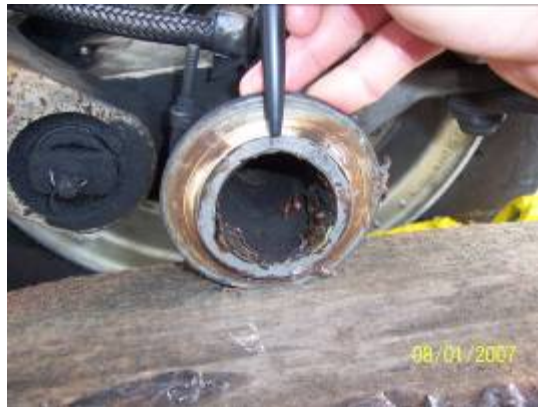
The right nose wheel axle shaft broken.

Figure 2: Damaged on the right nose wheel axle shaft

On the nose wheel axle and inner cylinder assembly found an indication of a vertical fracture and there was no sign of scratches on the broken nose wheel axle, meanwhile there was no indication of damage on the right nose wheel bearings.

- a. Conduct inspection to all Boeing 737 fleet for the possibility of similar damage with Non-Destructive Test (NDT) methods.
- b. Evaluate and train all aircraft maintenance license hold Boeing 737 rating to improve the knowledge and the standard basic of aircraft maintenance.
- c. Review and evaluate validity and currency of Aircraft Maintenance Manual (AMM).

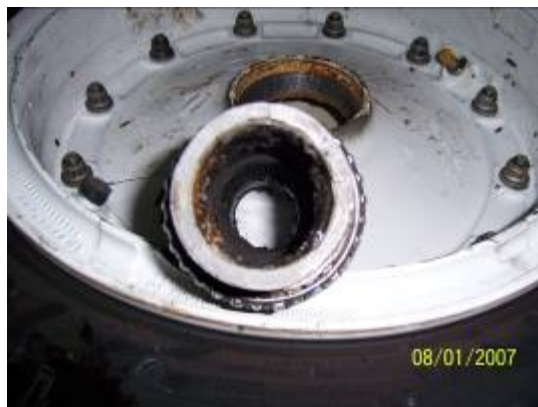
The right nose wheel axle shaft and the nose wheel were found on runway shoulder approximately 3 meters from the runway.

Figure 3: The right nose wheel axle shaft and the right nose wheel

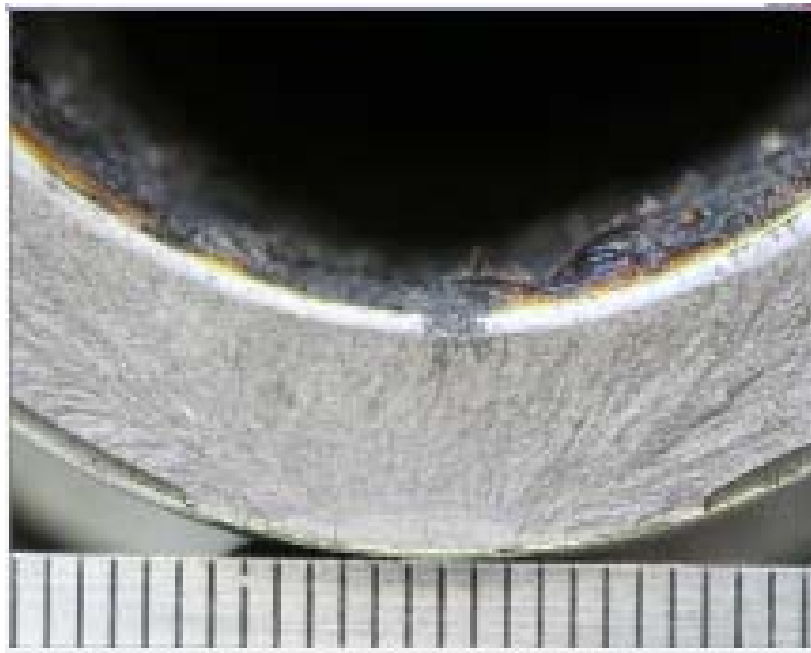
The examination concluded that the initial crack of the lower part of the right nose wheel axle shaft was indication of overloaded forces which initiated ten landings before occurrence as indicated by the beach marks.

Figure 4: Overload forces indicated by beach marks

The metallurgy examination found that the failure was due to high load impact indicated by beach mark that was initiated about ten landings prior to occurrence.
