FINAL
KNKT.08.11.20.04

**NATIONAL
TRANSPORTATION
SAFETY
COMMITTEE**

Aircraft Accident Investigation Report

**Indonesian Civil Aviation Institute
Beech Sundowner C-23; PK-ANX
Budiarto Airport, Curug, Tangerang
Republic of Indonesia
27 November 2008**

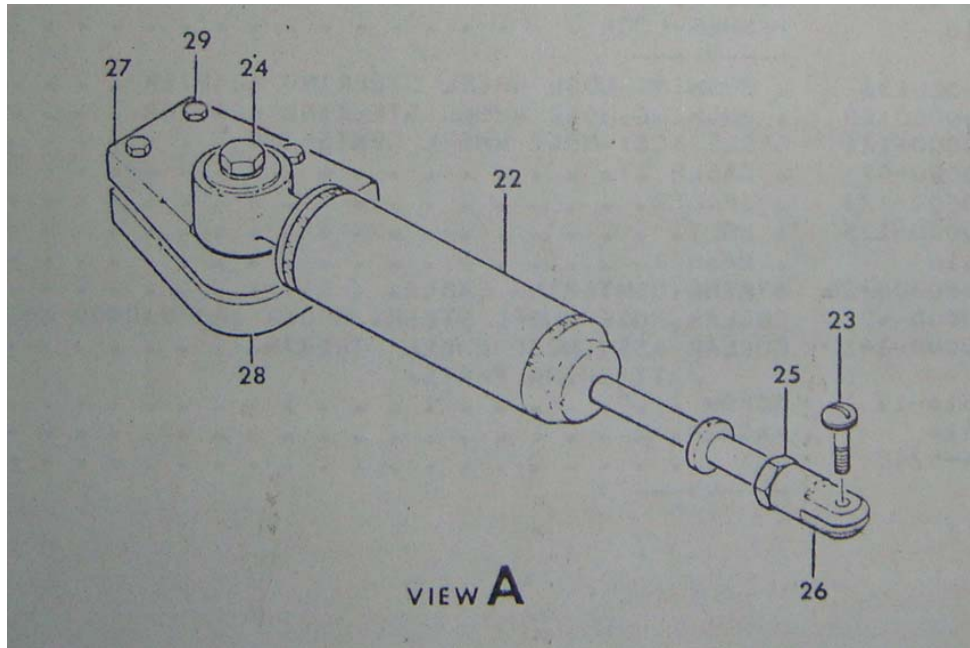
Figure 1: The shimmy damper scheme

The shimmy damper located in the nose wheel, and the function was to absorb the aircraft vibration during rolling. The investigation found the shimmy damper was not functional, caused there were vapor inside and then failed reduces the vibration during landing roll.

The investigation found that the hydraulic of the shimmy damper was leakage.

During landing roll the aircraft was vibration due to the hydraulic of the shimmy was leakage. It could result failed to reduce the vibration during landing roll.

The National Transportation Safety Committee recommends that the Indonesian Civil Aviation Institute should maintain the shimmy damper properly.

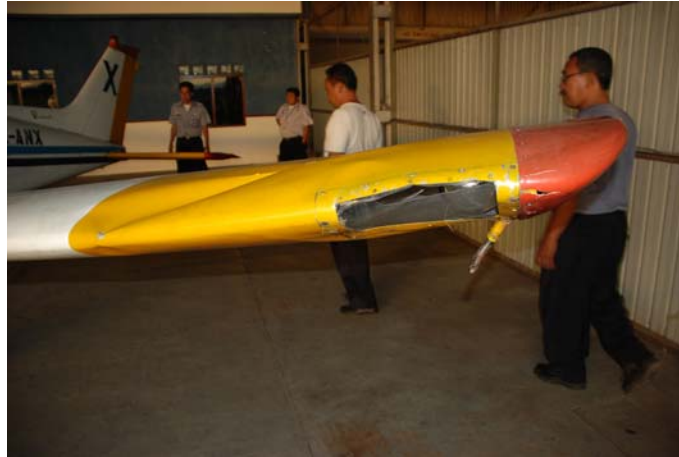
The left wing was dent and the wing tip was broken.

Figure 2: The left wing was dent and the wing tip was broken

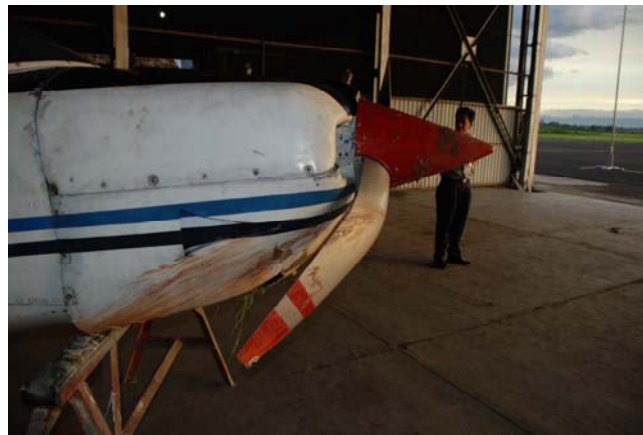
The one propeller was bent rearward.

Figure 3: One of the propellers was dent

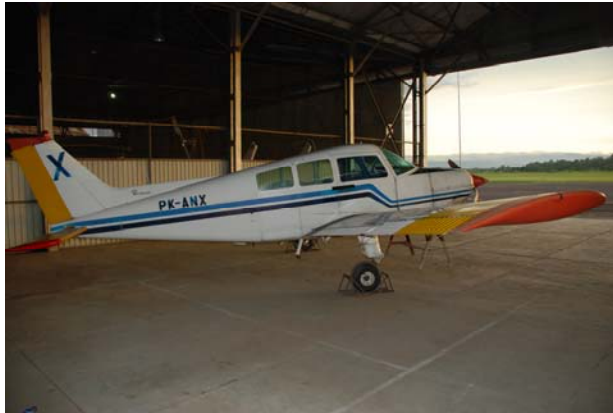
There was no damaged on the fuselage.

Figure 4: The aircraft fuselage condition after occurrence

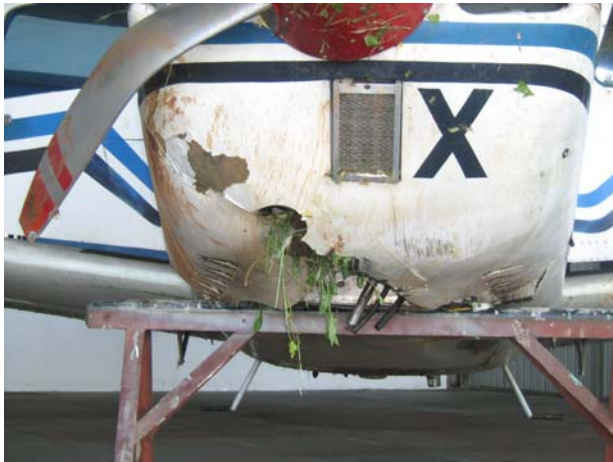
The lower engine cowling was broken.

Figure 5: The lower engine cowling condition after occurrence

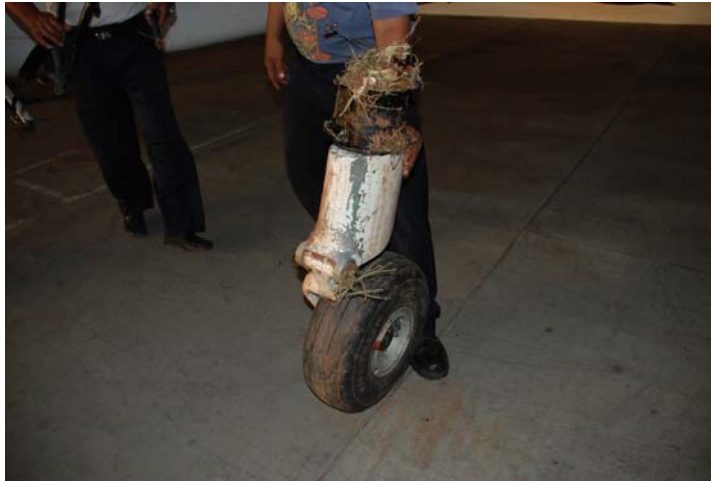
The nose wheel was broken.

Figure 6: The nose wheel was damaged

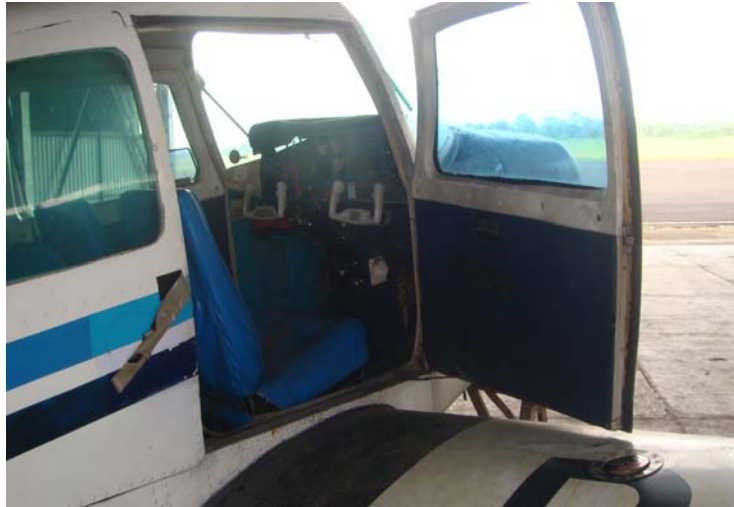
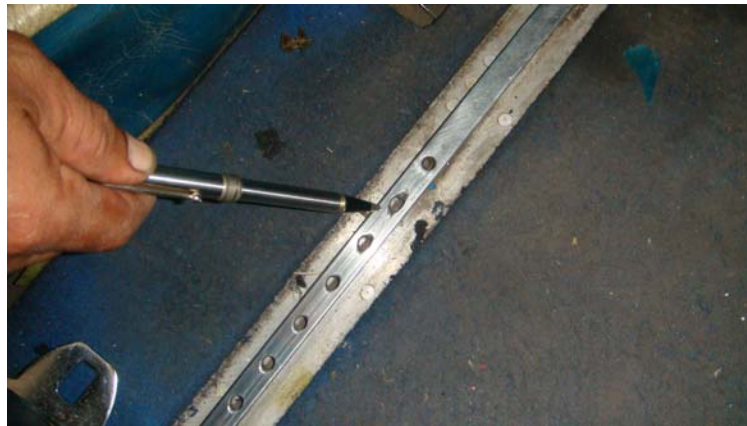
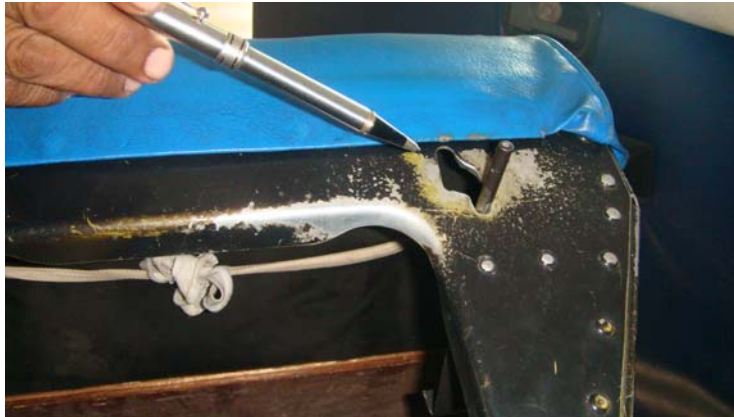
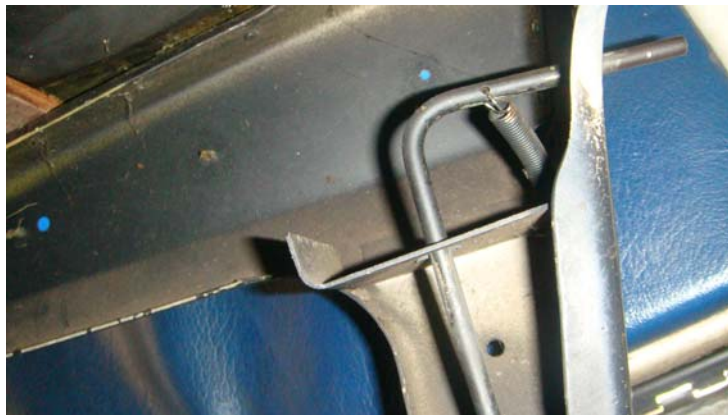
The investigation found that the pin not inserted correctly in the hole track due to the handle improper lock. It's indication that the hole of the handle lock was worn-out.

While the recovered by pushed the brake pedal the pilot seat moved rearward due to the locking mechanism was not engaged properly to the seat track.

The student's seat had not been set and secured properly prior to the takeoff caused the locking pin loose and the pilot seat moved rearward.

The National Transportation Safety Committee recommends that the Indonesian Civil Aviation Institute to ensure the pilot to set and secure properly the seat locking system prior take-off.
