KNKT 08.01.04.04

Aircraft Accident Investigation Report

**PT. Aviastar Mandiri
PK – BRP
De Havilland DHC-6-300 Twin Otter
Sogapa Aerodrome, Papua
Republic of Indonesia**

30 January 2008

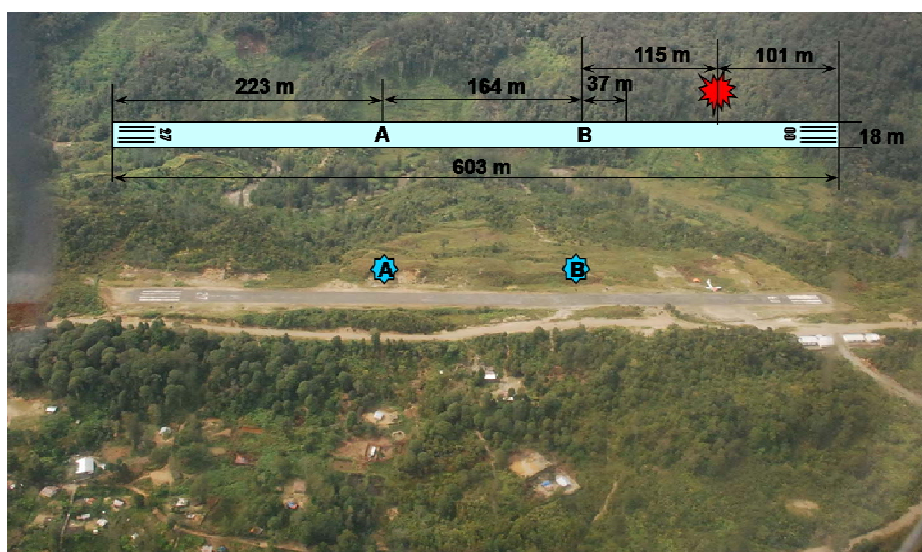
Figure 1: “A” is the touch down point, “B” is the location of fatally injured person beside the runway

Witnesses who had knowledge of aircraft operations at Sugapa, informed the investigators that the aircraft was slightly higher than normal when it was on final approach, and it made a steep approach. It touched down heavily approximately 250 meters from the landing threshold end of the runway. The nose wheel contacted the runway heavily before the left main wheel. Shortly after touchdown, the aircraft veered to the left.

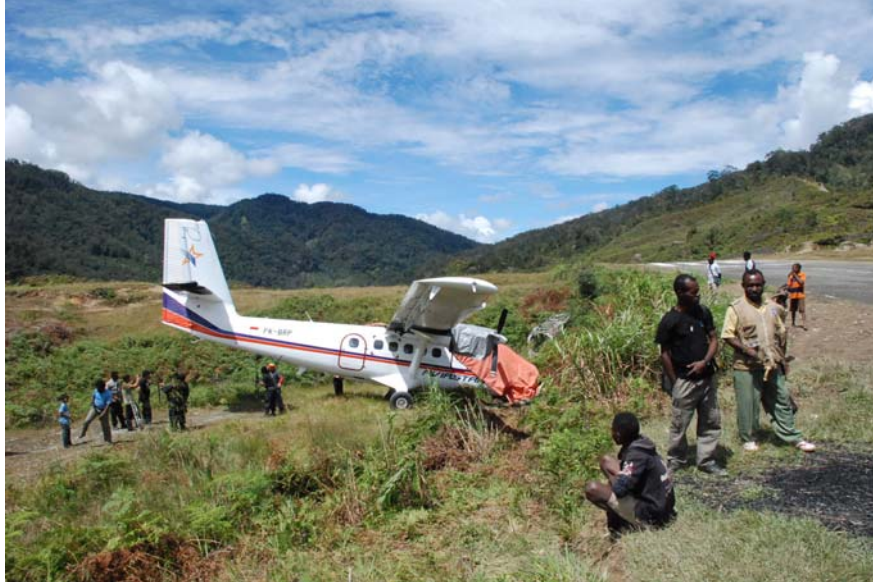
Figure 2: Aircraft after impact with the embankment

The impact site was approximately 5 meters to the left of runway 27, 101 meters from the departure end of the runway. It impacted an embankment about 5 meters from the side of the runway. The aircraft came to a stop on a heading of 360°.

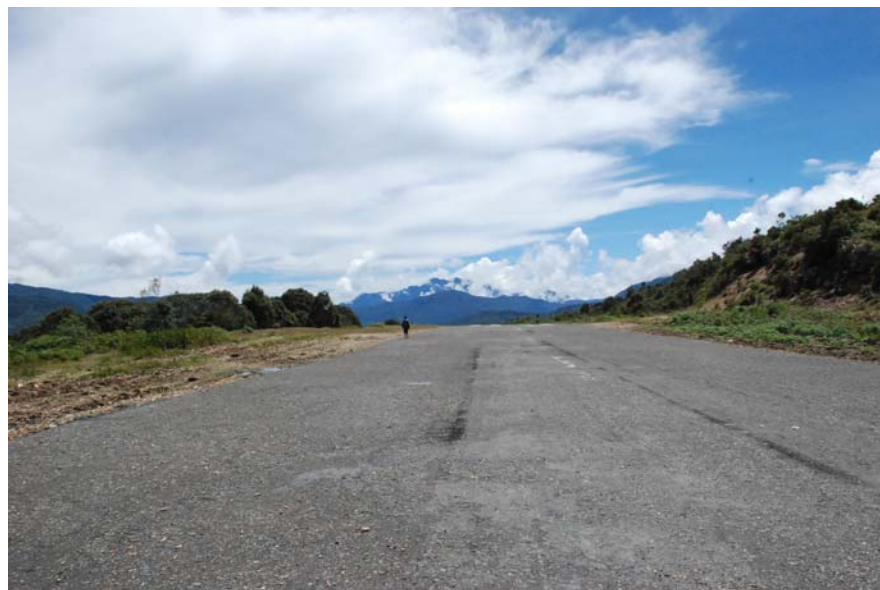
Figure 3: Nose wheel and left wheel marks of skidding to the left, starting from touch down point

There was strong evidence on the asphalt runway of tire rubber from the nose and left main wheel tires for 164 meters, as well as side load scuff marks on all tires.

The nose-wheel tire mark on the runway indicated that the nose wheel was not centered (cocked left) at touchdown, and was subjected to a high impact force. The investigation determined that the nose landing gear fork crack and deformation were consistent with it having been subjected to a high impact force. The nose landing gear subsequently failed and separated from the aircraft.

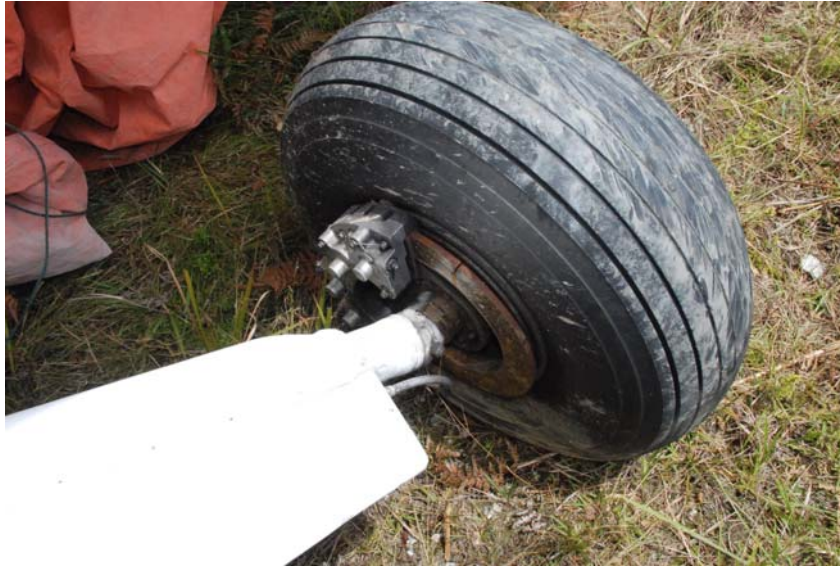
Figure 4: Skidding marks (to left) on the right tire

The following evidence was consistent with a heavy (hard) landing on the nose landing gear first, followed by the left main landing gear: the left arm of the nose landing gear fork was cracked and deformed; tire rubber tracks from the nose and left main wheel tires for 164 meters; and side load scuff marks on all tires.

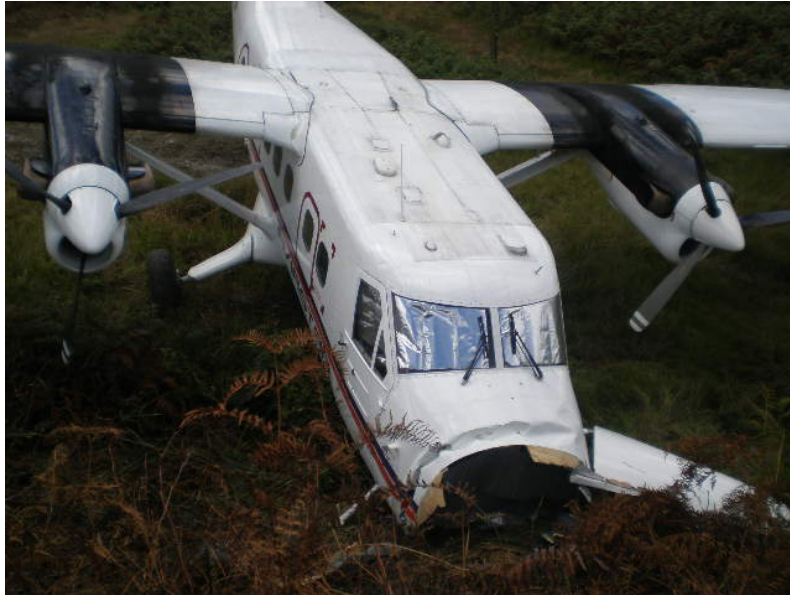
The aircraft was substantially damaged. The nose landing gear was torn from the aircraft causing structural damage to the forward fuselage. The left wing tip was substantially damaged and the cabin roof was distorted.

Figure 5: View showing aircraft nose damage

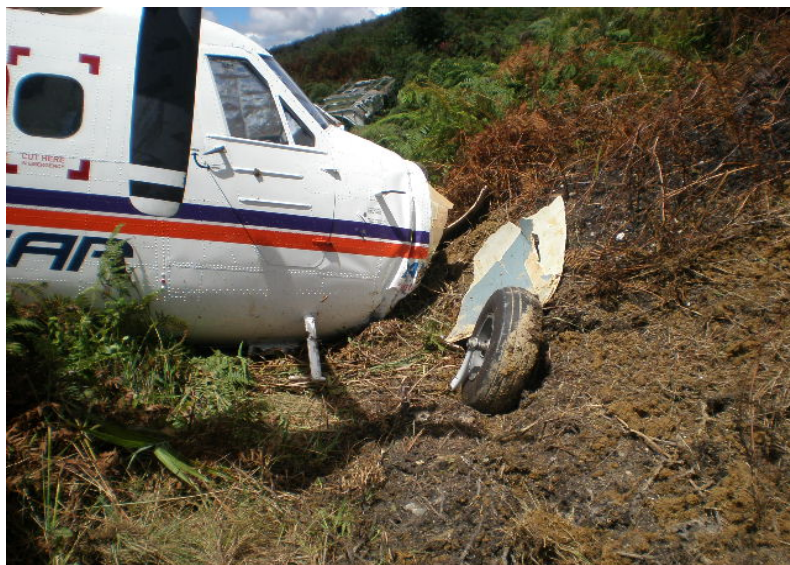
Figure 6: Nose and nose landing gear damage

The left arm of the nose landing gear fork was cracked and deformed.

The nose landing gear fork cracked and was deformed as a result of being subjected to a high impact force during the touchdown. The pilot in command was unable to maintain directional control during the landing roll.

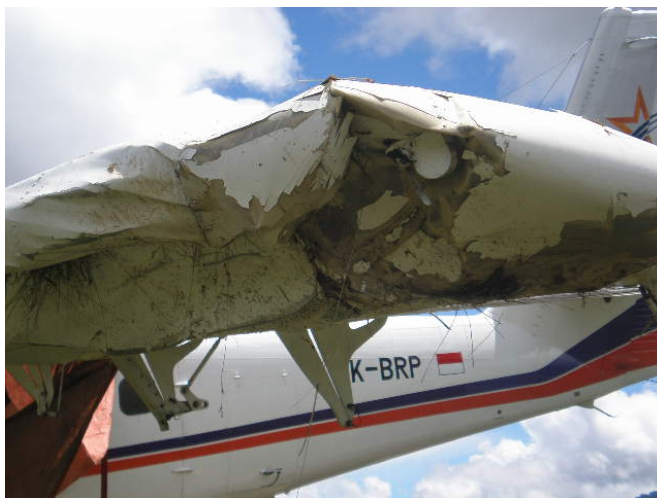
Figure 7: Left wing tip damage
