KNKT 08.28.12.04

Aircraft Investigation Report

**PT. Aviastar Mandiri
PK – BRS
Twin Otter DHC6-400
Ewer Airstrip, West Papua, Papua
Republic of Indonesia**

12 December 2008

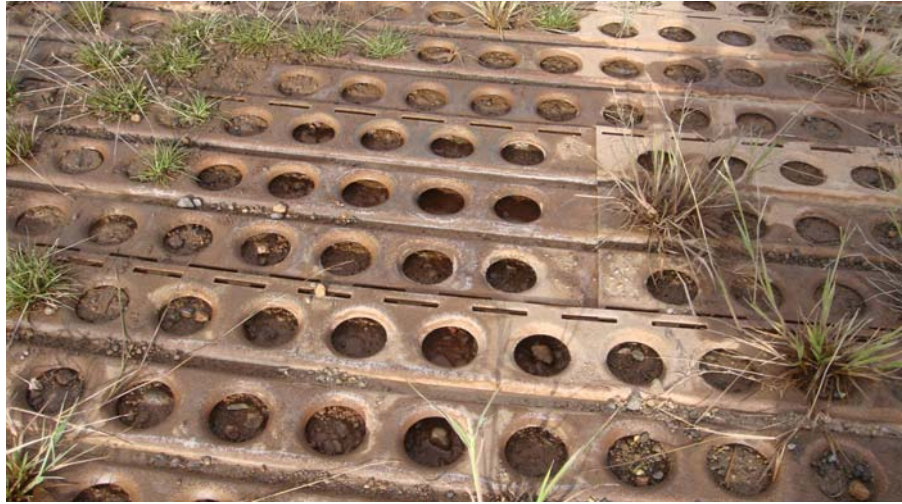
The Ewer runway was constructed on swampy ground, using the marsden matting to give a solid surface.

Figure 2: The marsden matting steel plate runway surface

During the on-site investigation, the investigators found that a number of marsden matting fixing pins had worked loose and were sitting high above the steel matting. This had the potential to cause damage to aircraft tires. However, in the case of this accident, no tire damage was found. The marsden matting surface had worn smooth over many years in service and traction could not be assured.

The National Transportation Safety Committee recommends that the Directorate General of Civil Aviation require Indonesian airport operators with marsden matting airstrips, to inspect the marsden matting and ensure that traction can be assured when the marsden matting is wet.

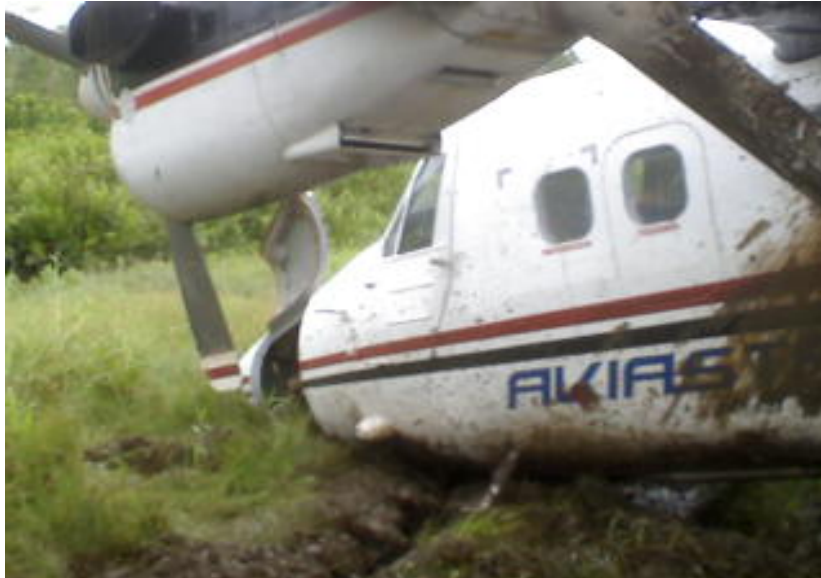
Figure 4: Forward fuselage and nose landing gear buried in soft ground

The nose cone and nose-baggage compartment and taxi light were broken when the nose landing gear sank into swampy ground outside the runway hard surface. The nose landing gear was not damaged.

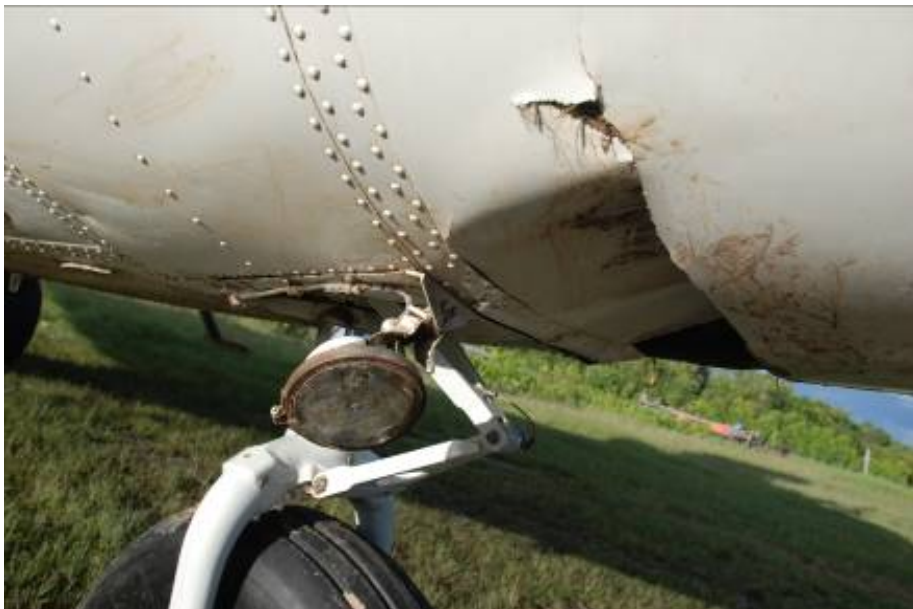
Figure 5: Nose landing gear assembly and nose structure

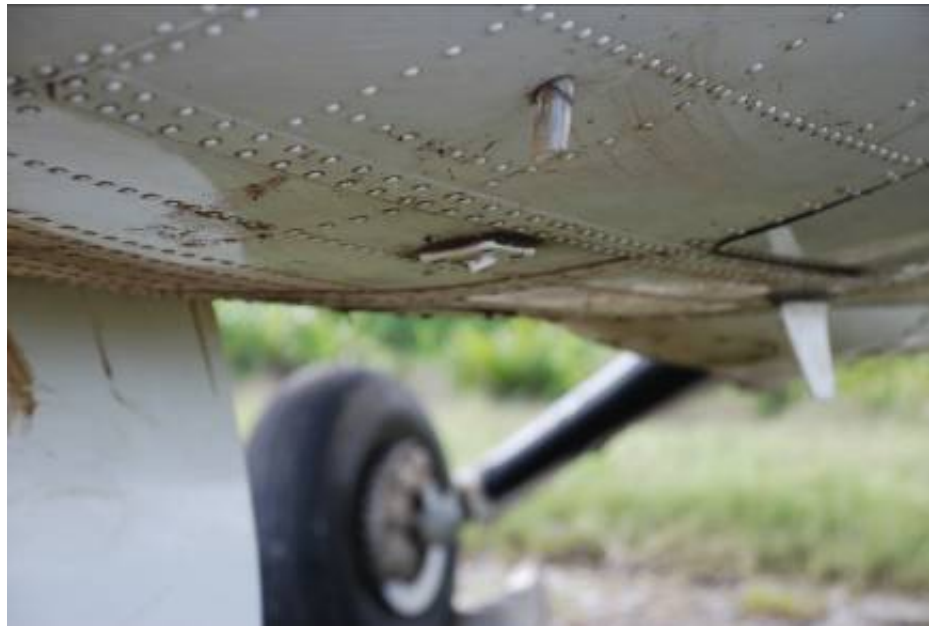
- The nose, nose-baggage compartment and associated structure, and nose-wheel landing light were substantially damaged.
- The leading edges of the left propeller blades were gouged.
- The ADF antenna was fractured and the rudder cable tension had slackened due to the airframe distortion.

Figure 6: Broken ADF antenna

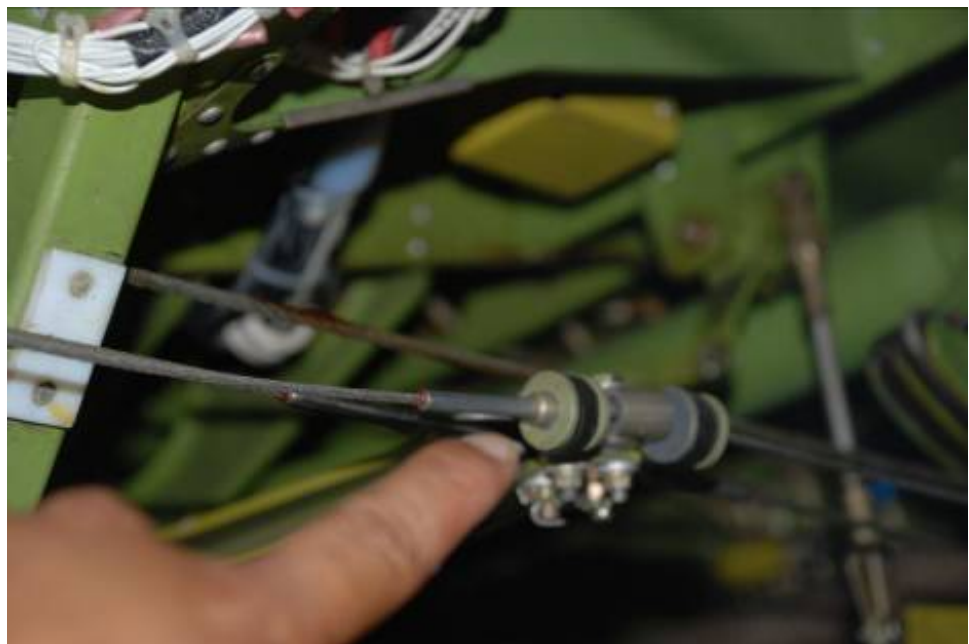
Figure 7: Rudder cable tension slackened from structural damage at impact

The rudder cable tension had slackened, however the investigation determined that this was caused by the damage to the forward fuselage structure during the impact.

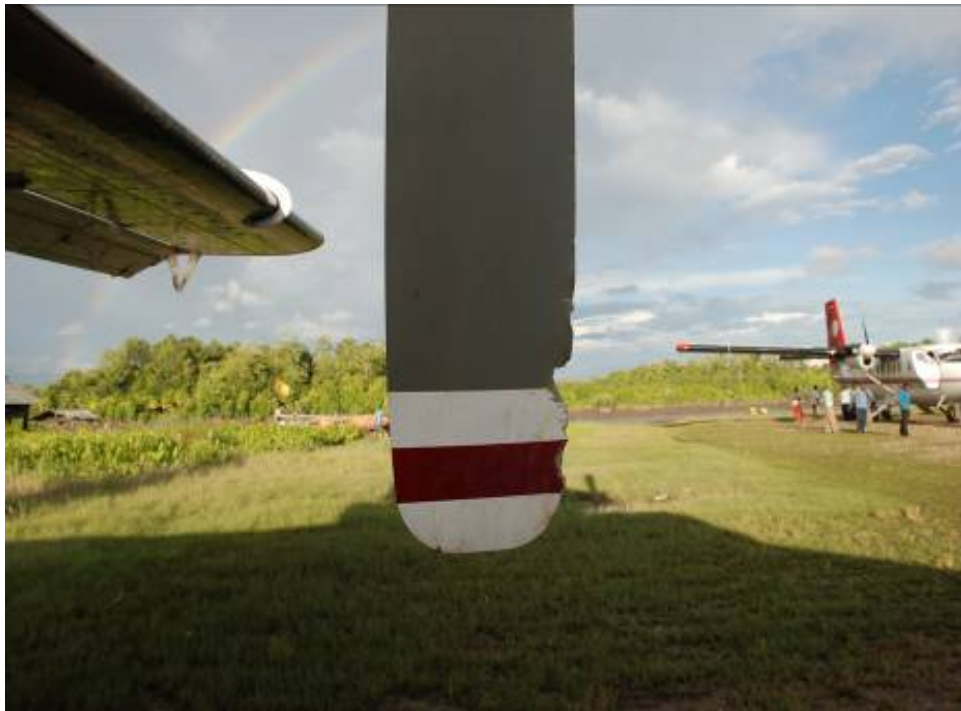
Figure 8: One damaged left propeller blade

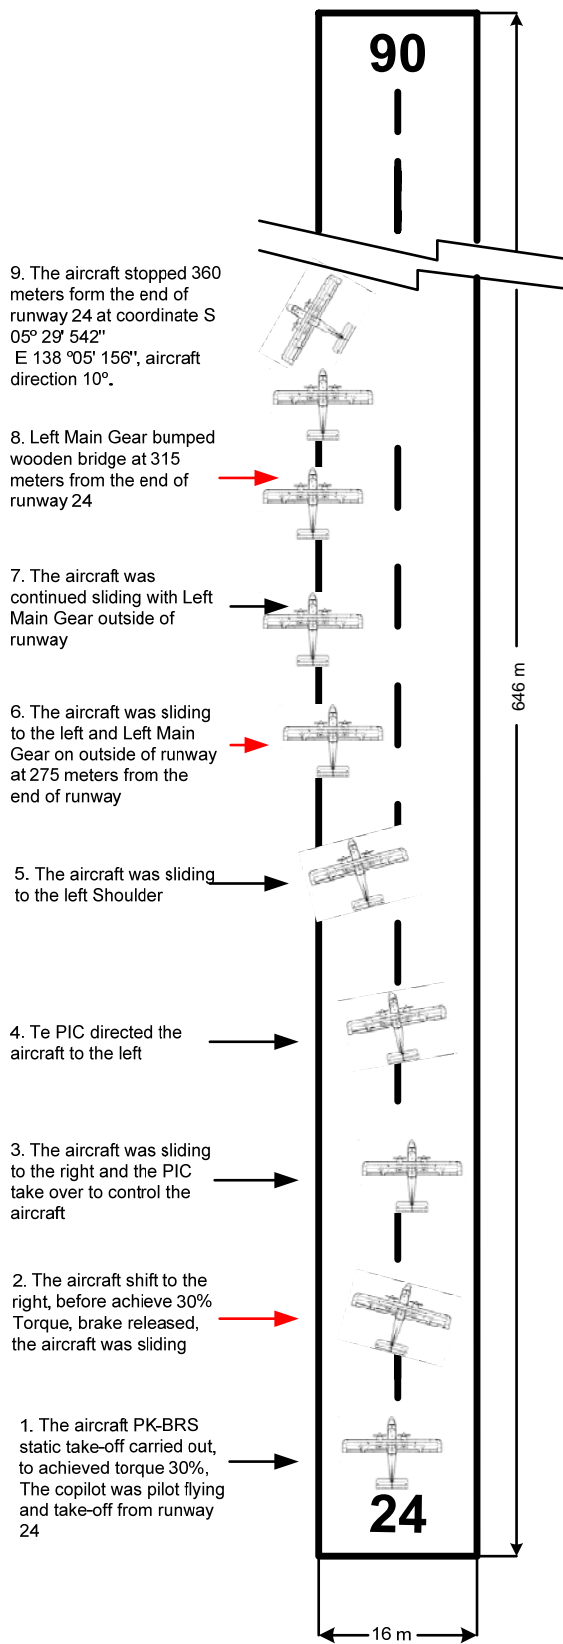
However, he was unable to prevent the aircraft from swinging to the left and it rolled through the centreline to the left side of the runway. The PIC aborted the take off and attempted to regain the runway centreline from the left using nose-wheel steering. That attempt was unsuccessful, and the aircraft veered further left and slid off the runway into wet soft ground on the edge of the marsden matting² runway. It came to a stop 360 meters from the departure end of the runway on a heading of 190 degrees.

Figure 9: The aircraft PK-BRS accident sketch

There was no evidence that the pilots attempted to arrest the swing using asymmetric power. The PIC's attempts to regain directional control were unsuccessful and the aircraft left the runway surface and the nose wheel sank into the soft wet ground, swinging left onto a heading of 190 degrees; 50 degrees from the runway 24 heading.

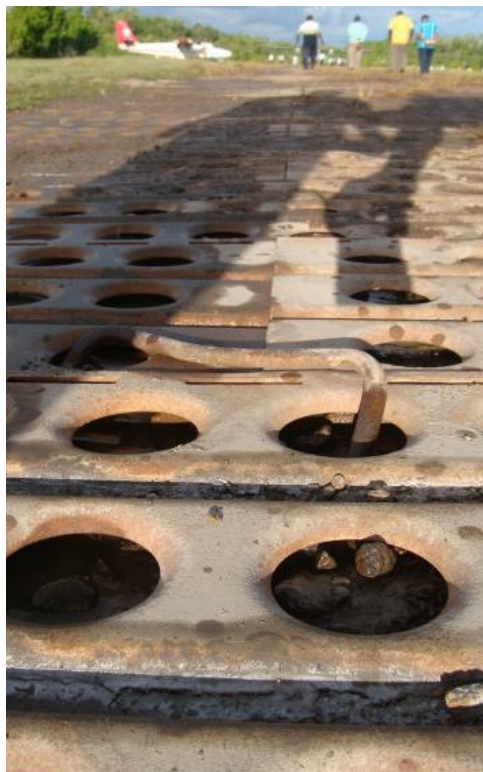
Figure 10: Marsden matting fixing pin sitting high above steel plate

The National Transportation Safety Committee recommends that the Directorate General of Civil Aviation require the Ewer Airport operator to inspect the marsden matting airstrip and ensure that there are no exposed locating pins or other objects that could present a hazard to aircraft.

The National Transportation Safety Committee recommends that the Directorate General of Civil Aviation require Indonesian airport operators, with marsden matting airstrips, to inspect the marsden matting and ensure that there are no exposed locating pins or other objects that could present a hazard to aircraft.
