KNKT 08.04.09.04

Aircraft Serious Incident Investigation Report

**PT. Sriwijaya Air
PK – CJC
Boeing Company 737-300
Depati Amir Airport, Pangkal Pinang
Republic of Indonesia**

18 April 2008

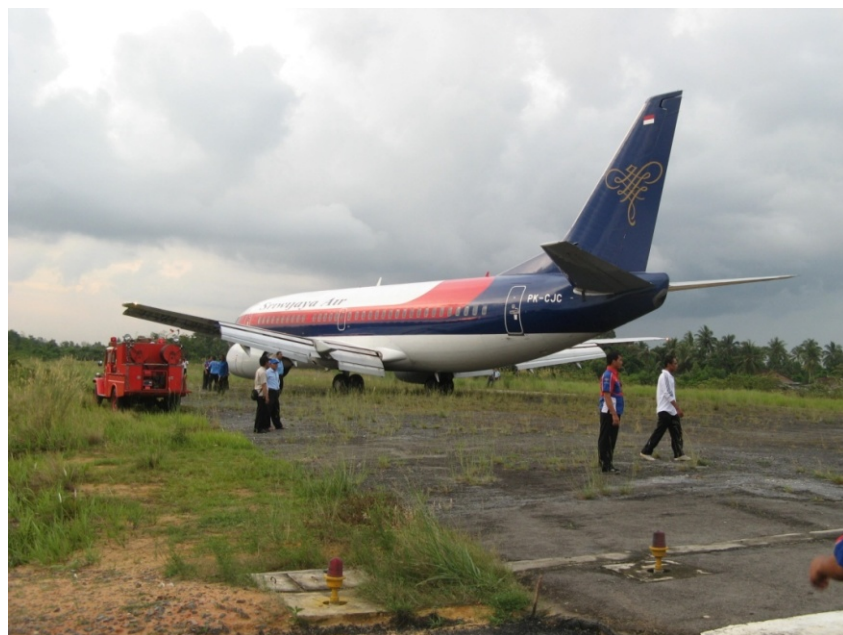
The aircraft touched down about 750 meters from the landing threshold end of the runway, with about 1,250 meters remaining. During the landing roll the aircraft overran the end of the runway, and stopped 50 meters beyond the end of the runway, within the stop-way.

Figure 1: Final position of the aircraft on the stopway

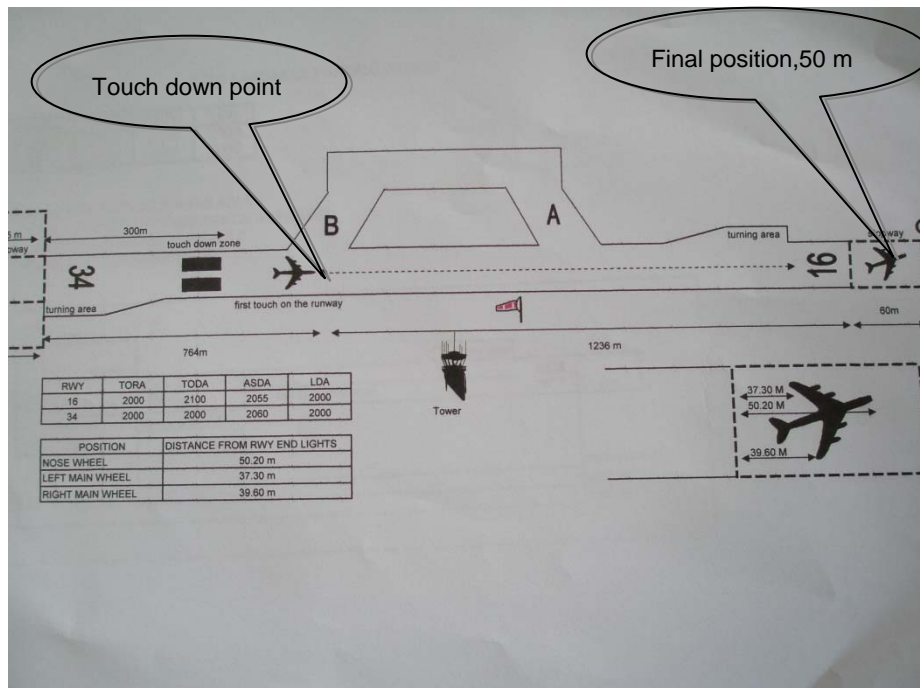
Figure 2: Diagram of the runway, showing touchdown point, and final position of the aircraft

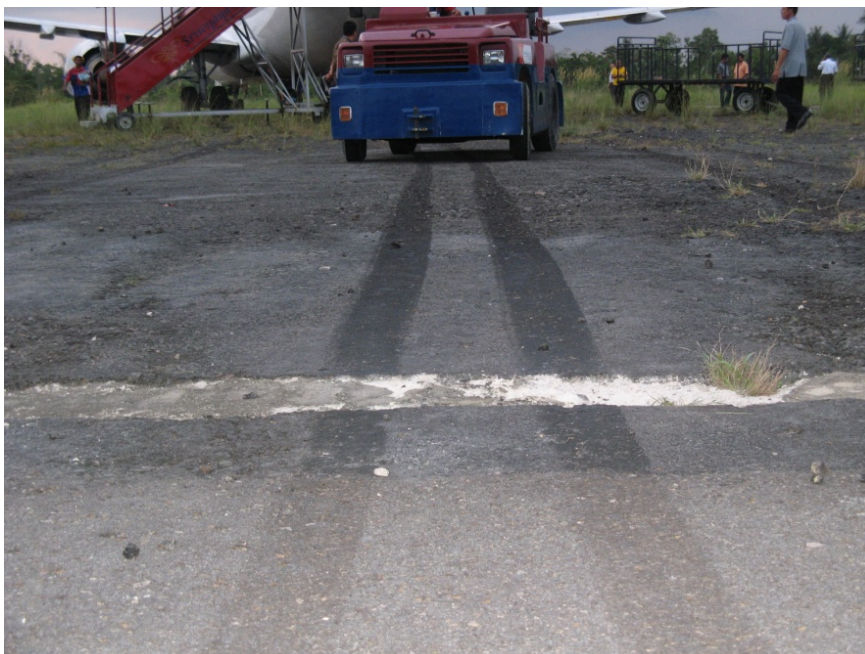
Figure 3: Tire marks on departure end of the runway

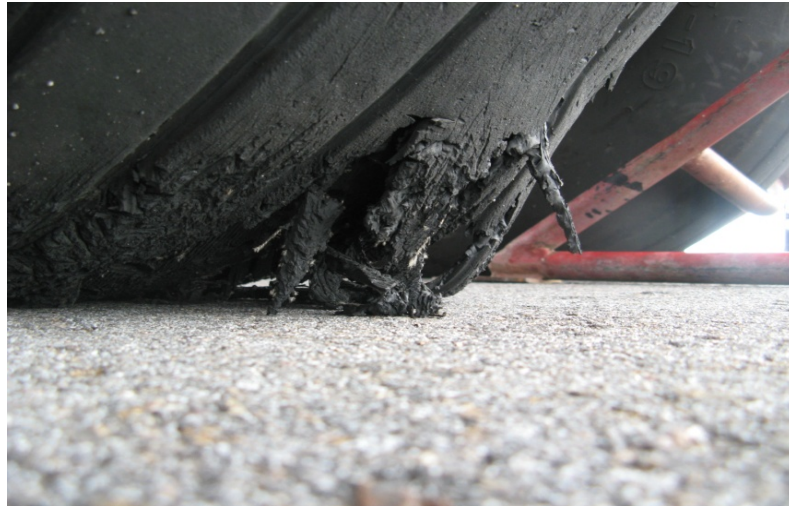
The inboard main landing gear tires (number two and number three)² were substantially damaged. Both engines' fan blades were substantially damaged (gouged), and the number-two engine air intake screen was dented.

Figure 4: Tire number three was substantially damaged

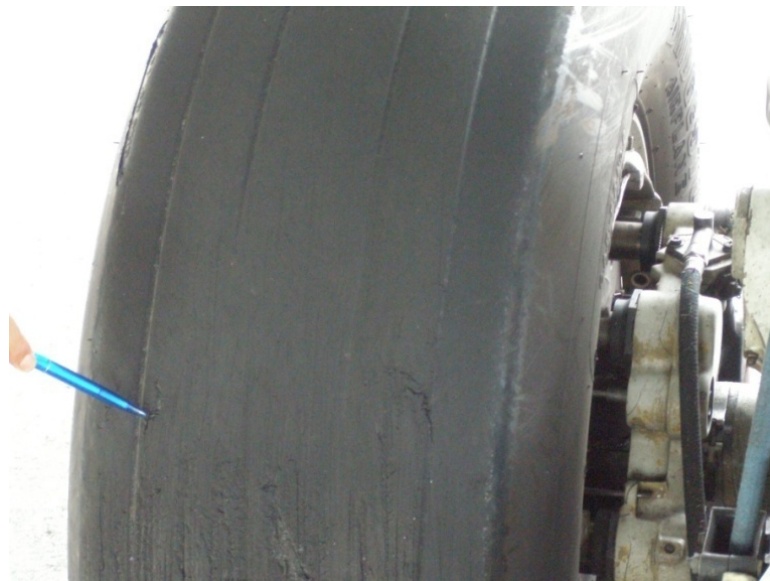
Figure 5: Damaged tire number two

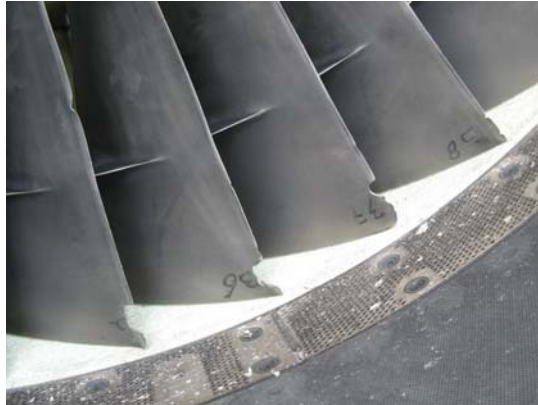
Both engines' fan blades were substantially damaged (gouged), and the number-two engine air intake screen was dented.

Figure 6: Damaged engine fan blades

The dust reported by the air traffic controller came from the runway end that was covered with loose stones and sand, which caused the damage to the engines' fan blades and the engines' air intakes. This indicated that high thrust reverse was still being applied to both engines at the end of the landing roll. It was also confirmed by the FDR data. The marks on the runway also showed evidence of heavy brake application as the aircraft entered the stopway.

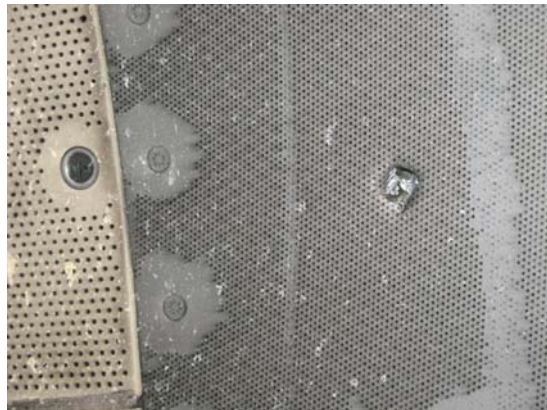
Figure 7: Damaged number-two engine air intake screen

The air traffic controller reported that as the aircraft left the runway and entered the stopway, there was a lot of dust. The investigation found that the stopway had loose stones and sand, which damaged both engines' fan blades and engines' air intake. This evidence confirmed the flight recorded data that the full reverse was still being used at the end of the landing roll.

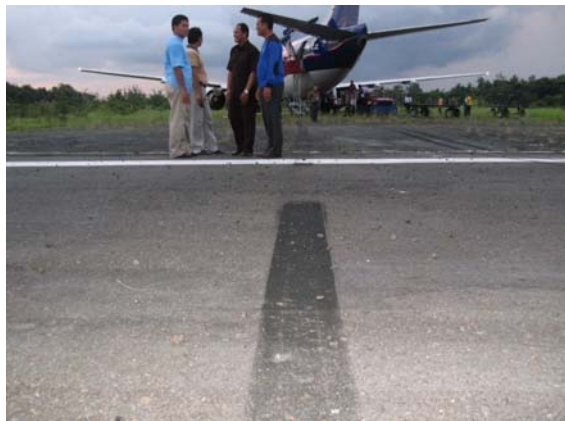
Figure 8: Tire marks at the end of the runway, and onto the stopway
