FINAL
KNKT.08.04.10.04

Aircraft Accident Investigation Report

**PT. Derazona Air Service
Bell 206 B Jet Ranger ; PK-DAT
Labih Ricefield, Labih Village, Gianyar, Bali
Republic of Indonesia**

23 April 2008

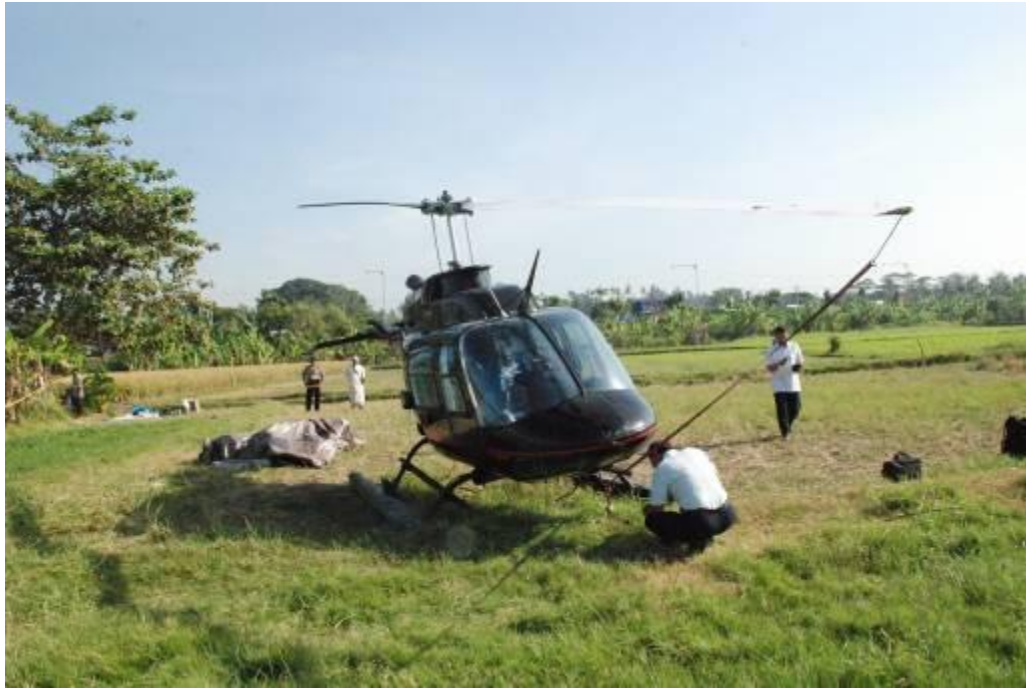
Figure 1: The aircraft condition after accident

The aircraft was substantial damaged, the severe damaged was as follows:

- The tail boom was broken;
- The tail rotor blade damaged;
- The right attachment skid was broken;
- The rotor blade damaged.

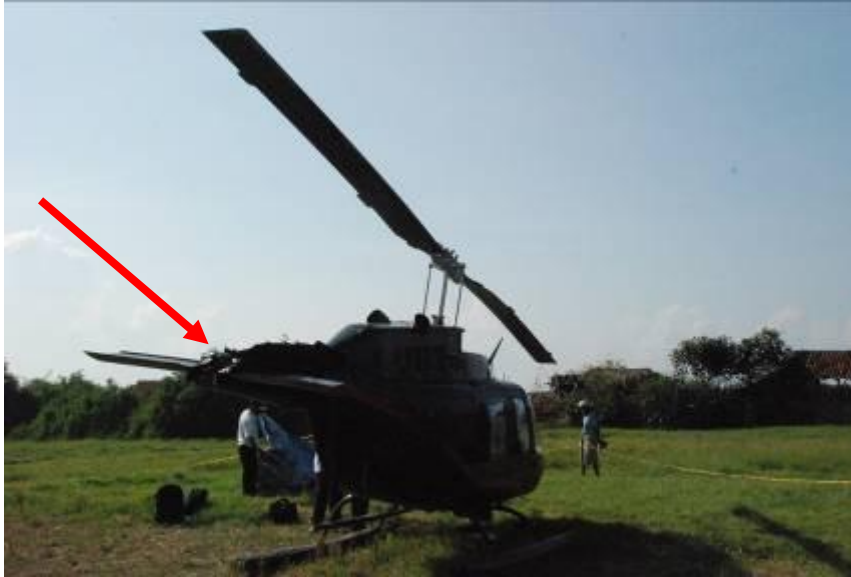
The tail boom was broken by main rotor shaft, during the aircraft impact to the ground.

Figure 2: The tail boom was broken

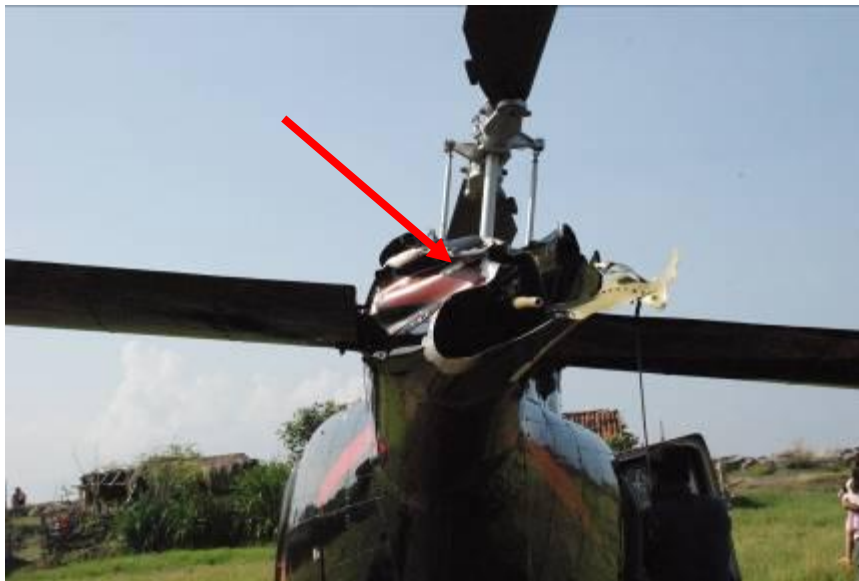
Figure 3: A right torn leads to the tail boom

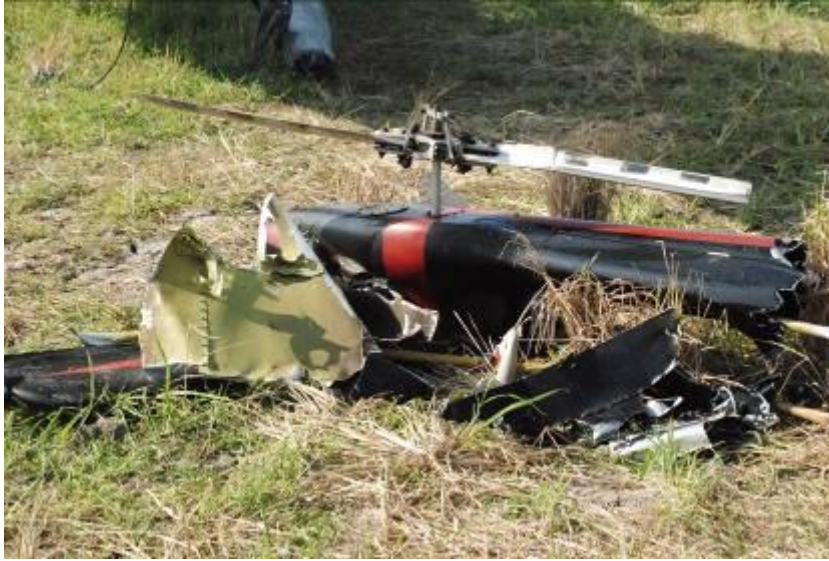
The tail rotor was detached from the helicopter; the wreckage was not far from the helicopter.

Figure 4: The tail rotor wreckage

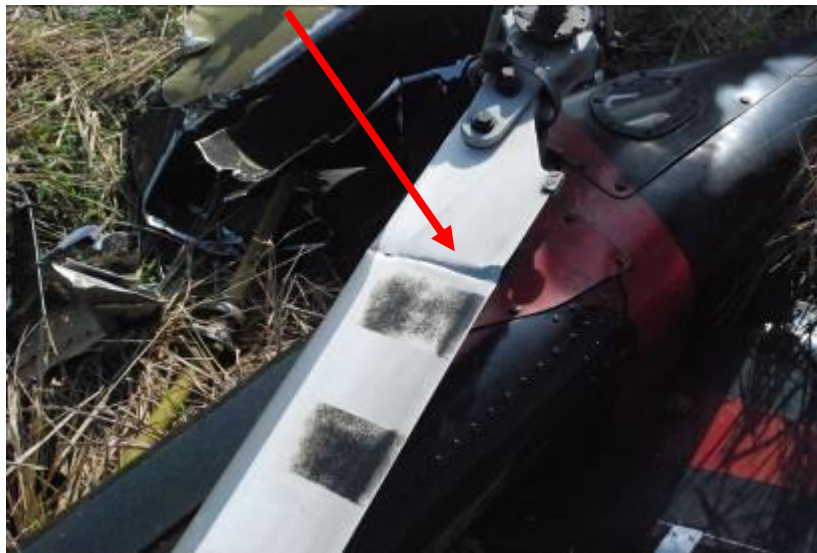
Figure 5: The tail rotor blade was broken

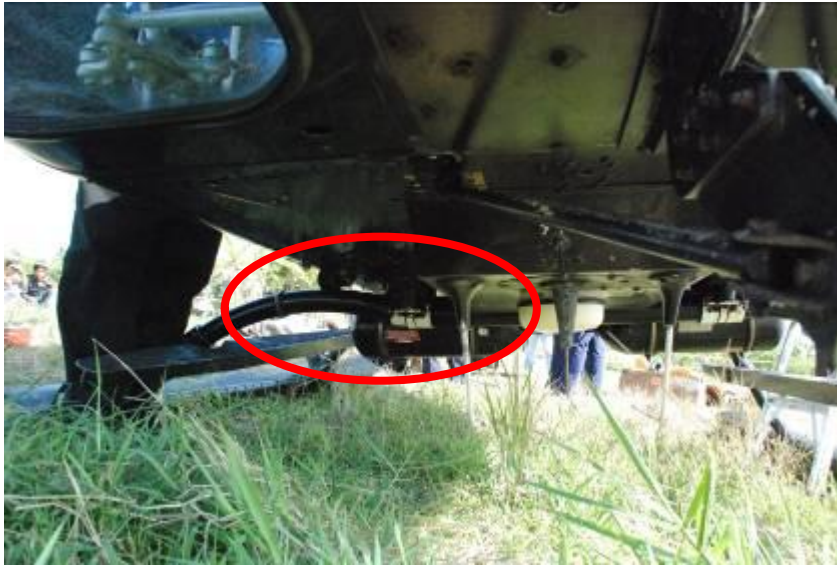
The helicopter skid was bent due to the aircraft impacted with the ground.

Figure 6: The forward right skid was bent

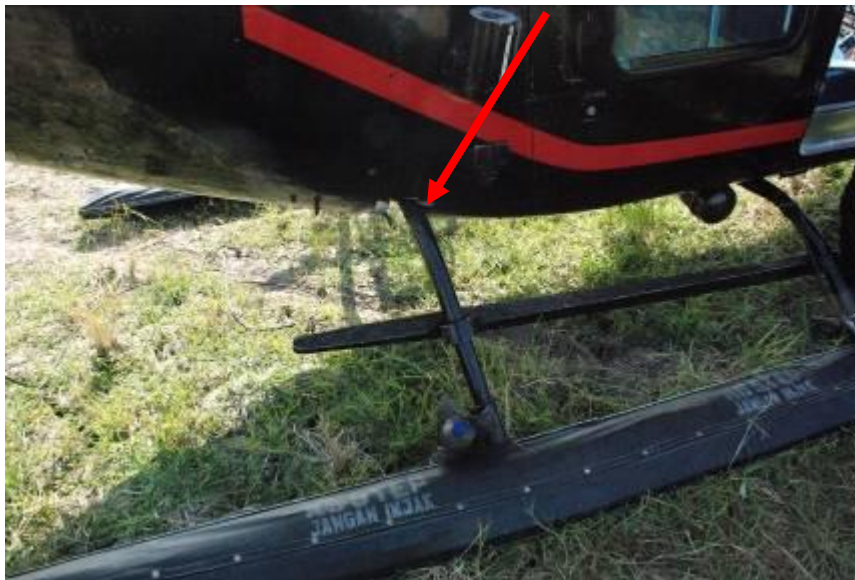
Figure 7: Aft right skid was bent

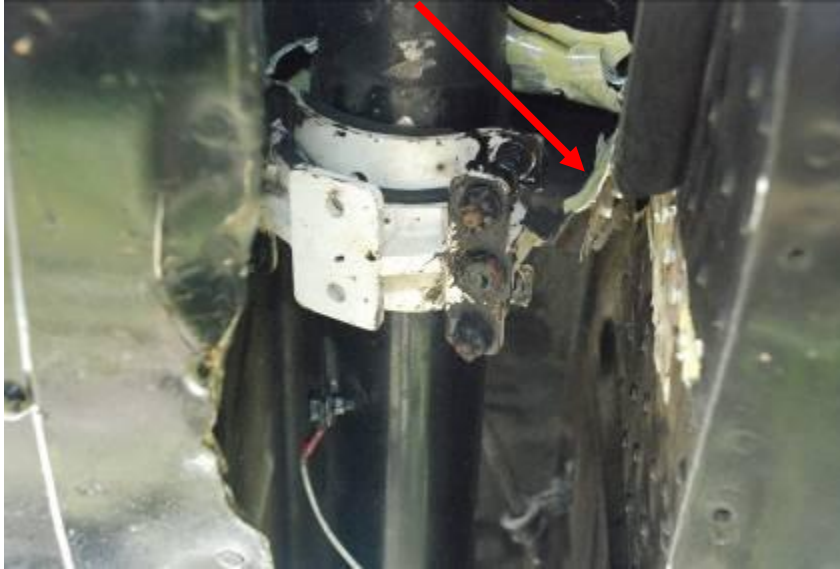
The fwd right attachment skid torn and detached.

Figure 8: The fwd right attachment skid torn and detached

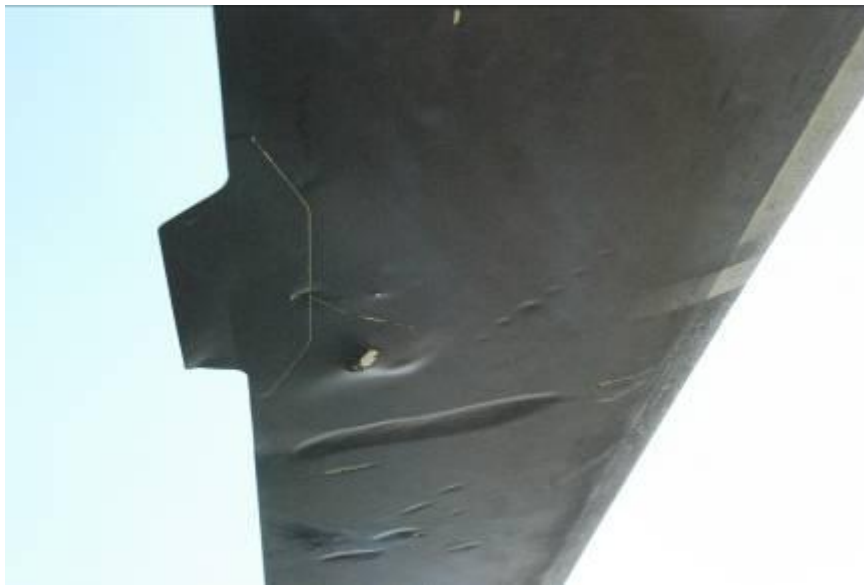
The main rotor blade was damage; caused impact by the ground.

Figure 9: The main rotor blade surface marking

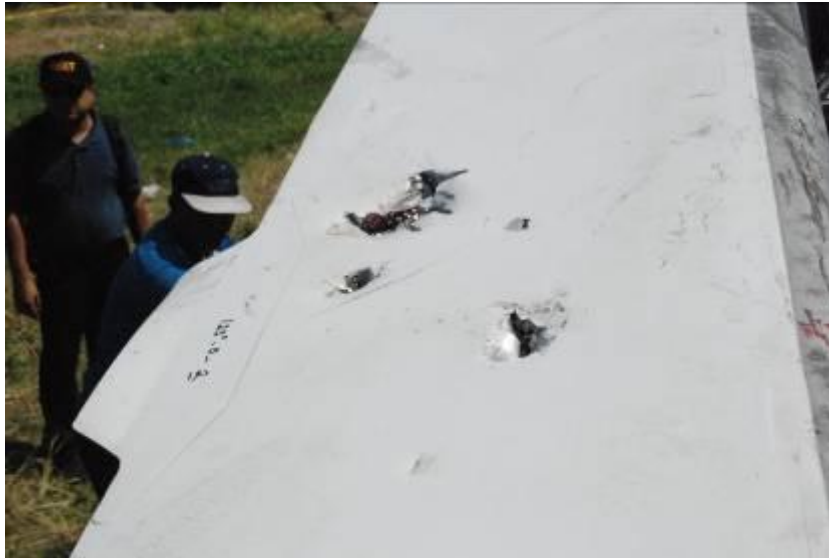
Figure 10: The main rotor blade surface marking caused impact to the ground

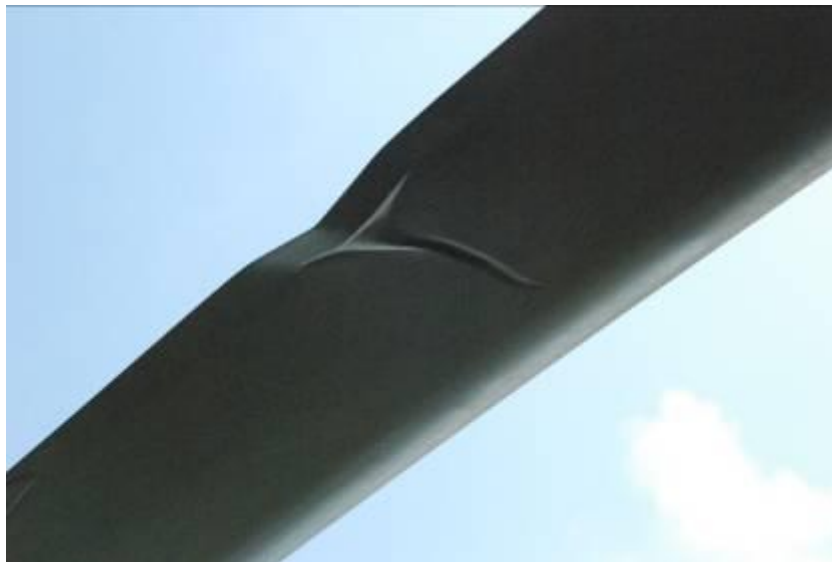
Figure 11: The main rotor blade trailing edge was bent caused impact

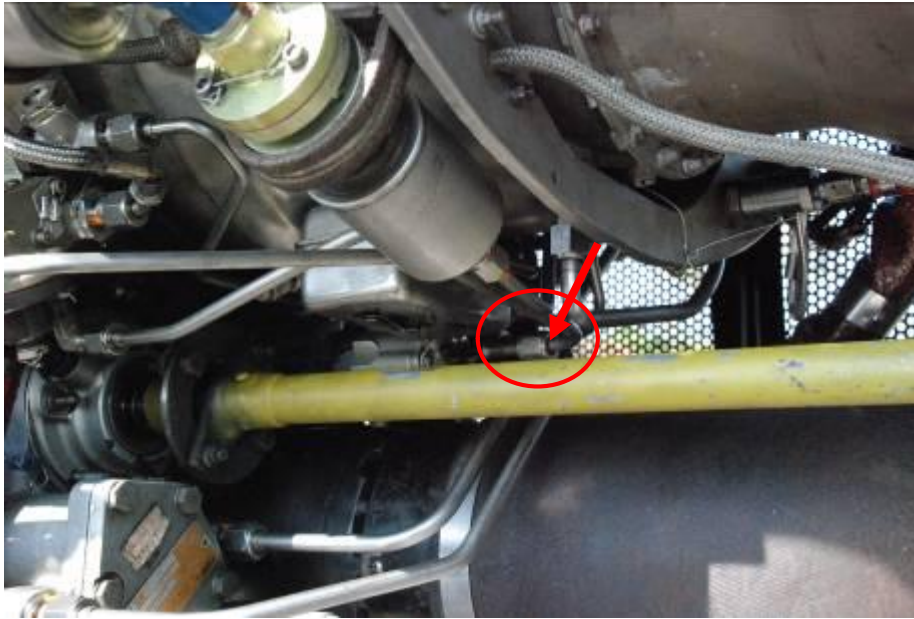
Investigation found that the plumbing connection (B Nut) detached. If the B nut still attached mark by torque paint

Figure 13: The plumbing connection (B Nut) position detached

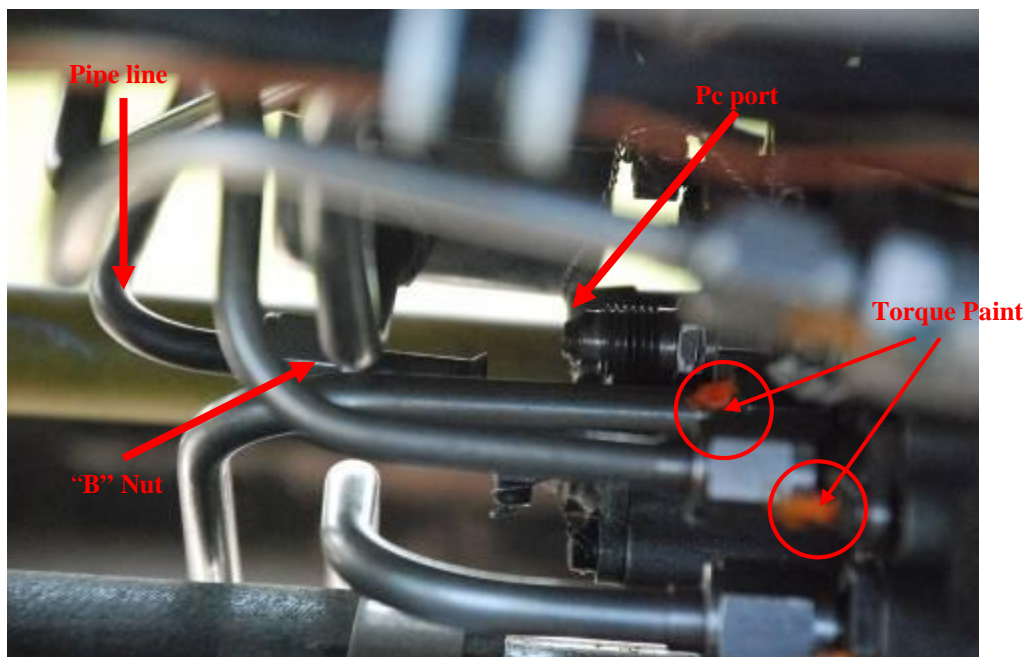
Figure 14: The plumbing connection (B Nut) detached, the B nut still attached mark by torque paint

The investigation found the Pc port of B-nut FCU was detached, indicated there was no slippage marks (torque paint).

The helicopter engine has no power, caused no pressure from compressor. There was effect from the Pc port of B-nut FCU detached.

No later than 50 flight hours from the effective date, inspect all control system plumbing connecting the Gas Producer fuel control, the Power Turbine governor, and the compressor (Pc, Py, Pr, Pg, Po, P1, P2, pipelines) for condition and proper assembly including the correct torque values and the slippage marks (torque paint) at the B-nut by using proper tooling in accordance with the appropriate Allison (now Roll Royce Corp.) operations and maintenance manual in association with the particular Allison (now Roll Royce Corp.) Alert Commercial Service Letter which pertain to the same object Reference CSL-A-169, A-1166, A-2113, A-3117 and A-4036.

The National Transportation Safety Committee recommends that the Directorate General Civil Aviation to ensure the operators which operation engine Allison Model 250 series should follow the EASA Airworthiness Directive 2004-0009 R2.

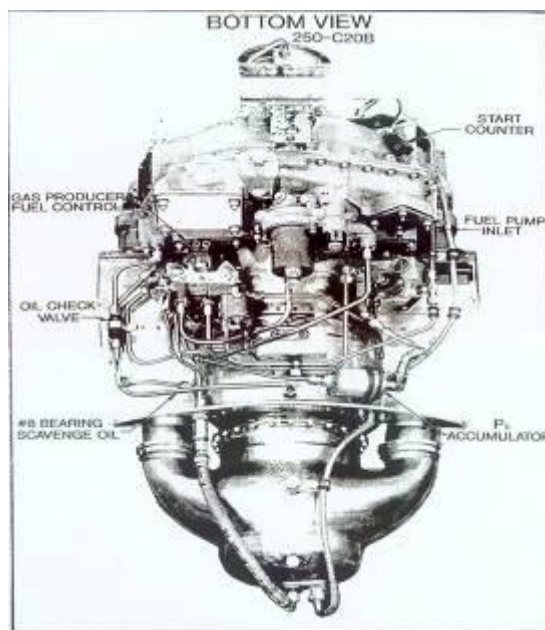
The detached Pc port of B-nut can made the air pressure changed in the Px and Py bleed the same with the outside air pressure (Pa), then the two Bellows of different sizes will return to its original position. This resulted in the fuel valve will in the "Idle" position; although the grip is positioned to set the engine RPM to high RPM, the engine rotation still the same because the fuel valve is open. The engine still worked in a low rpm or "Idle".

Figure 15: Pc port detached

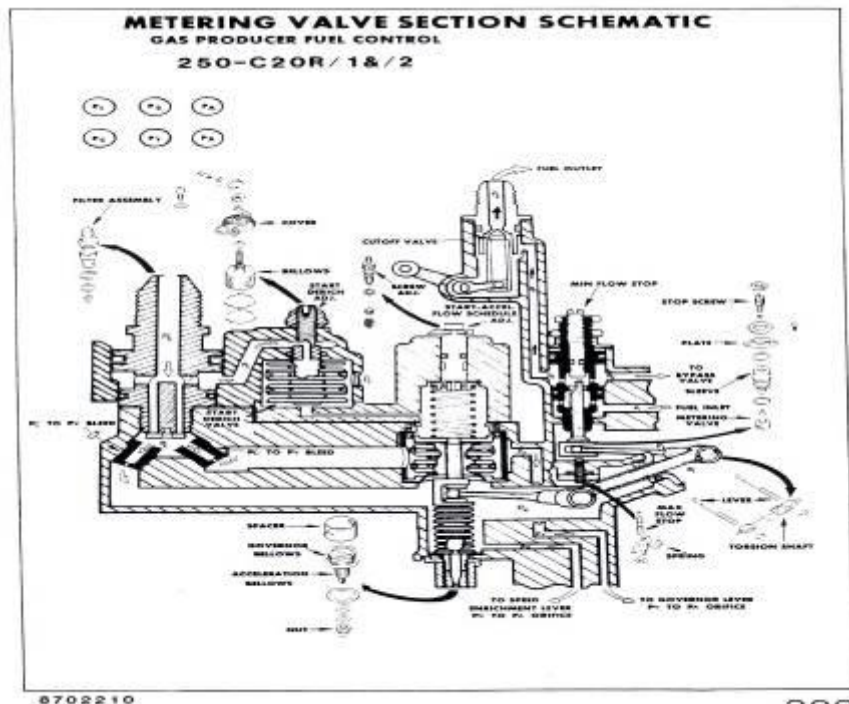
The Metering Valve Section schematic shows B Nut detached from Pc port, the fuel flow output automatic on idle position, because there is no pressure from the compressor flows into the Px and Py bleed for move Governor Bellows and Bellows Acceleration.
