KNKT.08.07.16.04

Aircraft Accident Investigation Report

**PT. Garuda Indonesia
PK – GZN
Boeing Company 737-400
Syamsudin Noor Airport, Banjarmasin,
Kalimantan
Republic of Indonesia**

23 July 2008

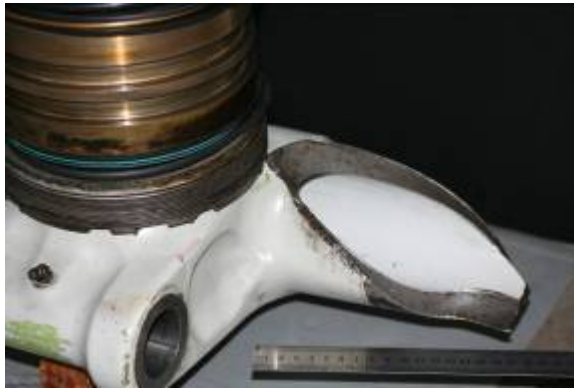
The number-one main landing gear axle fractured.

Figure 1: The fractured axle of the number-one main landing gear

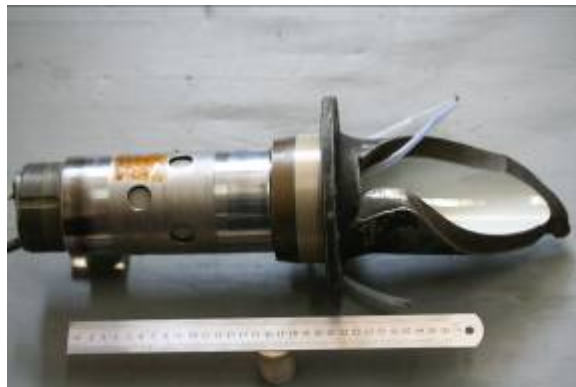
- The failure was of a fatigue mode as clearly indicated by beach marks.
- The fatigue crack originated from one of the brake mounting holes approximately at 5 o'clock position, propagating inward.
- The number of beach marks corresponded to the landing cycles.
- The fracture surface beyond the fatigue crack propagation was the final fast failure.

Figure 2: The broken axle

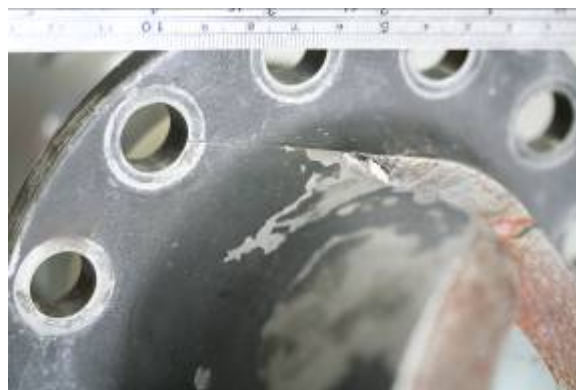
Figure 3: The crack at the hole edge propagated inward

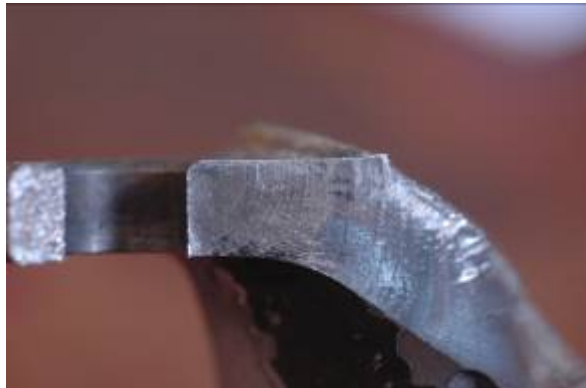
Figure 4: Beach marks on the fracture surface.

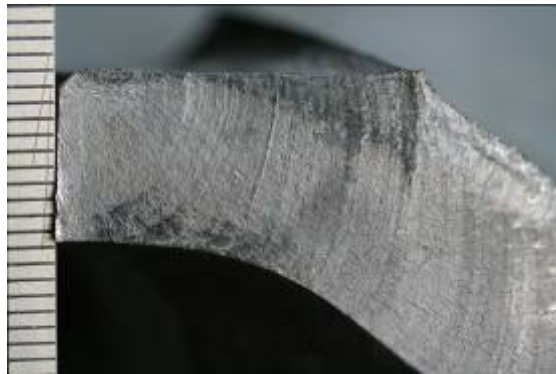
Figure 5: Beach marks propagating from the hole edge

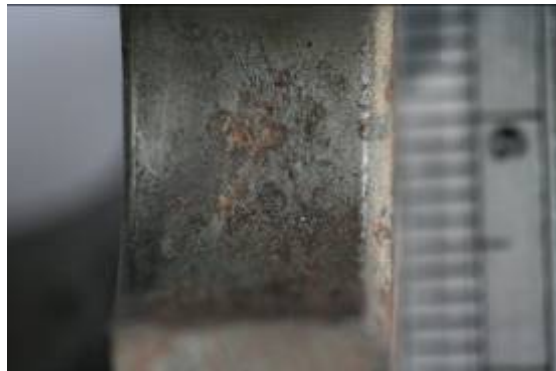
Figure 6: Corroded surface

The corrosion at the attachment hole increased the stress concentration locally.

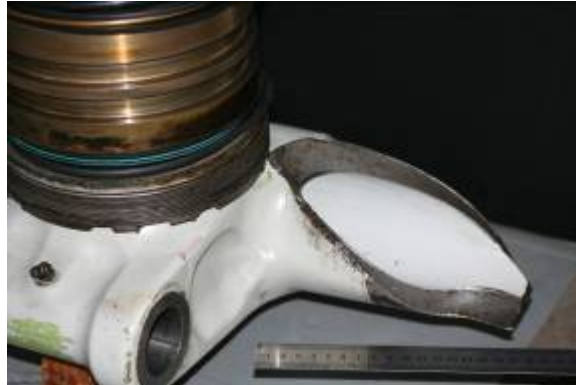
A Boeing 737 aircraft of Garuda Indonesia PK GZN experienced a failure on its L/H main landing gear axle, i.e. at no.1 wheel position. The failed axle is shown in Fig.1.

Figure 1: The failed axle of the L/H Main landing Gear

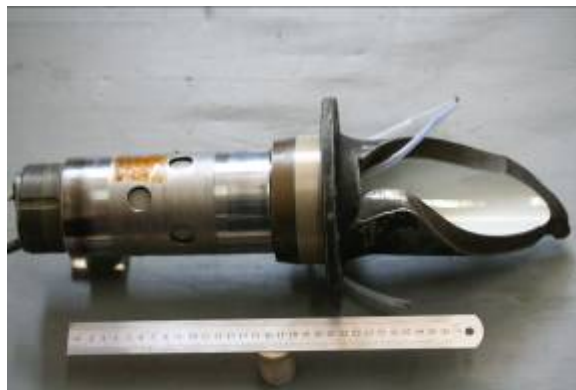
Figure 2: The broken axle

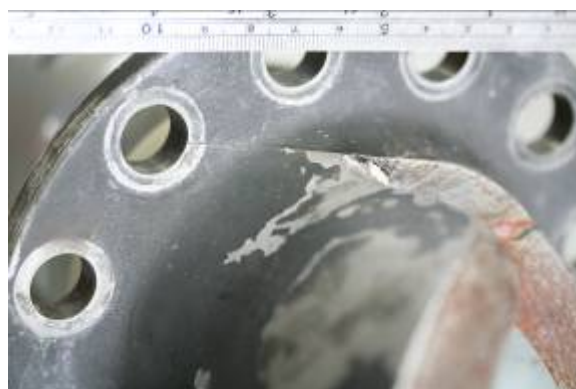
The crack was originated from one of the brake mounting holes approximately at 5 o'clock position, propagating inward.

Figure 3: The crack at the hole edge propagated inward

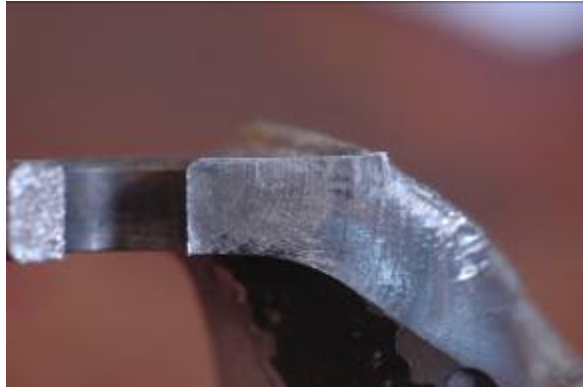
The failure is of a fatigue mode as clearly indicated by beach marks.

The beach marks correspond to the landings. Therefore the number of beach marks indicates the number of landing cycles until the final failure occurred.

Figure 4: Beach marks on the fracture surface.

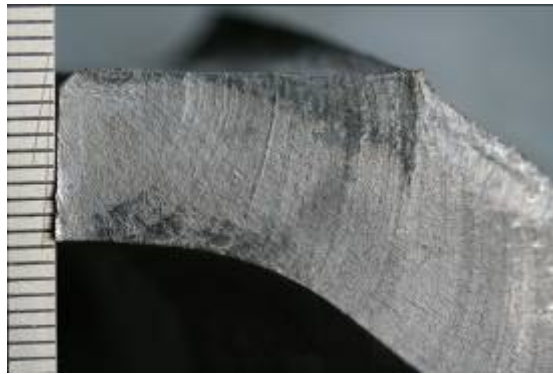
Figure 5: Beach marks propagating from the hole edge

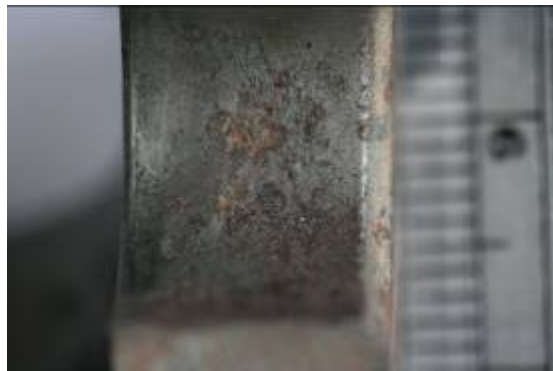
Figure 6: Corroded surface

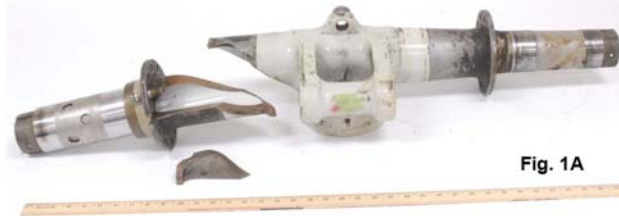
Fig. 1A

1) Figure 1 shows the as-received condition the portion of the inner cylinder that was submitted to Boeing. The right hand side axle fractured between the brake flange and the vertical post section of the inner cylinder (fig. 1A). Examination of the fracture surface revealed that the origin was located at the surface of one of holes in the brake flange (white arrow in figure 1B).

Fatigue crack initiation at pitting on bore (white arrow Fig 1B). Crack propagation by fatigue for ~2.5" prior to final separation (Fig 1C).

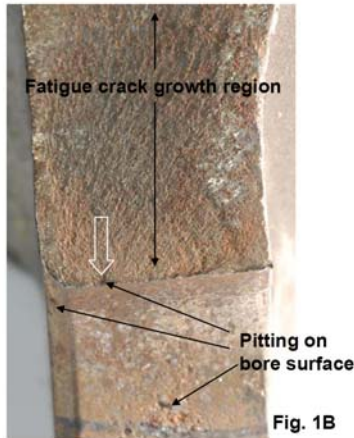
Fig. 1B

2) The bore surface exhibited scattered corrosion pitting which served as the initiation site for the fracture which occurred by a fatigue mechanism. The crack propagated by fatigue for a length of approximately 2.5" before final fracture through the axle wall occurred by ductile separation (figure 1C).

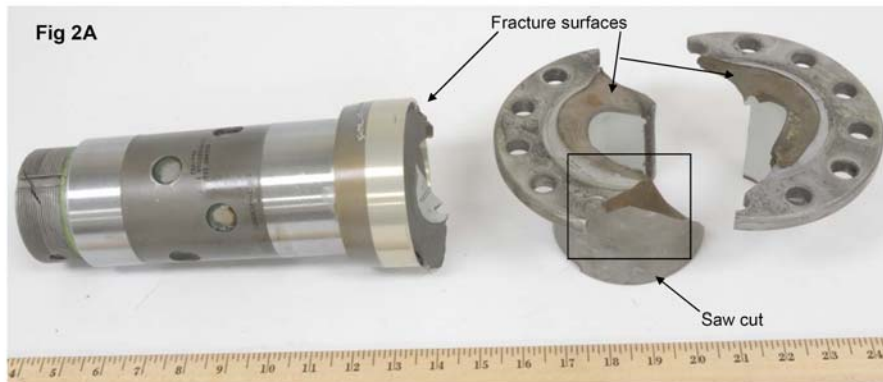
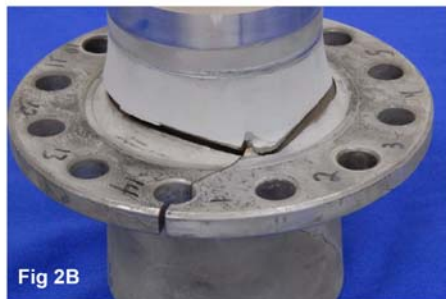
1) Figure 2 shows the as-received condition of the fractured axle segments that were submitted to Boeing. The fracture emanated from a bolt hole on the brake flange and progressed in a helical direction through the axle wall.

Figure 2: Photographs showing the as-received condition of submitted axle segments. Note that crack emanated from flange hole and progressed in a helical direction through the axle wall.

Fig 2A shows pieces separated to expose fracture path. Box in Fig. 2A indicates area of fracture presented in figure 3. Fig 2B show relationship between axle segments when fitted together.

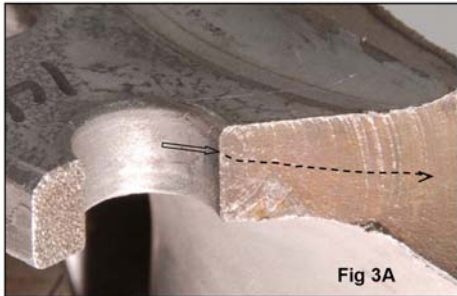
Figure 3A & 3B: Photographs showing fracture surface details.

2) Examination of the fracture surface revealed that the origin was located at the surface of one of the holes in the brake flange (arrowhead in figure 3A). Crack initiation and propagation were the result of a fatigue mechanism.

Fig. 3A shows the fracture initiation site located at surface of brake flange bolt hole indicated by arrowhead. Initiation and propagation were the result of a fatigue mechanism with crack growth in the direction indicated by dashed arrow.

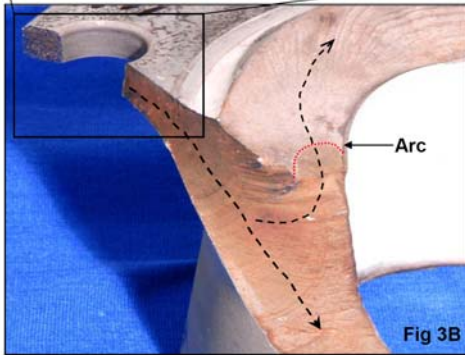
3) The fracture surface exhibited two distinct colors (figure 3B). The majority of the surface displayed light oxidation consistent with heat tinting which develops when alloy steel is exposed to temperatures of approximately 350F - 400F. This is the temperature used at overhaul for stress relief and hydrogen relief bakes. The remainder of the fracture surface was dull gray, typical of a fairly recent separation event. The presence of the oxidation suggests that the discolored portions of the crack were present when the inner cylinder was last overhauled.

Fig. 3B shows the crack propagation path as indicated by dashed black arrows. Note change in coloration on the fracture surface indicated by the dashed red arc. The bronze color inside the arc was consistent with light heat tinting oxidation. The dull gray color outside the arc was free of oxidation and corrosion, and consistent with a more recent fracture.

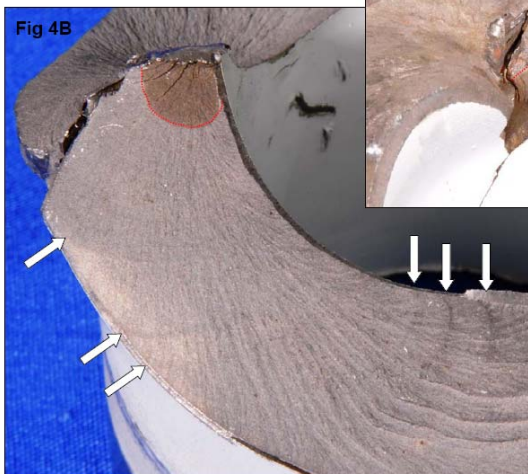
Figures 4A & 4B:

5) The fracture throughout the discolored region was the result of fatigue propagation which had progressed for a distance of approximately 3” to reach the terminus identified by the red arc. Several crack arrest marks were also visible on the gray colored fracture surface beyond the arc (figures 4A and 4B). These marks indicated that this portion of the fracture was due to incremental ductile separation which occurred once the part was returned to service after overhaul.

Photograph showing the mating fracture surfaces in the area of the coloration change denoted by red arcs and shown in Fig 3B. Note multiple visible crack arrest marks (at white arrowheads) beyond red arc indicating additional cyclic crack propagation prior to final fracture.

Figure 4A is surface on segment containing brake attach flange.

Figure 4B is mating surface on segment containing wheel bearing journals.

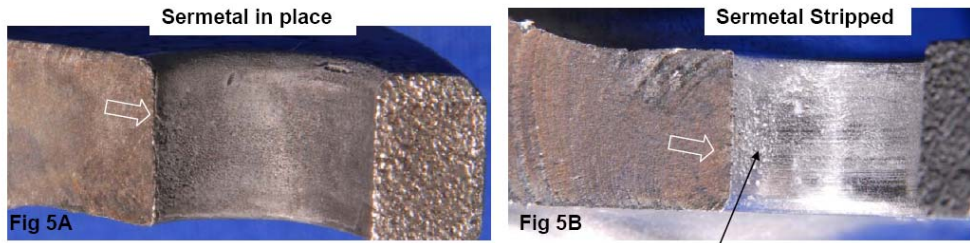
6) Stripping of the Sermetel coating on the flange and bolt holes in the area of the fracture revealed the presence of underlying corrosion pitting in the base metal (figure 5A – 5C). The fracture initiated from one of the areas of heavy pitting (figure 5B).

Figure 5A: Bore surface at fracture origin (arrow) with Sermetal coating in place.

Figure 5B: Bore surface at fracture origin (arrow) with Sermetal removed which exposed underlying corrosion pitting in base metal.

Figure 5C: Flange and bore surface adjacent to fracture with Sermetal removed to expose underlying base metal pitting.
