SHORT SUMMARY REPORT

Aircraft Accident Investigation Report

PT. Adam SkyConnection Airline (Adam Air)

Boeing 737-400, PK-KKT

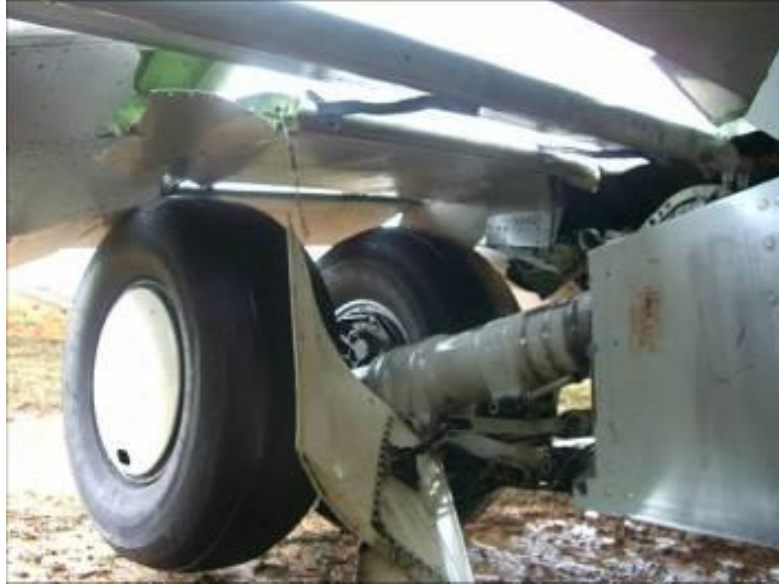
The aircraft was seriously damaged with the right main landing gear assembly detached and collapsing backward and damaging the right wing and flaps. The right engine was displaced from its attachment point.

Figure 1: Right landing gear collapsed rearward

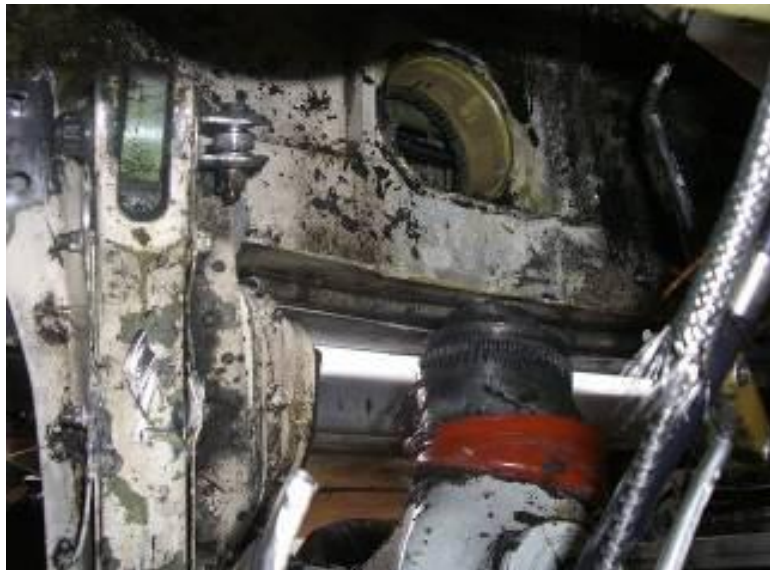
Figure 2: Detached right main landing gear retraction axle

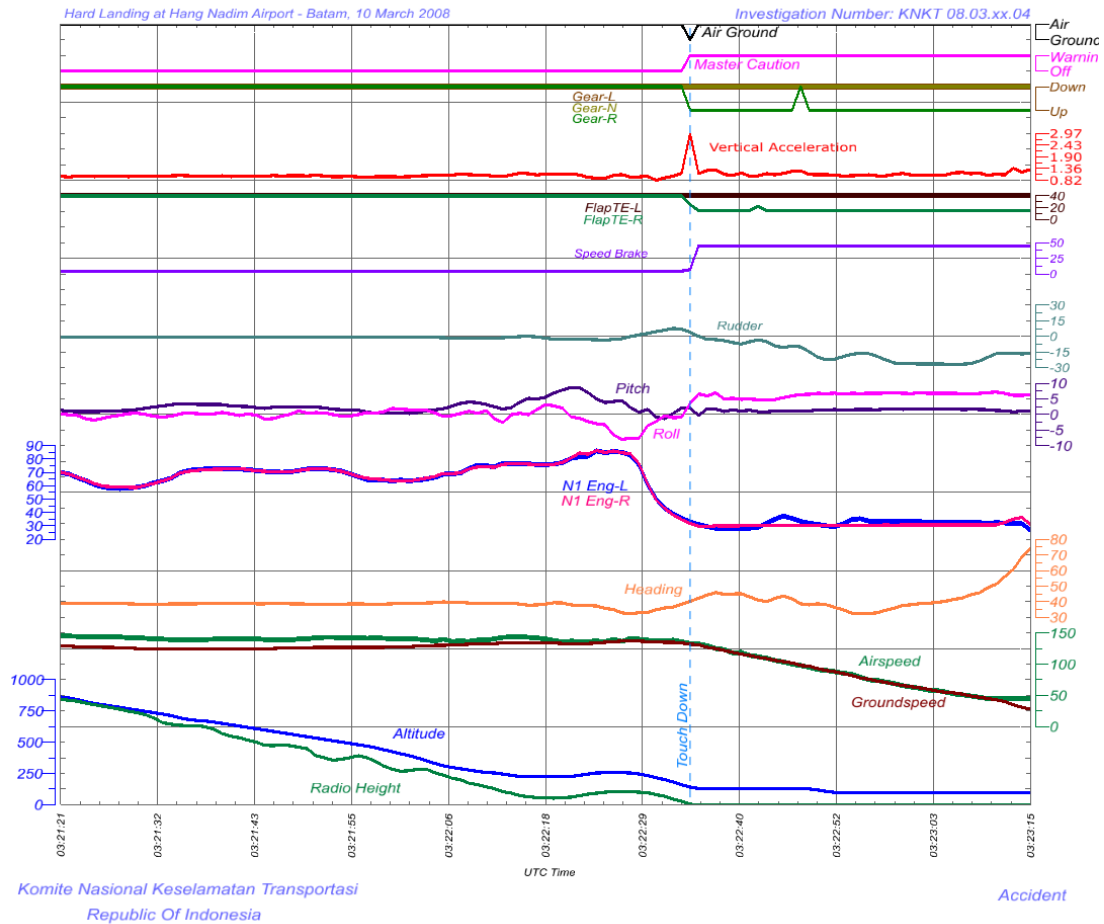
The FDR data showed that the vertical acceleration during landing was 2.97g, however this amount of vertical acceleration should not damage the landing gear. The FDR data showed that just after touchdown, the right main landing gear collapsed.

Figure 3: The significant FDR recorded parameters

The FDR also recorded that the aircraft experienced hard landing and had bounced on a previous flight, and the value of the vertical acceleration recorded was 1.78 g. It was most likely that the hard landing and bounce had affected the strength of the landing gear.

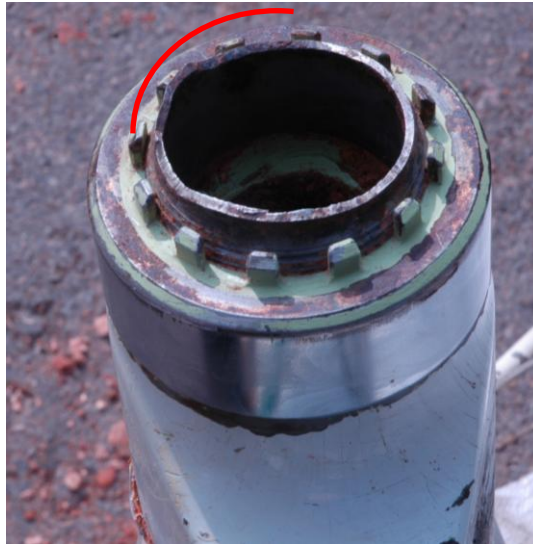
The examination of the failed landing gear also found corrosion on the fracture surface of the right main landing gear strut.

Figure 4. Corrosion found on fracture surface (red arc)

The accident flight experienced hard landing with recorded vertical acceleration of 2.9g, however this value should not have damaged the landing gear. The examination on the fracture of the right main landing gear found some parts had corrosion. This corrosion indicated that this part had been cracked for some time before the accident,

and had weakened the landing gear strength. The decreased landing gear strength most likely made the right main landing gear collapsed on landing with 2.97 g. The investigation could not determine the exact time the crack initiated.
