KNKT.08.10.21.04

Aircraft Accident Investigation Report

PT. Wings Abadi Airlines

Boeing Company MC Donnell Douglas DC9-82

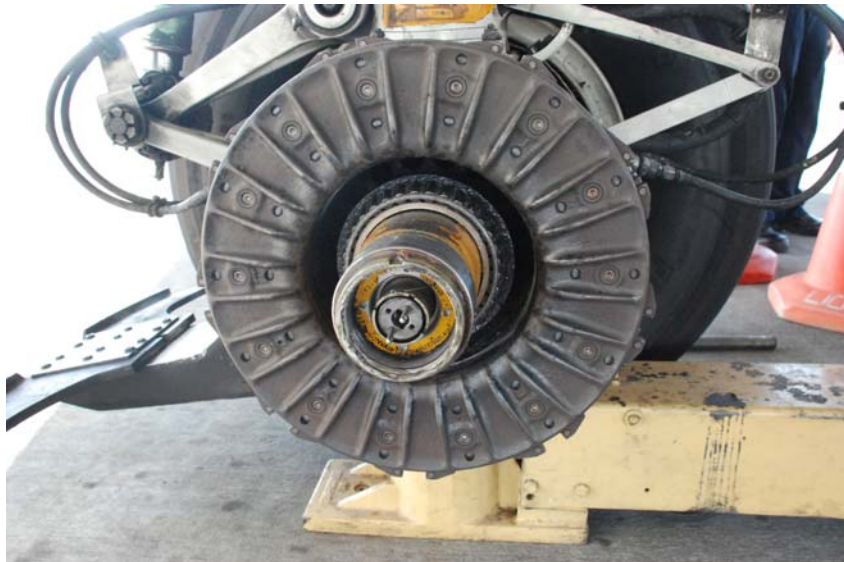
The number-two (left inboard) main wheel had separated from its axle. The axle nut and the axle cover also separated from the axle. The nut was found in the axle cover. The axle-nut locking mechanism was still in its position.

Figure 1: The number-two main wheel axle

Wheel number two (left main inboard) separated from the left main landing gear axle. The attaching nut had separated from the axle, but was still in the axle cover. There was no indication of nut loosening since the locking mechanism was still in position. The detachment of the nut was due to axial displacement. This was only possible when the strength and tightness between the threads of the axle and the nut was not sufficient.

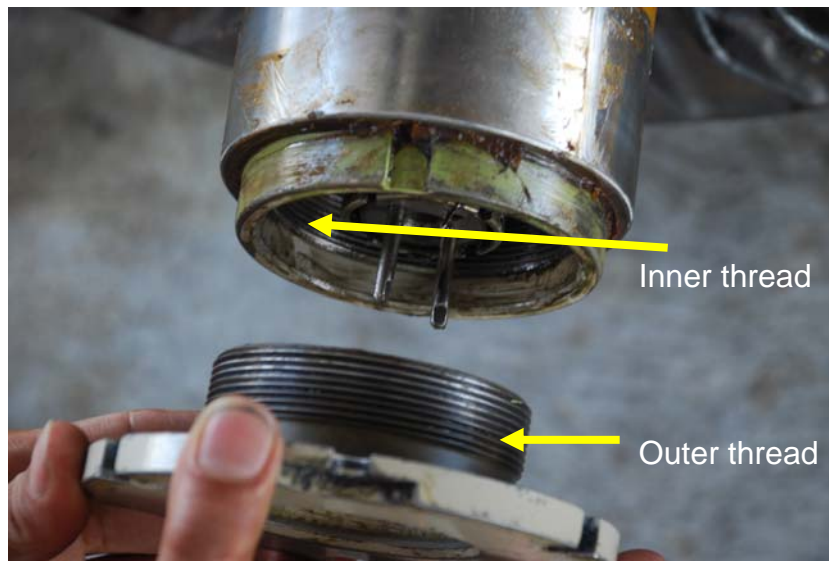
Figure 2: The main wheel axle and axle nut

This situation is detailed in section 1.18 of this report and lead to the conclusion that the inner threads of the left landing gear axle number two and axle number one, were worn out. The tightening was only possible at about the last two threads. In such situations the strength and tightness of the thread joint could not be assured by the magnitude of tightening torque.

The worn inner threads of the axle number two (the left inboard main landing gear) caused the detachment of the axle nut and the separation of wheel number two.

The investigation determined that the axle threads were worn prior to the reinstallation of the wheel at the last servicing, and the wheel and nut should not have been fitted to the aircraft; the axle should have been replaced.

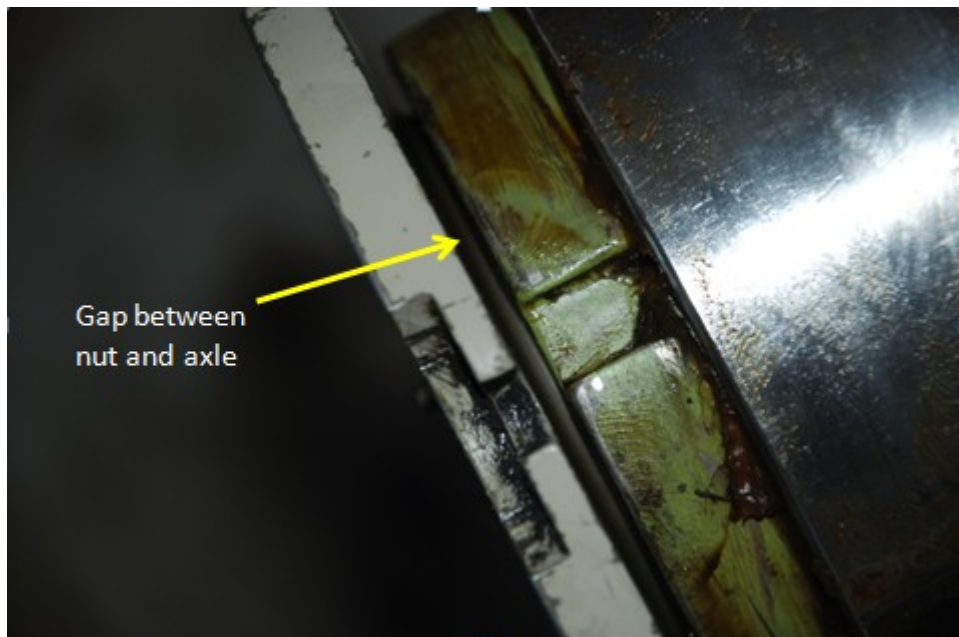
- The detached nut from wheel number two was re-installed onto axle number two (left main inboard axle). After three turns, the nut was still loose/slag.
- The detached nut from wheel number two was installed onto axle number one (left main outboard axle). After three turns, the nut was still loose/slag.
- The detached nut from wheel number two was installed onto axle number three (right main inboard axle). The nut was able to be tightened.
- The nut that had been removed from serviceable axle number three was installed onto axle number two. After three turns, the nut was still loose/slag.
- The threads on axle number two were excessively worn.

Figure 3: After tightening by three turns, the nut was still loose and had slag relative to the axle

McDonnell Douglas DC9-82 aircraft in its fleet for possibility of worn axle threads. The recommendation drew the operator's attention to the need for any axle found to have inner threads worn to be removed and replaced by a serviceable axle.

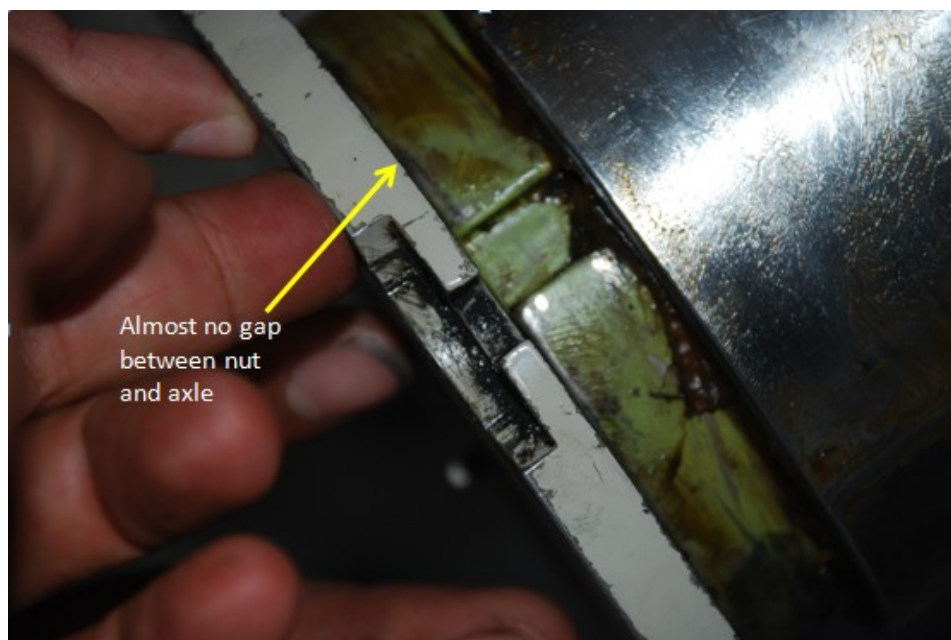
The nut was pushed toward the axle, without turning the nut on the threads, and the gap between the axle and the nut closed. Figure 5.

Figure 4: The gap between the axle and the nut after pushing the nut
