KNKT 08.10.21.04

Aircraft Serious Incident Investigation Report

Merpati Nusantara Airline

Boeing Company 737-400 ; PK-MDO

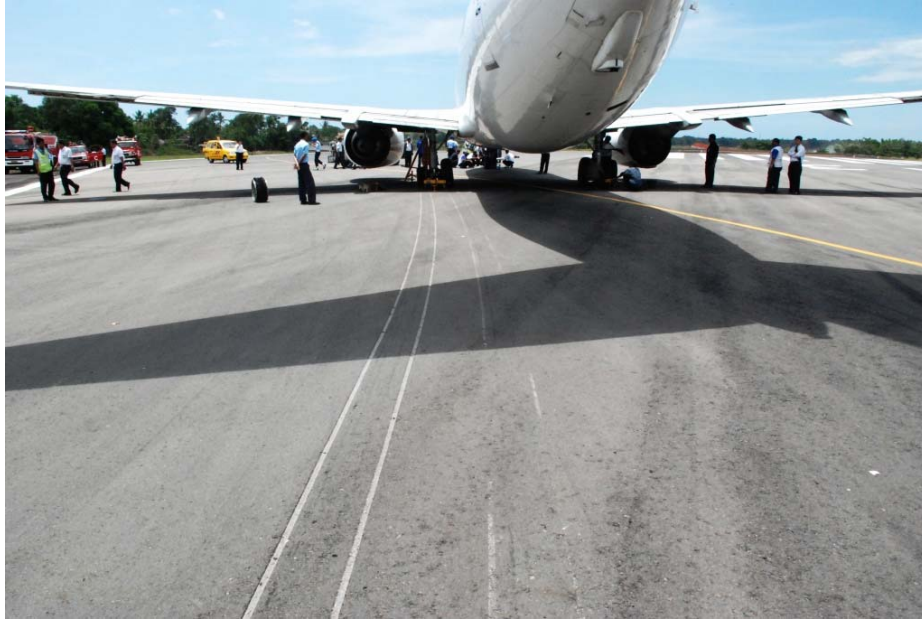
The PIC stopped the aircraft on the runway turning area. Both left main-wheel tires had been severely damaged. Both right main-wheel tires deflated as the fuses had melted by overheat. Part of the left main landing gear door detached.

Figure 1: The aircraft after the incident being prepared to be towed to apron.

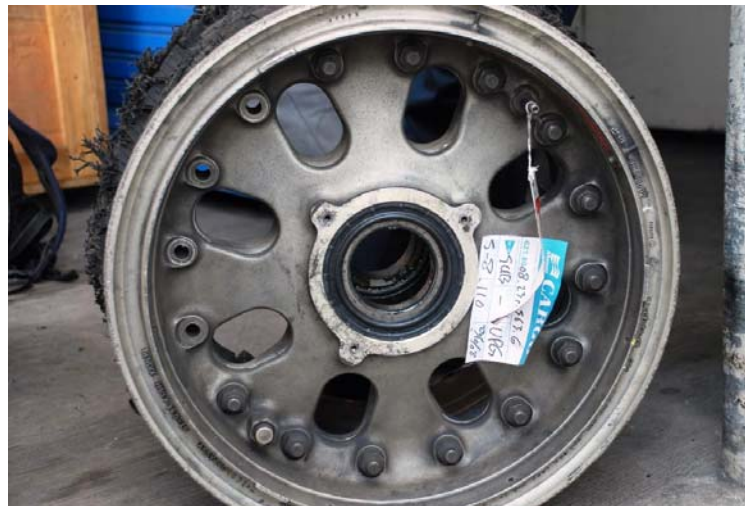
Examination of wheel hub number 1 revealed that 4 of 16 bolts on the wheel hub had broken (Figure 2). One bolt which was still attached adjacent to the four failure bolts was found cracked. These five broken bolts and three nuts that were attached to the broken bolt which were collected at Makassar were sent to the Laboratory of Mechanical Metallurgy of the Faculty of Mechanical and Aeronautical Engineering of Institute of Technology, Bandung (ITB).

Figure 2: Wheel number-1 hub with four of sixteen bolts that were broken

The inner side of wheel number-1 hub (as shown at figure 2) was found in a clean condition. There was no indication of tire over heating. This indicated that there was no slippage between the tire and the wheel rim. The outer side of this tire was extensively damaged.

The deflation of wheel number one was due to loosening of wheel hub halves as four of sixteen bolts were broken.

A further examination on hub of wheel number one found that four bolts of 16 bolts (Figure 2) were missing. The mating surface of the wheel hub becoming loosened led the tire pressure to rapidly deflate. The failure of the number one tire was immediately followed by number two tire burst due to overload.

- For single bolt failures, each tie bolt adjacent to the broken bolt should be removed and scrapped.
- For multiple bolt failures, all tie bolts in the wheel should be scrapped

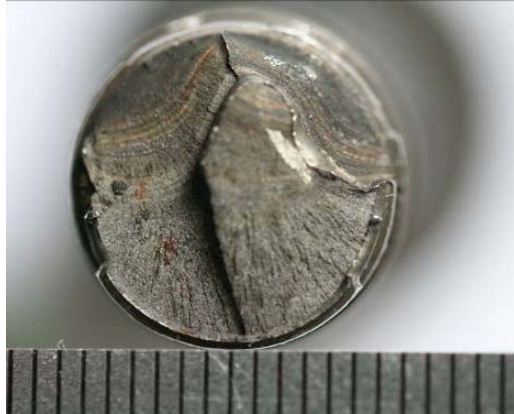
The sequence of failure can be described as follows. The bolts with broader fatigue fracture surfaces areas were the bolts that failed first. In this discussion, this bolts identified as bolts B (Figure 3) and followed by bolt C (Figure 4), which were located between bolts A and D.

Figure 3: Bolt B; Fracture surface with a fatigue crack of 14mm long. (circumferentially)

The bolt examination concluded that the fatigue cracks on all 4 fail bolts were originated from the thread roots. The fatigue cracks of bolts B and C were present before the take off in Makassar. Most likely the disintegration of both bolts (B and C) occurred during the initial phase of take off followed by disintegration of bolts A and D. The disintegration of four bolts caused the seal between the two wheel halves extruded and release the tire pressure.

The fatigue fracture of bolts A and D were initiated and propagated in the take-off phase. The circumferential length of the fatigue crack of bolt A and D were approximately 7mm and 6mm respectively. The development of fatigue crack during the take off is in average 6.5mm. The final fatigue crack length of bolt B and C are 14mm and 11mm respectively. Using a simplified calculation, the crack length on bolt B and C before take off at Makassar can be estimated to be $(14-6.5)= 7.5\text{mm}$ and $(11-6.5)= 5.5\text{mm}$ respectively.

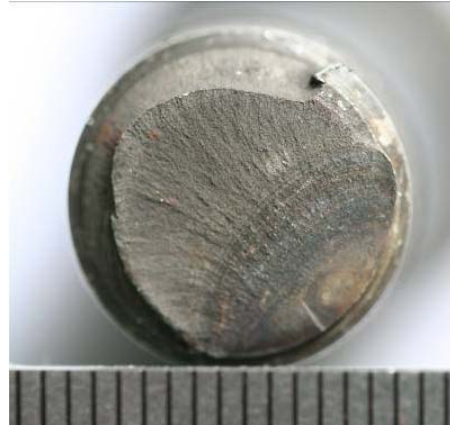
Figure 4: Bolt C; Fracture surface with a fatigue crack of 11mm long. (circumferentially)

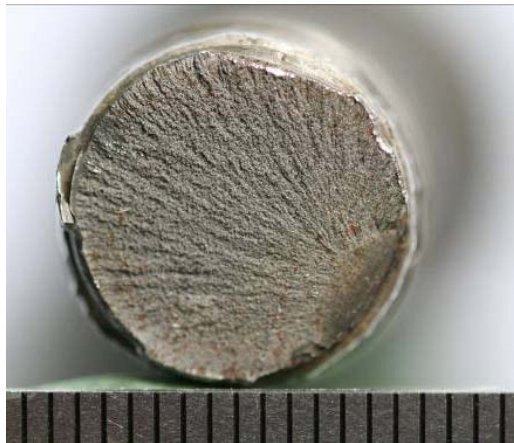
Following the failure of bolts B and C, the adjacent bolts - in this discussion identified as bolts A (Figure 5) and D (Figure 7) received higher load and subsequently failed with narrower area of fatigue crack or broader area of final failure.

Figure 5: Bolt A: Fracture surface with a fatigue crack of 7mm long (circumferentially).

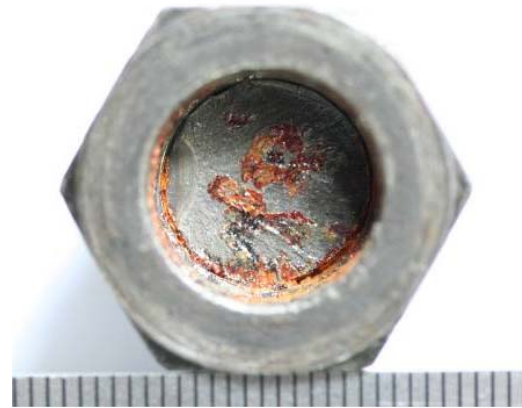
Figure 6: Nut & broken bolt A

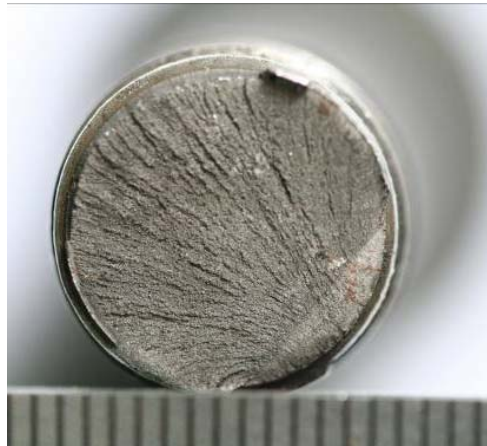
Figure 7: Bolt D: Fracture surface with a fatigue crack of 6mm long (circumferentially).

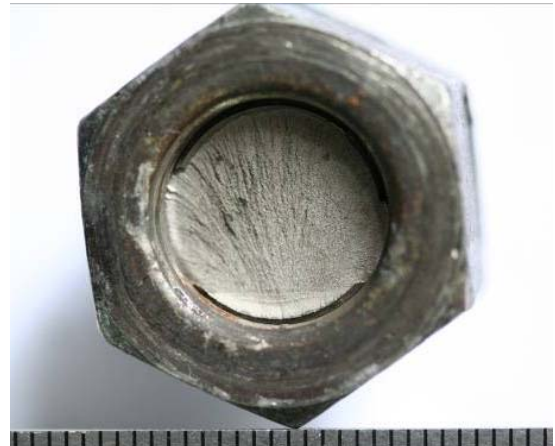
Figure 8: Nut & broken bolt D

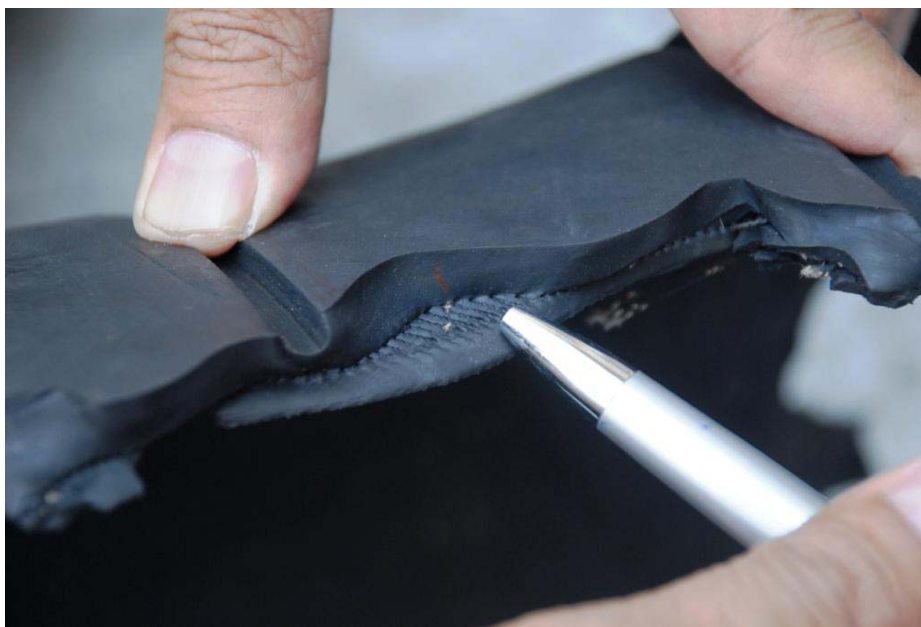
Figure 9: The shape of the cut and the nylon holes are not types of damage by FOD.

The shape of cut on the piece of tire has an angle and curved. The nylon pulled out from its position. This was evidence that the tire failure was not caused by foreign object damage (FOD).

Blue marks as result of the chemical reaction of magnesium to heat would be an indication of tire under inflation for a period of time. That evidence was not found on this piece of tire, indicating that the tire did not fail as result of under inflation. There was also no evidence of tire delamination.
