KNKT.08.08.17.04

# NATIONAL TRANSPORTATION SAFETY COMMITTEE

*Aircraft Accident Investigation Report*

**PK – RCZ**

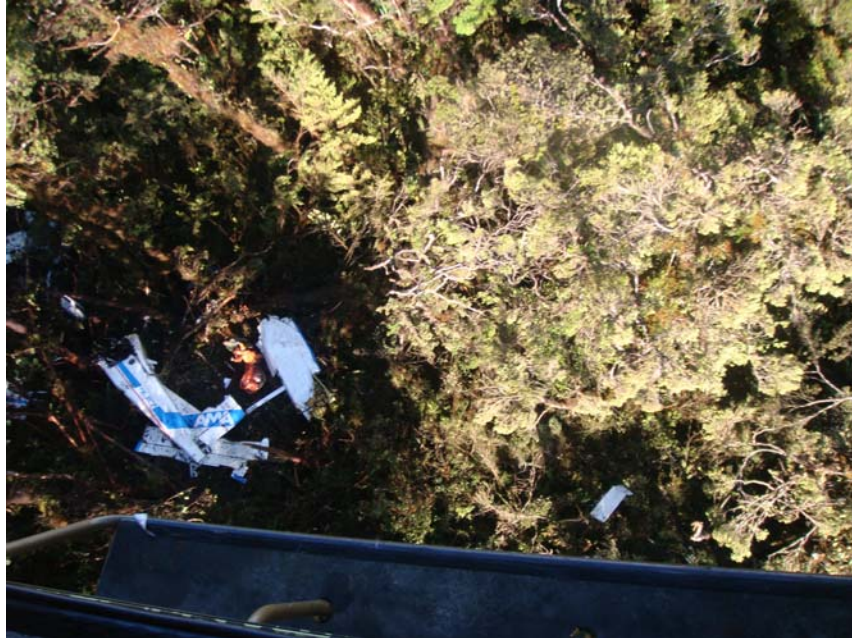
**Figure 2: Wreckage PK-RCZ in NduNdu Pass at 6400 feet**

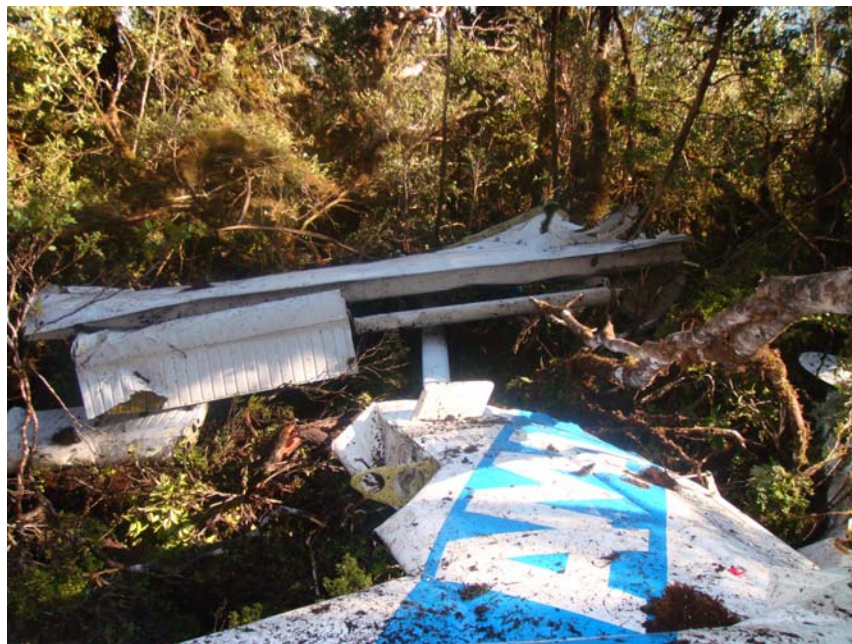
**Figure 3: Outboard section of the right wing and tail section separated from the aircraft**

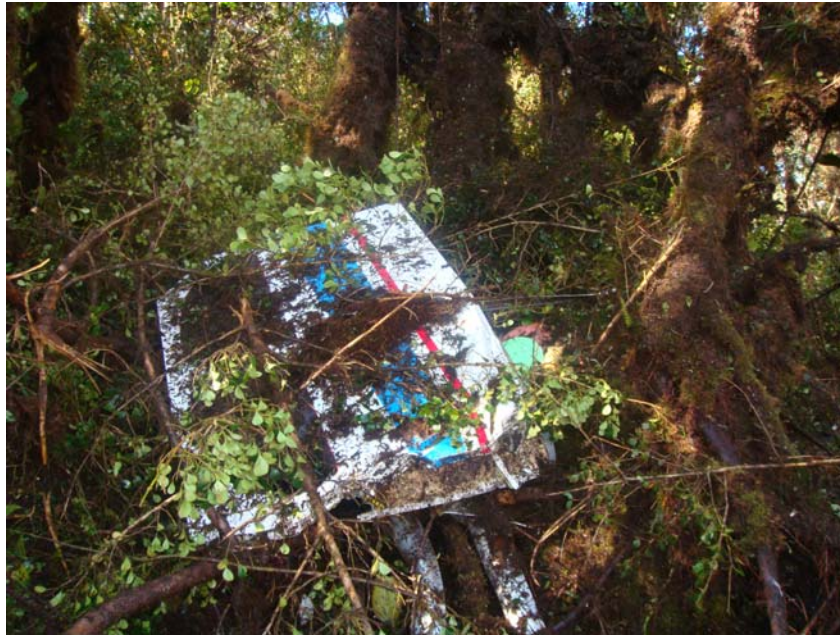
**Figure 4: Right door of PK-RCZ**

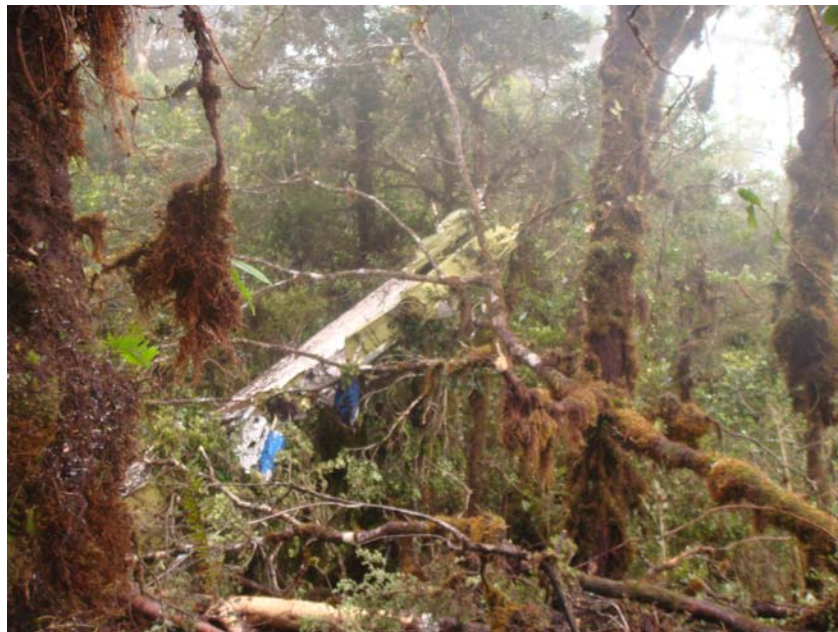
**Figure 5: Inboard section of the right wing**

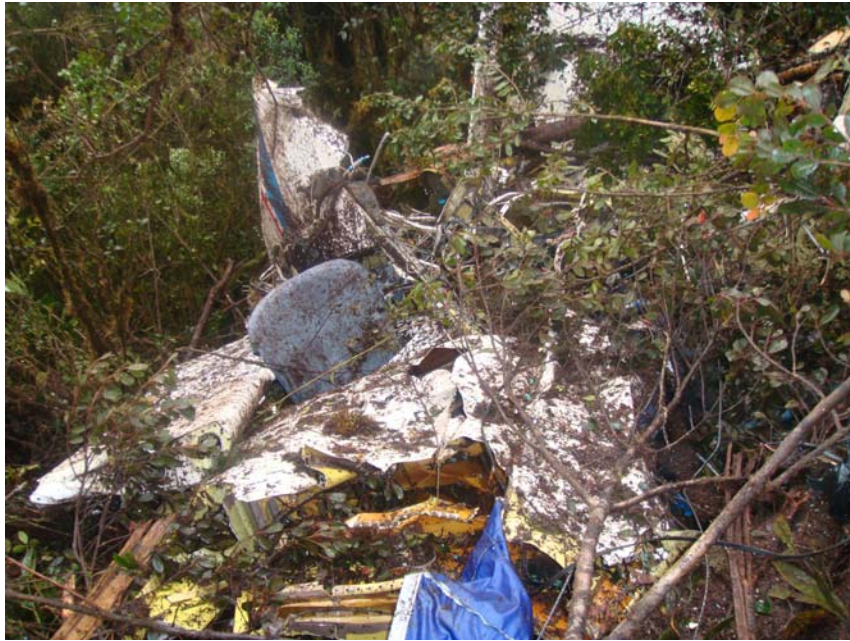
**Figure 6: Left wing and pilot's seat**

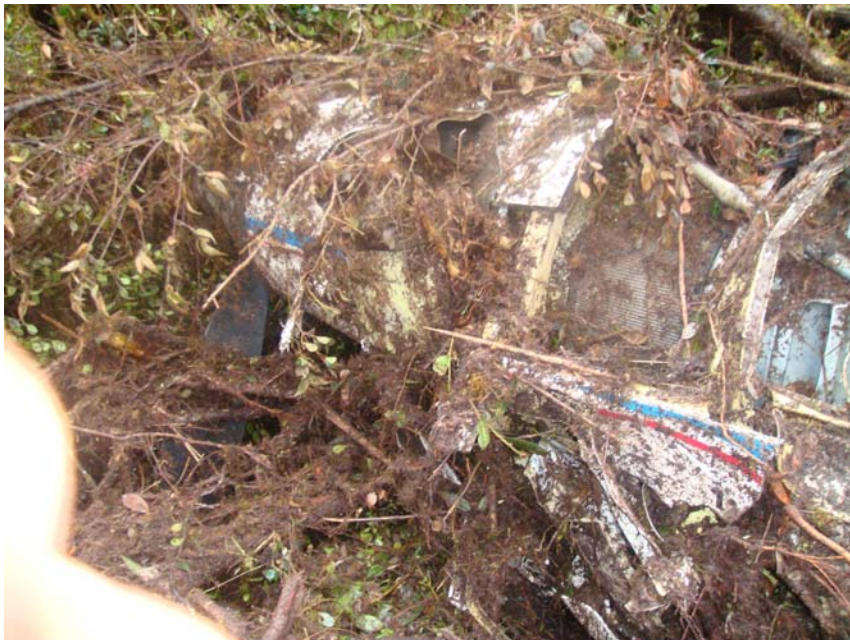
**Figure 7: Engine**

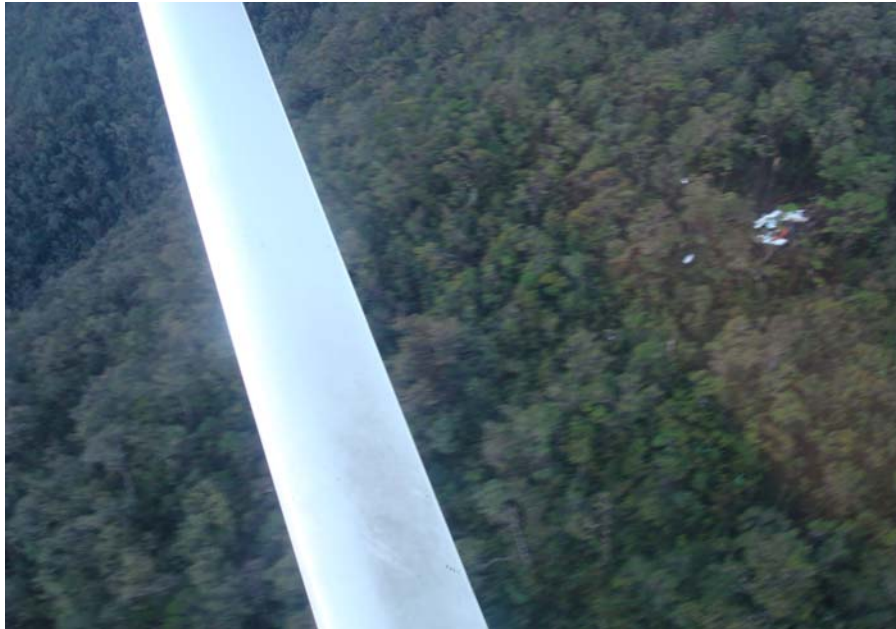
**Figure 8: Wreckage of PK-RCZ on the slope above NduNdu Pass**

The accident site was to the east of the NduNdu Pass at 6,400 feet. The investigation determined that it is likely that the pilot continued flying towards the Pass towards the NduNdu aerodrome in instrument meteorological conditions (IMC). The aircraft impacted the mountain slope to the east of the Pass while cruising. The impact was severe and the accident was not survivable.
