**FINAL**  
KNKT.08.03.06.04

# NATIONAL TRANSPORTATION SAFETY COMMITTEE

Aircraft Accident Investigation Report

**Federasi Aero Sport Indonesia (FASI)**  
**Pelikan; PK-SKI**  
**Pamulang Village, Tangerang**  
**Republic of Indonesia**  
**16 March 2008**

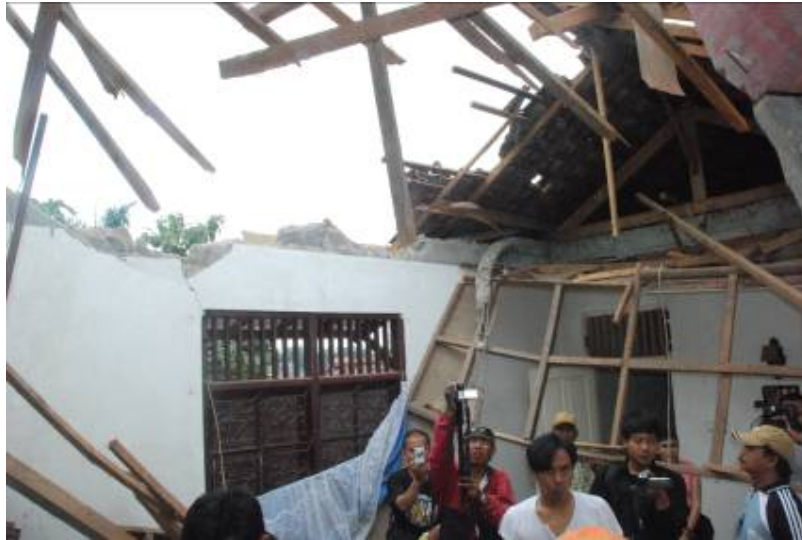
The aircraft was crashed in the residential area in Pamulang village and four house damaged due to this accident.

**Figure 2: The damaged house**

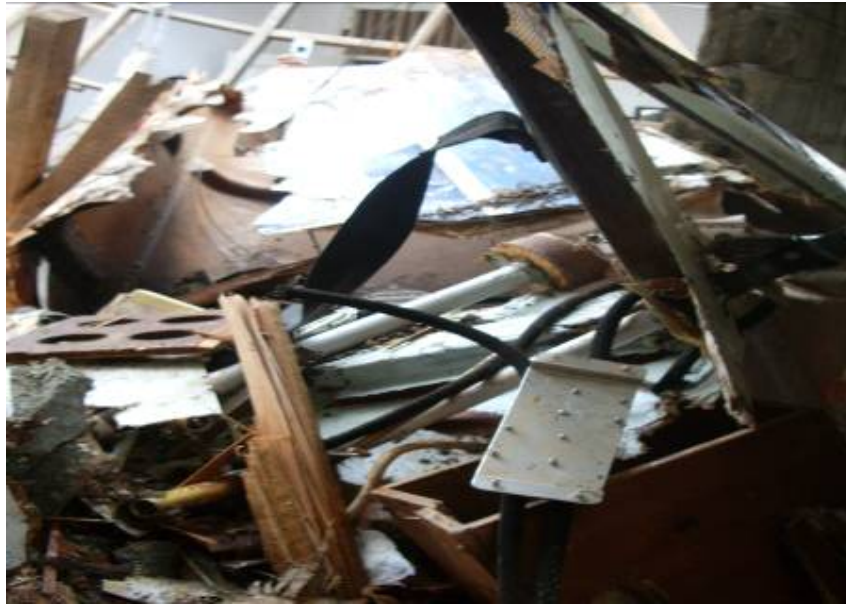
- a. The aircraft wings was loose and destroyed;
- b. The cockpit was destroyed;
- c. The fuselage was destroyed;
- d. The elevator and fin was destroyed and found at the house number 11;
- e. The landing gear was damaged;

**Figure 3: The aircraft wreckage**

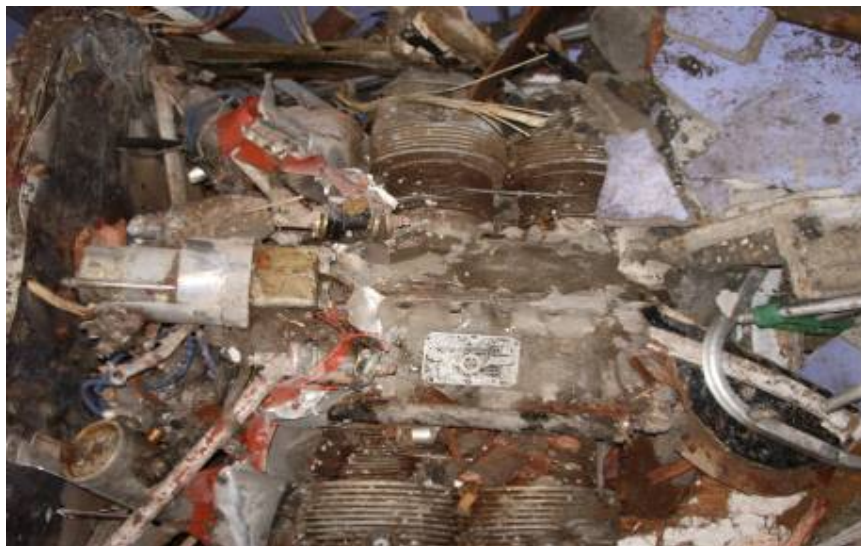
**Figure 4: The aircraft wreckage**

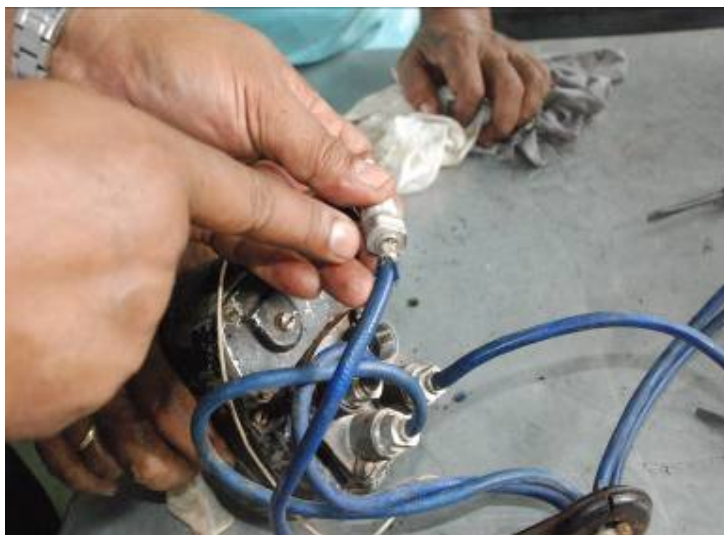
The number 4 left magneto harness was broken, measured by high tension lead tester. The right magneto has unstable ignition due to the spring carbon brush was weak and the internal magneto was dirty caused oil inside the magneto. The plastic or Teflon washer was not attaching in the right magneto.

The number 4 left magneto ignition harness has been broken and the carbon brush spring on right magneto weak or did not press properly the distributor to the carbon most likely produced and unstable ignition.

The number 4 cylinder did not produce power, so that the engine was not produce sufficient power for operating the aircraft.

Figure 6: The left magneto harness broken

The aircraft was crashed due to losses power due to ignition problem.

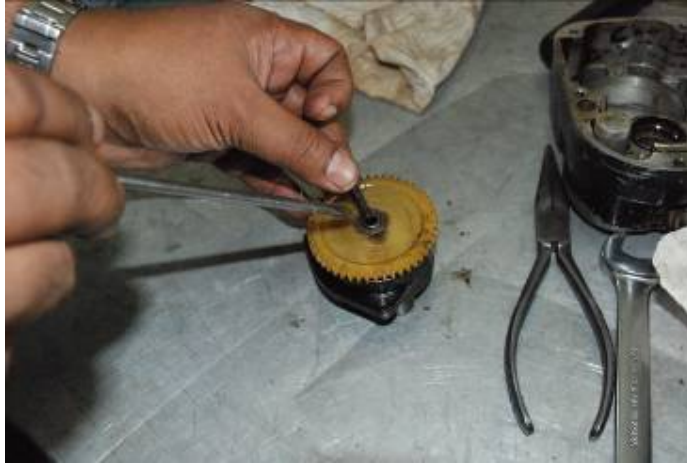
**Figure 7: The carbon brush spring was weak**
