KNKT/08.26/09.02.39

Aircraft Accident Investigation Report

DORNIER 328-100

PK-TXL; EXPRESS AIR

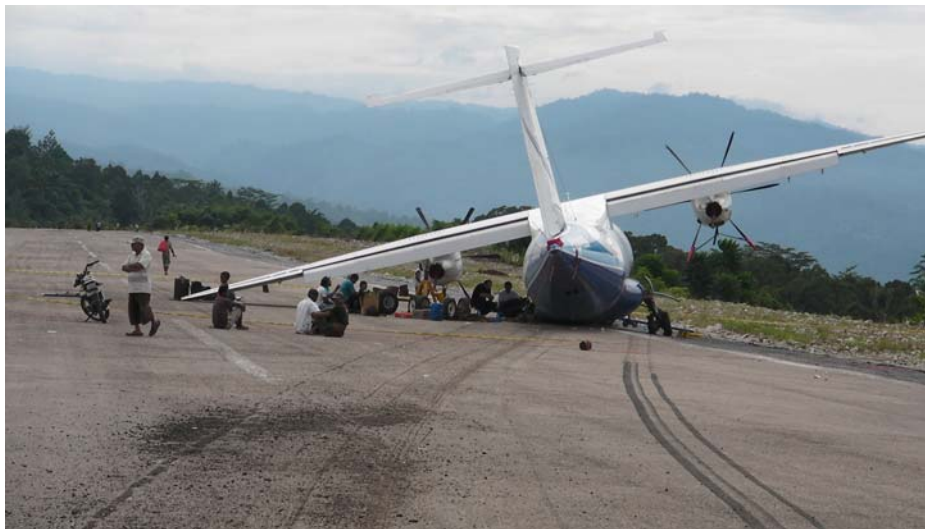
The aircraft touched down heavily approximately 5 meters before the touch-down area of runway 10 at Torea Airport, Fak-Fak at 01:33. The investigation found that the left main landing gear touched the ground first (5 meters before the end of the runway), and the right main landing gear touched the ground (4.5 meters from the end of the runway). It stopped on the runway, approximately 500 meters from the touch-down area (figure 1).

Figure 1: PK-TXL, at Torea Airport, Fak-Fak, Papua on 6 November 2008

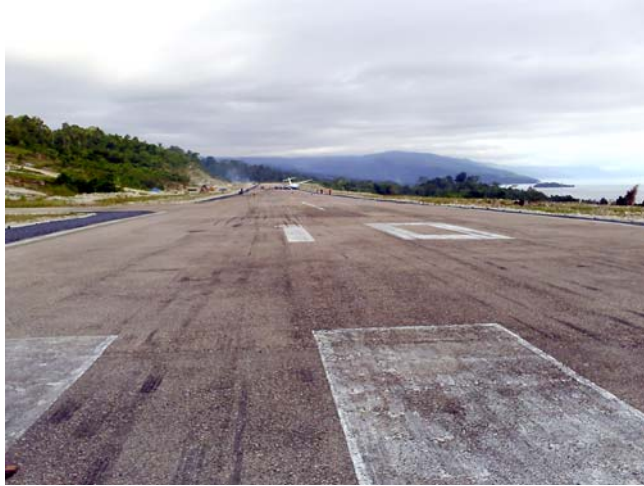
There were no tire marks on runway after the initial touch-down marks, until approximately 100 meters from the end of runway. There were left wheel marks and body marks on the runway up to the final position of the aircraft. These marks were heavy and provided a continuous track of the aircraft along the runway to its final position.

Figure 2: Area of no wheel marks from PK-TXL on the runway

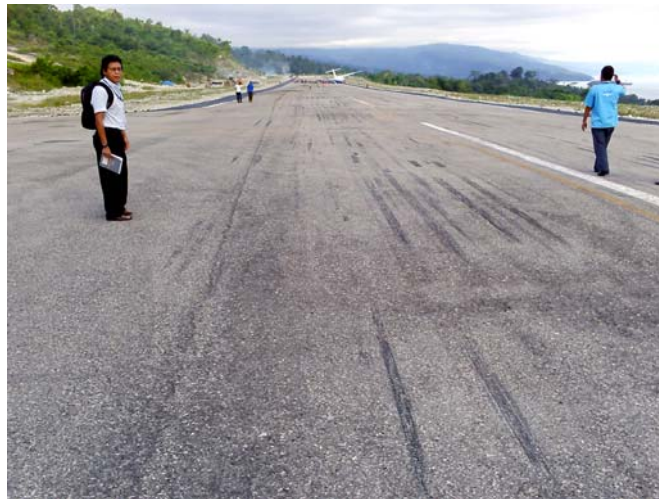
Figure 3: Left wheel mark from PK-TXL on the runway approximately 100 meters from the touch-down end of the runway.

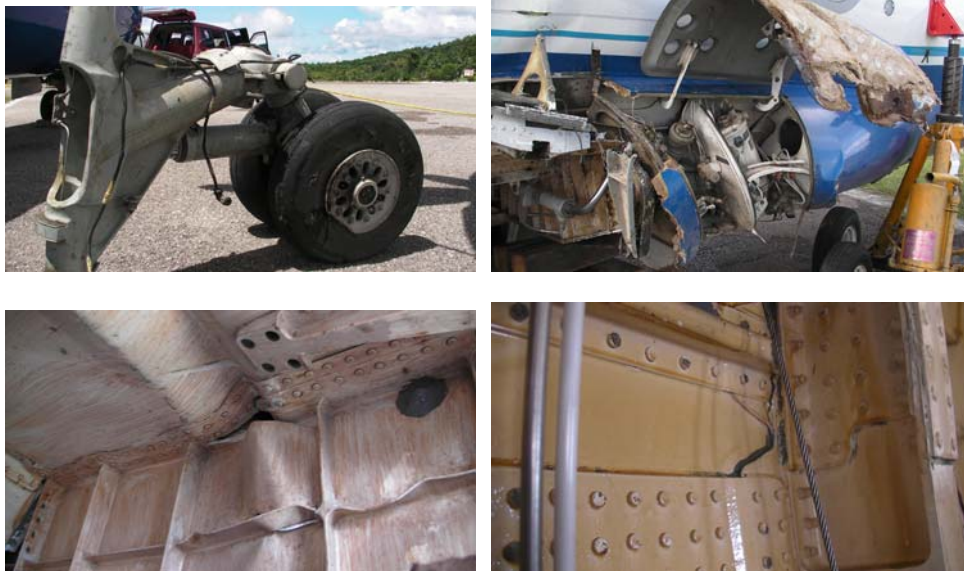
The left main landing gear fractured in two places; at the front pivot point, and the aft pivot point. This occurred when the landing gear impacted the end of the runway which is 30 cm higher than the touch-down area (Figure 3). The left fuselage contacted the runway surface 200 meters from the touch-down point and the aircraft slid with the left lower fuselage on the ground for a further 300 meters, before it stopped at the right edge of the runway. The wing tip and left propeller blade tips also touched the runway and were damaged.

The left main landing gear, the structure around left main landing gear bay, and the left lower fuselage skin, were substantially damaged. Wheel³ & tire number 1, tire number 2, and tire number 3 were also damaged. The left propeller tips and the left wing-tip were damaged due to ground contact.

Figure 4: Damaged left main landing gear, landing gear bay, and left fuselage structure

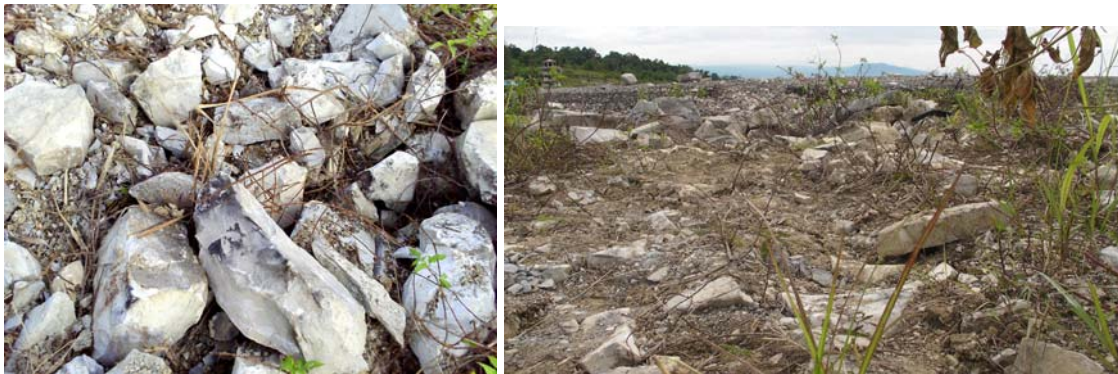
There were tire marks on the stones 5 meters before the end of the runway, and wheel and fuselage scrape marks on the runway.

Figure 6: Tire mark on stones 30 cm below runway level, 5 meters before the end of runway

The runway at Torea Airport, Fak-Fak did not meet the ICAO Annex 14 Standard requiring a 90 meter RESA. It is likely that the aircraft would have landed safely and not been damaged if there had been a RESA.

The National Transportation Safety Committee recommends that the operator of Torea Airport, Fak-Fak, Papua review the runway complex to ensure that runway end safety areas (RESA) are established that meet the dimension Standards prescribed in the International Civil Aviation Organization (ICAO) Annex 14.

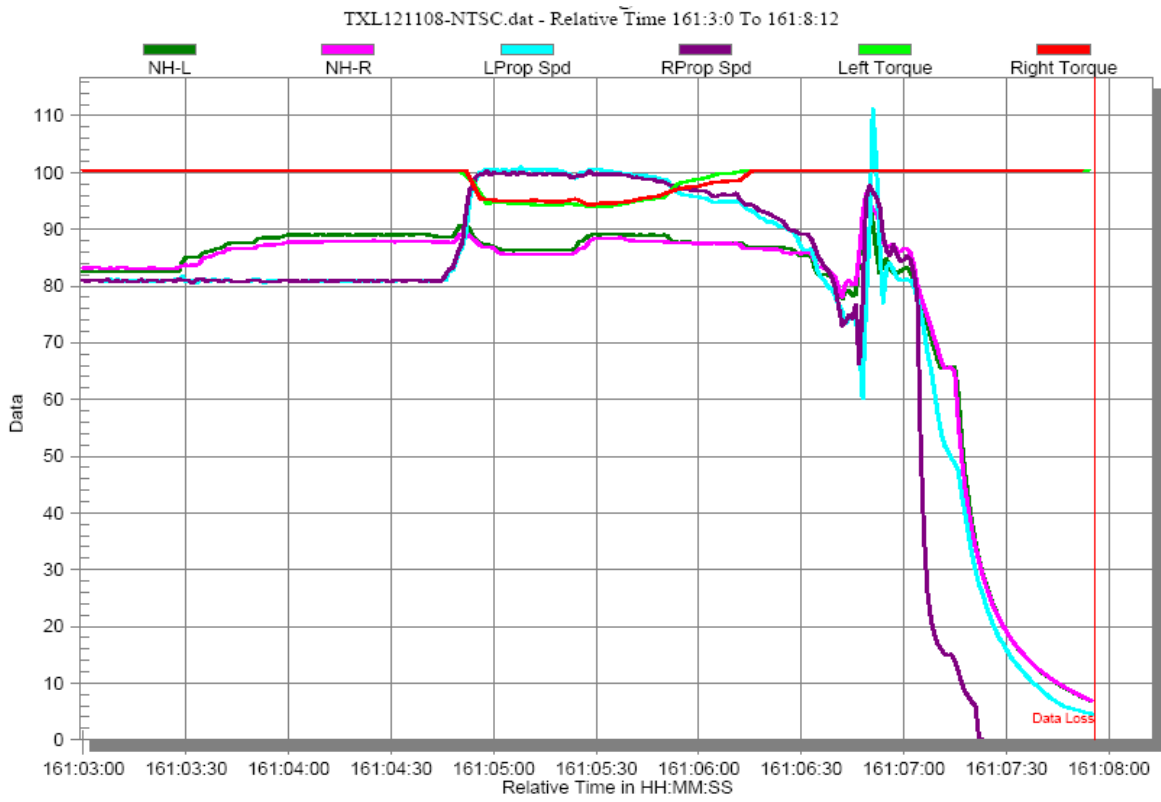
Graph 1

The Digital Flight Data Recorder data showed evidence that the aircraft descended suddenly and rapidly when it was on short final approach. About 65 seconds before ground impact, the RPM of both propellers commenced to decrease to approximately 70% with the NH increasing to 85%. Propeller RPM then suddenly reduced, followed by an immediate and rapid increase of propeller RPM to 111% left and 97% right, then just as sudden and rapid, the left propeller RPM reduced to 77% and the right to 80%. Given that the propellers are constant speed units, the sudden and rapid changes could not be explained other than the probability that a crew member had made the control inputs.
