KNKT 08.01.02.04

Aircraft Accident Investigation Report

PK-VSE

Casa 212-200

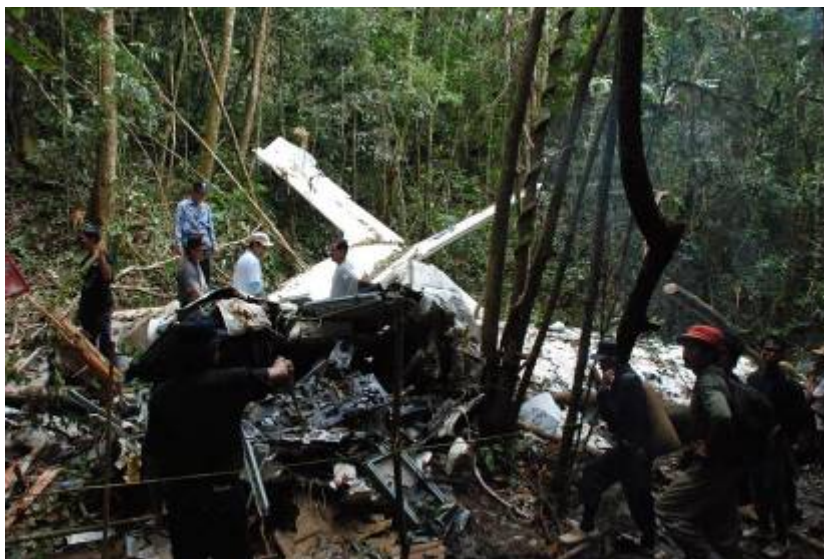
Searchers subsequently found the aircraft wreckage at an elevation of 2,766 feet, about 3.4 NM from Long Apung Airport. The coordinates of the accident site were 01° 39.483' S and 115° 00.265' E near Lidung Payau Village, Malinau, East Kalimantan. The accident site was on the left downwind leg of the runway 35 circuit.

Figure 1: PK-VSE accident site

The aircraft was destroyed by impact forces. The right wing root was substantially damaged by a post-impact fire.

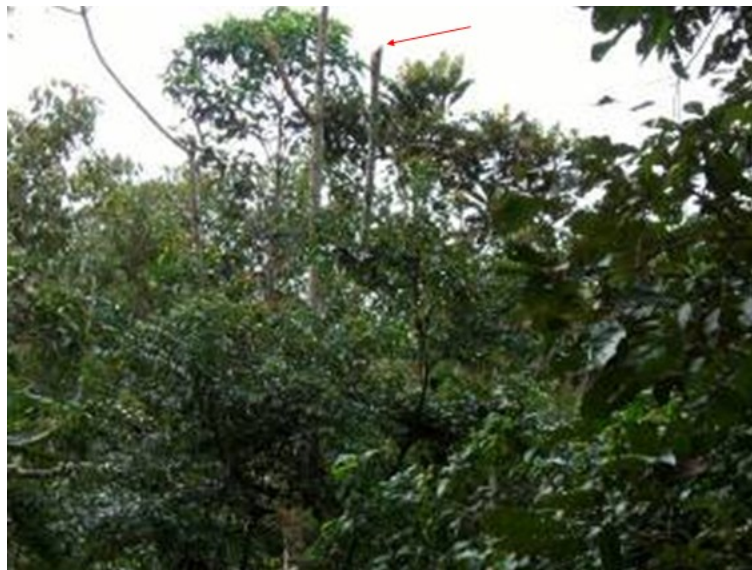
The aircraft impacted trees and the terrain and wreckage was confined to the immediate accident site.

Figure 2: Arrow shows first impact with tree

There was no evidence of pre-impact fire. A post-accident fuel-fed fire substantially damaged the right wing root area. No rescue fire fighting services attended the accident site nor were they available in the remote location.

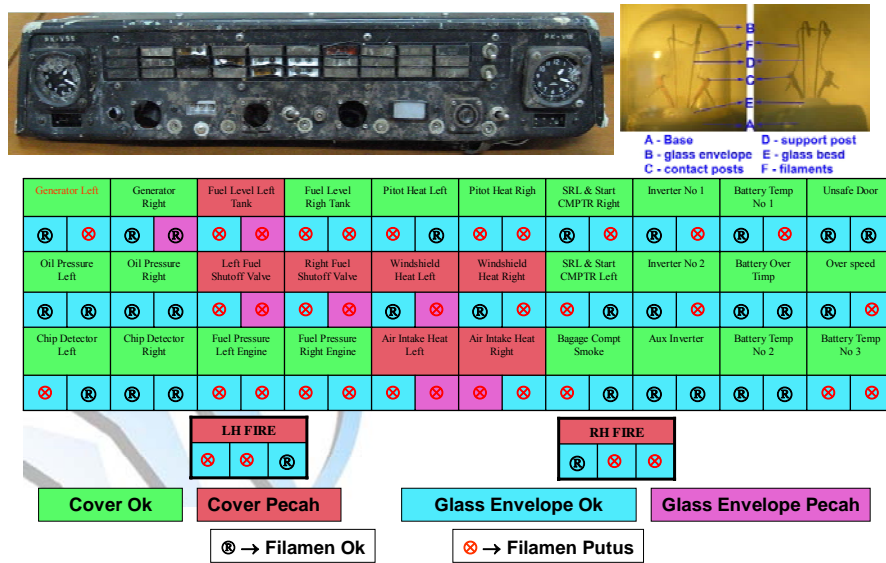
Bulb Analysis Instrument Panel

The bulb (filament) examination of the instrument panel warning/caution lights revealed no evidence of in-flight fire.
