KNKT.08.03.06.04

Aircraft Accident Investigation Report

Transall C-160

PK-VTQ

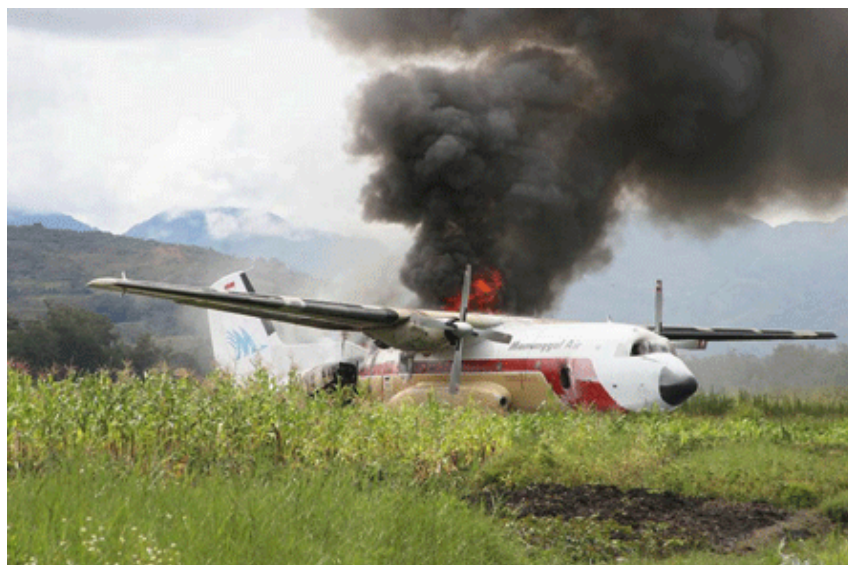
The pilots stopped the aircraft on taxiway “E”, and the occupants disembarked and attempted to extinguish the wheel-bay fire with a hand held extinguisher.

Figure 1: Transall C-160, PK-VTQ, on taxiway “E” at Wamena

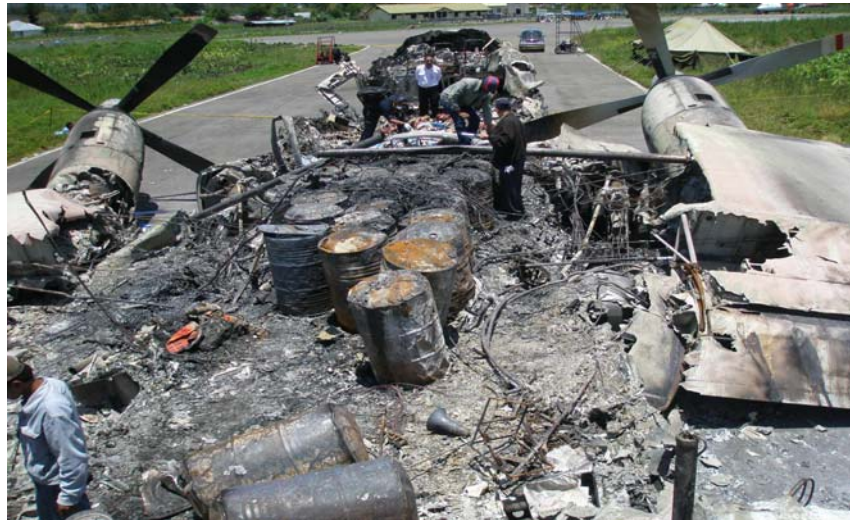
Fire destroyed the aircraft and its cargo of fuel in drums, after the aircraft stopped on taxiway “E”.

Figure 2: Burnt general freight, including diesoline and turbine fuel in drums

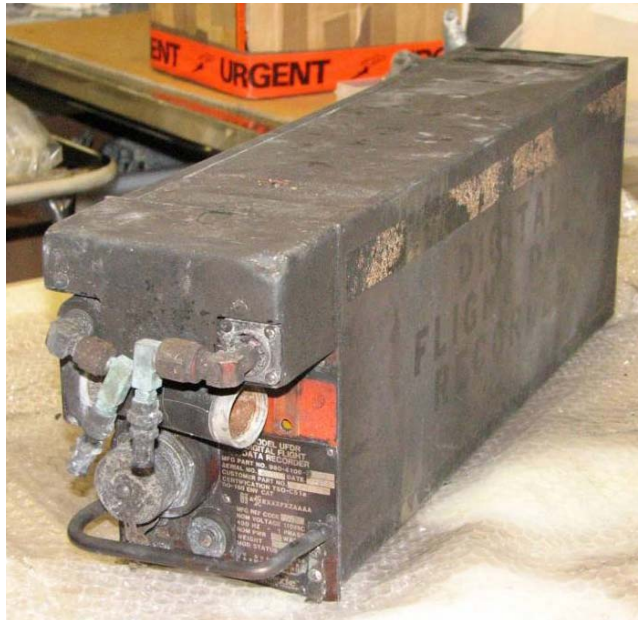
The flight recorders were recovered from the aircraft under the supervision of NTSC investigators. The flight recorder boxes were fire damaged, but the contents of the boxes were not affected by fire or heat. The recorders were sent to the Australian Transport Safety Bureau (ATSB) in Canberra for replay and analysis.

Figure 3: Fire damaged Universal Flight Data Recorder box

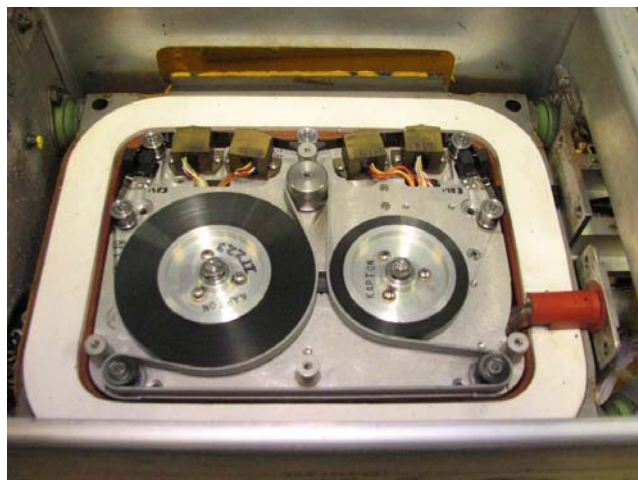
Figure 4: Undamaged contents of Universal Flight Data Recorder

The ATSB downloaded the data from the Universal Flight Data Recorder (UFDR) and found that only the following parameters were recorded:

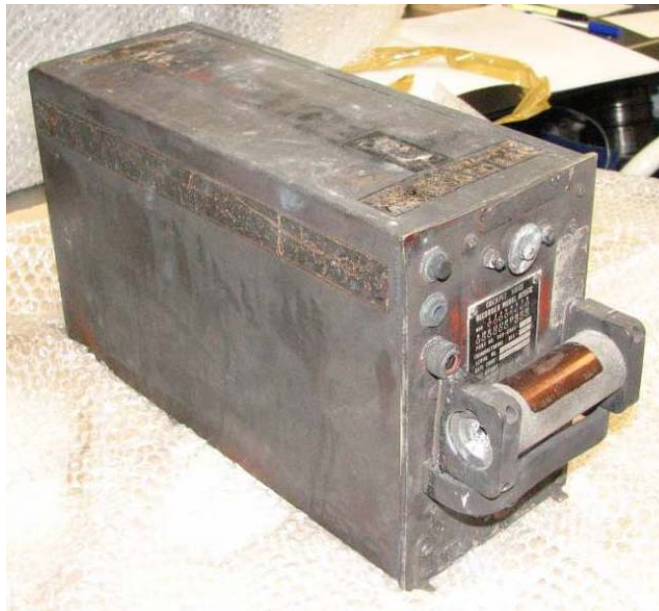
Figure 5: Fire damaged Cockpit Voice Recorder box

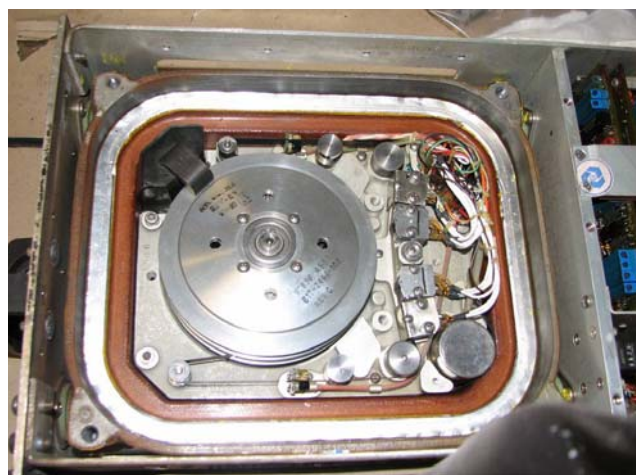
Figure 6: Undamaged contents of Cockpit Voice Recorder

The ATSB also sought to retrieve data from the cockpit voice recorder (CVR). However, recorded data only contained a previous flight sector and was extremely poor quality. The CVR was not recording during the flight sector from Jayapura to Wamena, and did not record any data at the time of the occurrence.

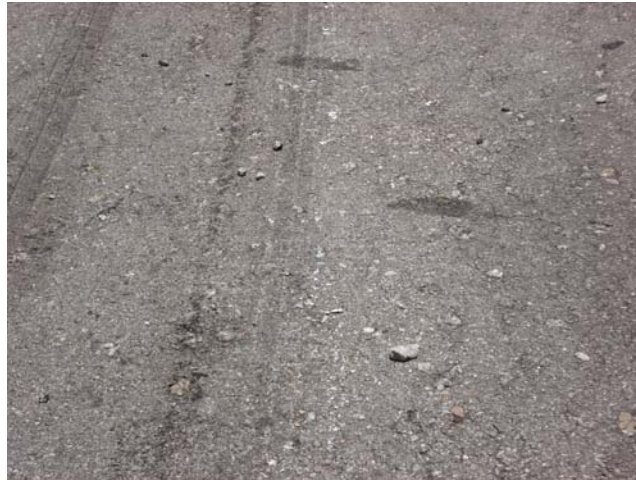
Investigators found molten metal on the runway along the left wheel track for about 16 meters, about 100 meters from taxiway “E”, between taxiway “E” and the departure end of runway 15. There was also molten metal along the left wheel track on taxiway “E”.

There was molten metal along the Transall's wheel tracks on the runway and taxiway "E".

Figure 7: Molten metal on the runway in the aircraft's wheel tracks

There was molten metal along the Transall's wheel tracks on the runway and taxiway "E". Due to the damage caused by the fire, the investigation was not able to determine the origin of the molten metal.

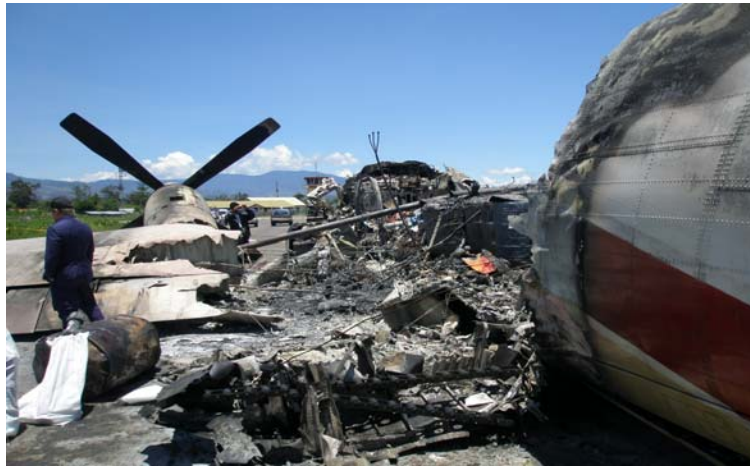
Figure 8: The fire started in the left wheel bay. The wings collapsed onto the main wheel area

The investigation determined that the left main wheels' brakes overheated during the landing roll. Due to the extreme fire damage, the investigation was not able to determine the condition of the brake pads at the time of the landing, and if that may have contributed to the overheating.

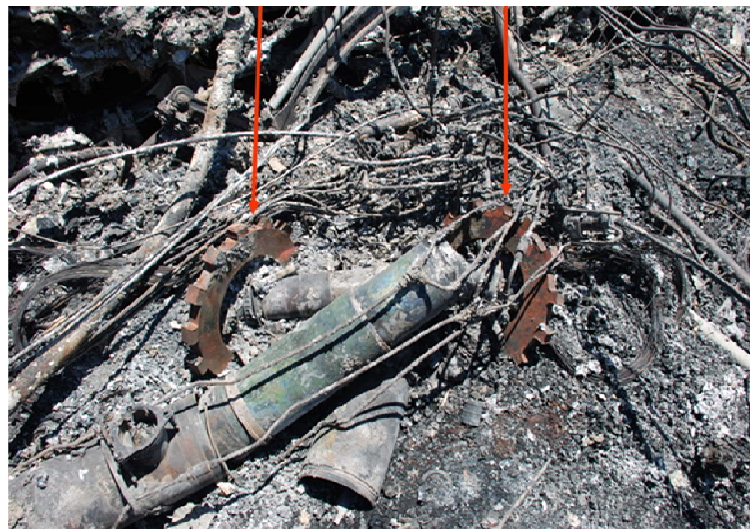
The left aft main wheels' inner and outer brake disks, hydraulic cylinders and lines were substantially damaged. However, the inner brake disc showed evidence of more severe burning, with sections of the disk missing.

Figure 9: Arrows point to left main landing gear, front brake outer and inner discs. Right arrow also indicates hydraulic lines

The evidence indicated that a brake cylinder and/or hydraulic line may have failed. It is likely that brake system hydraulic fluid under pressure, was the propellant that fed the fire.

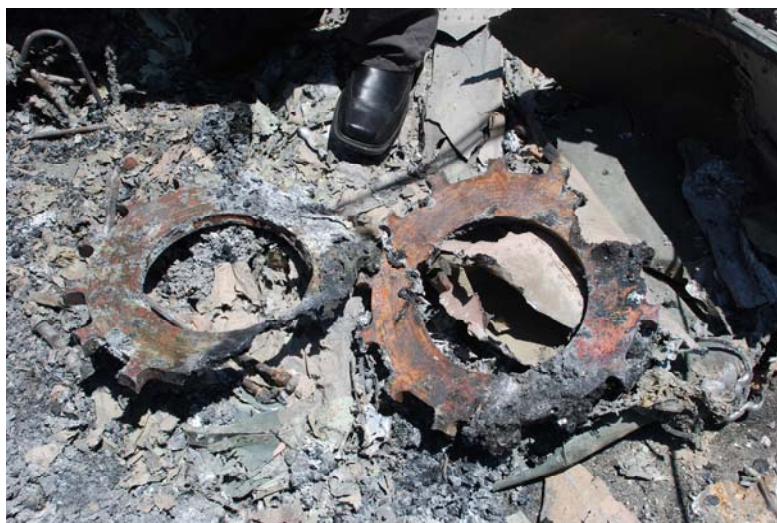
Figure 10: Left main landing gear aft brake inner and outer discs

A fire commenced in the brake assembly of one or more of the left main landing gear wheels. Sections of the left aft main wheels', inner and outer brake disks were substantially damaged, with sections missing; burnt away. The evidence was not conclusive due to the extreme fire damage. However, it indicated that a brake cylinder and/or hydraulic line may have failed. The investigation was unable to determine the location of the source of the fire propellant. It is likely that brake system hydraulic fluid under pressure, was the propellant that fed the fire.

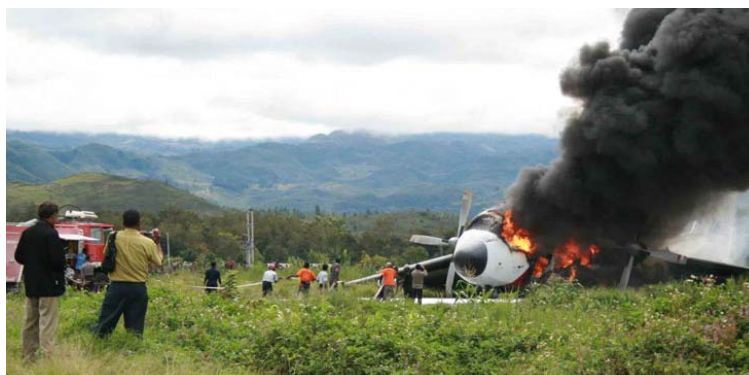
Figure 11: The RFFS was unable to extinguish the fire

The RFFS arrived at the aircraft 10 minutes after the aircraft stopped on taxiway "E". It took the RFFS officers a further 5 minutes to assemble the hoses and commence foam application on the fire. They were unable to extinguish the fire, and the fire self-extinguished about 3 hours later. The RFFS delay in applying fire suppressant resulted in the fire engulfing the aircraft.

The NTSC recommends that Directorate General of Civil Aviation (DGCA) review the status of the RFFS equipment at Wamena (a Class 2 airport) to ensure compliance with ICAO Annex 14 Standards.

The NTSC recommends that the Directorate General of Civil Aviation (DGCA) establish and exercise an Emergency Response Plan for Wamena in accordance with ICAO Annex 14 Standards.
