**NATIONAL
TRANSPORTATION
SAFETY
COMMITTEE**

Aircraft Serious Incident Investigation Report

AIRBUS A320-321

PK-YVE

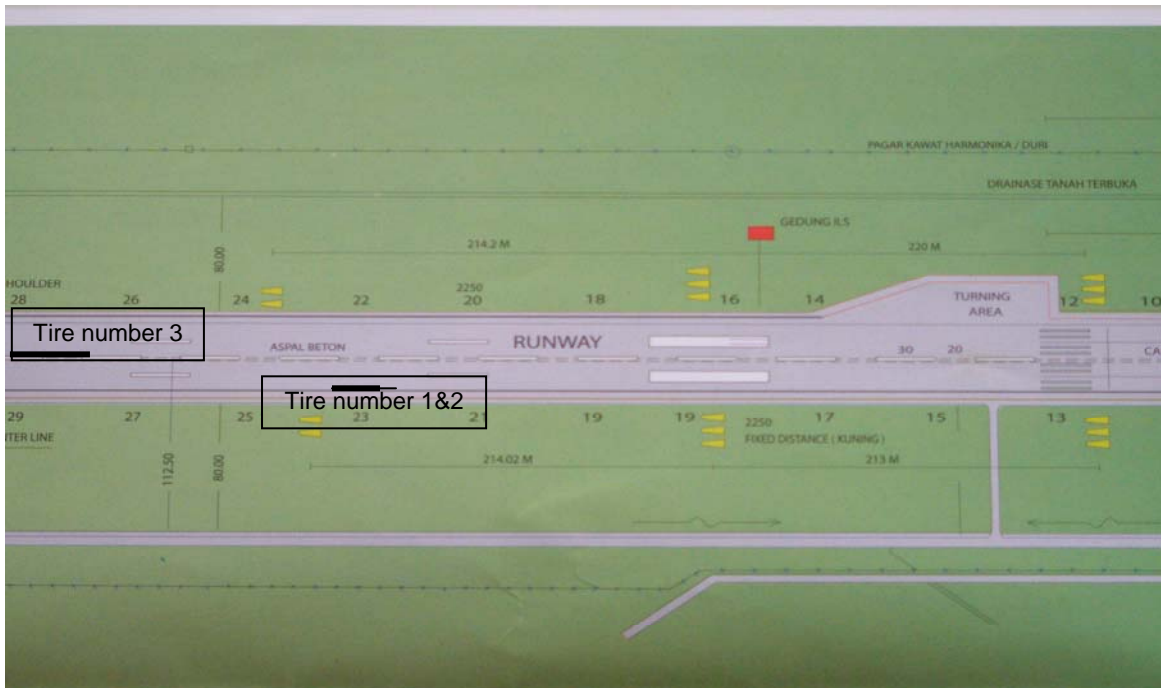
In the touch-down area, tire marks for PK-YVE were only clear for wheels 1 and 2. (Figure 2 and Figure 3).

Figure 2: Touch down tire marks on touch down area

The short distance of the tire marks for wheel numbers 1 and 2 indicated that the aircraft bounced, because the next evidence of tire marks was the tire marks for tire 3, approximately 200 meters beyond the initial touch-down marks for tires 1 and 2. This evidence showed that it was likely that the aircraft touched down with the left main landing gear, approximately at the departure end of the touch-down area. The aircraft then bounced and the right landing gear touched the runway followed shortly after by the left wheels contacting the runway again.

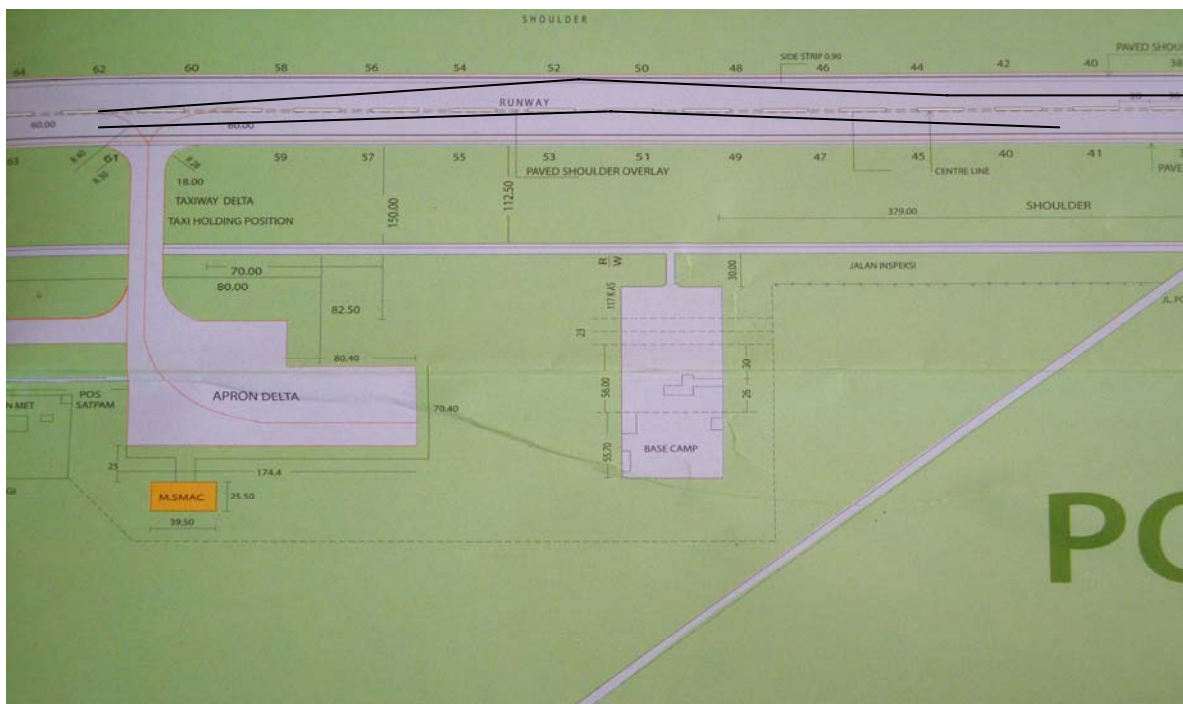
Figure 3: Rolling tire marks on runway up to final stop at adjacent to taxi way D

These marks were heavy and provided a continuous track of the aircraft along the runway to a position adjacent to taxiway D. There was evidence that the direction of those marks tracked initially right of centerline and then veered to the left of centerline. (See figures 3, 4, 5, 6, 7).

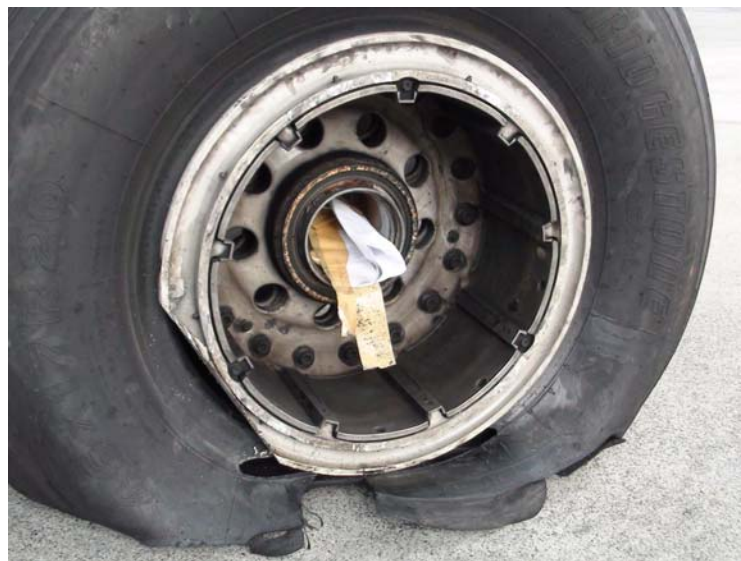
Tire numbers³ 1, 2 and 3 were substantially damaged and wheel numbers 1 and 2 were also substantially damaged.

Figure 4: Wheel number 1

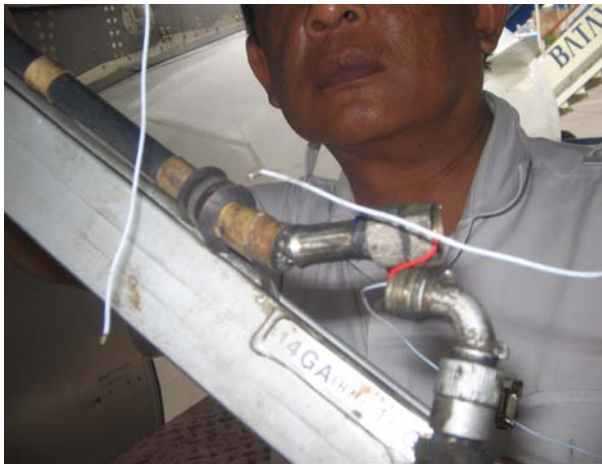
The left landing gear down-lock cable had been broken since the previous landing. The cable was shorter than the original cable. The cable may have been shortened during previous maintenance to change the proximity switch, effectively creating tension on the cable during landing gear extension and retraction cycles.

Figure 5: Broken left landing gear down lock cable

The investigation found that the left landing gear down-lock cable was broken. The aircraft touched down with the wheel brakes locked due to a hydraulic lock in the system, which was the result of an incorrect manual landing gear extension procedure being used by the pilots. All other landing gear systems were found to be normal.

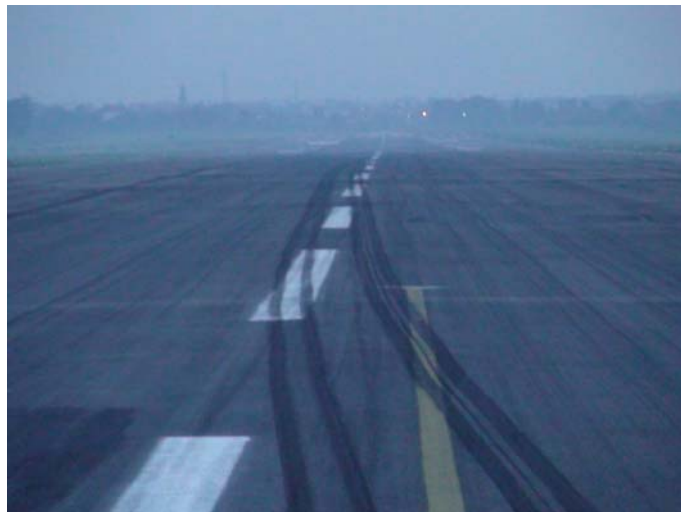
Figure 6: Tire mark on runway close to taxi way D

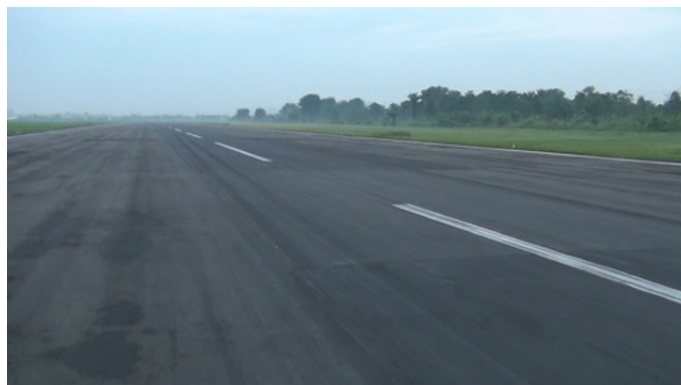
Figure 7: Tire number 1 and number 2 marks

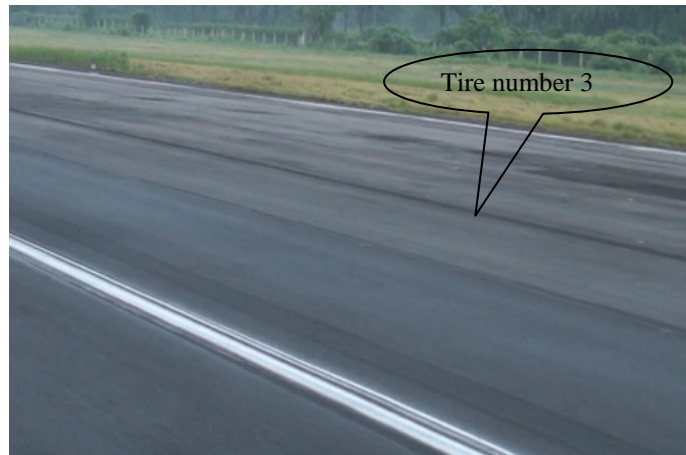
Figure 8: Tire number 3 mark

Tire marks on the runway indicated that wheels 1, 2, and 3 did not rotate during the landing. Other supporting evidence of wheels not rotating was the pattern of the damaged wheels and tires. (See figures 8 and 9). Wheel number 4 was not damaged and there were no distinctive tire marks on the runway from tire number 4. This indicated that wheel 4 was rotating during the landing roll. .

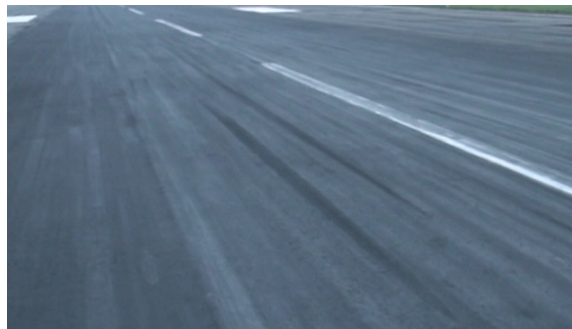
Figure 9: Touch down number 1 and number 2 tire marks
