KNKT 09.12.04.01

Aircraft Accident Investigation Report

PT. Aviastar Mandiri

British Aerospace BAe 146-300

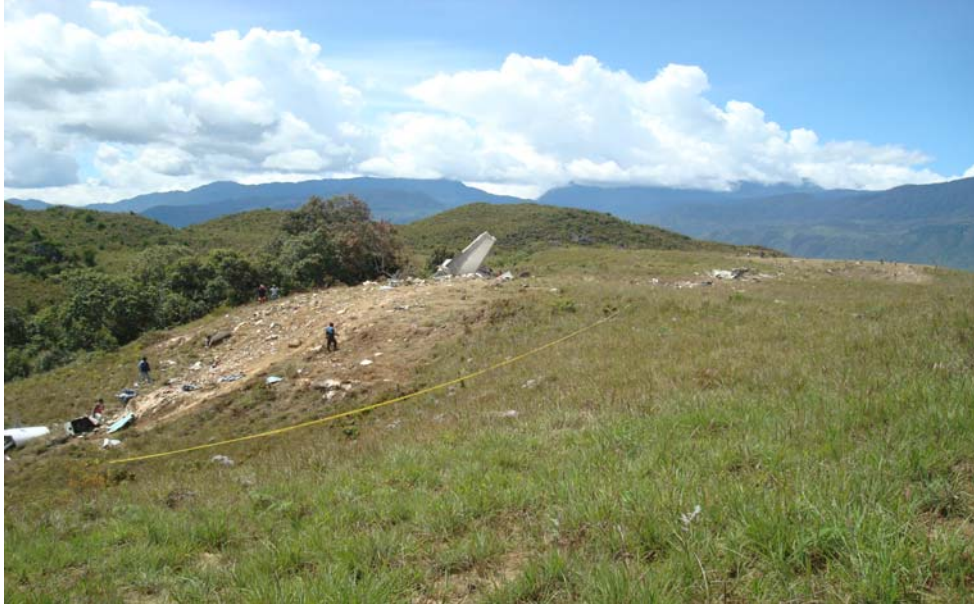
During the manoeuvre for the second landing approach, the aircraft impacted Pikei Hill³ on Tengah Mountain, 3.55 NM to the north west of Wamena Airport at 0743 local time, (2243 Coordinated Universal Time (UTC⁴)). The aircraft was destroyed and the occupants were fatally injured.

Figure 1: PK-BRD initial impact location

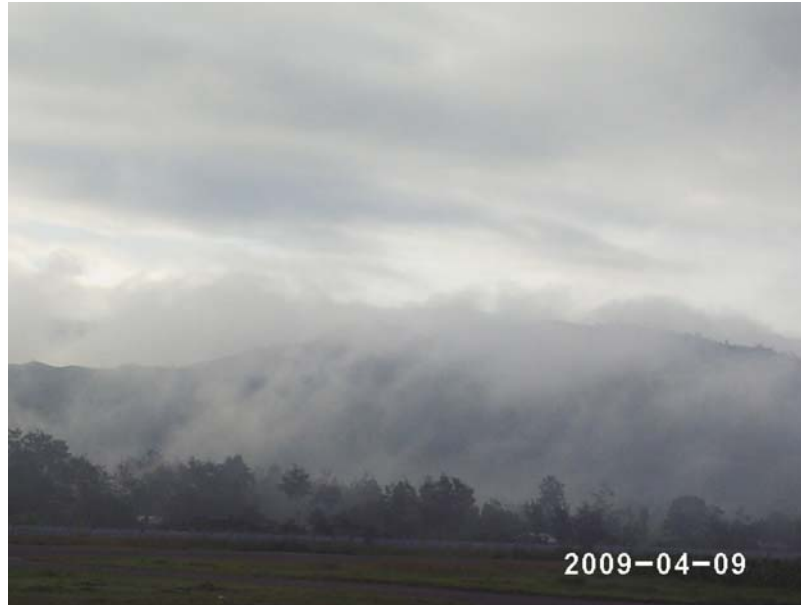
The meteorological report for takeoff and landing issued at 2300 (26 minutes after the accident) indicated that the wind was calm, visibility was 9 km. There was haze and broken cloud; base 300 meters. Temperature was 18 degrees C and the QNH 1010.3 hPa.

Figure 2: View of weather taken from the Wamena Airport shortly after the accident

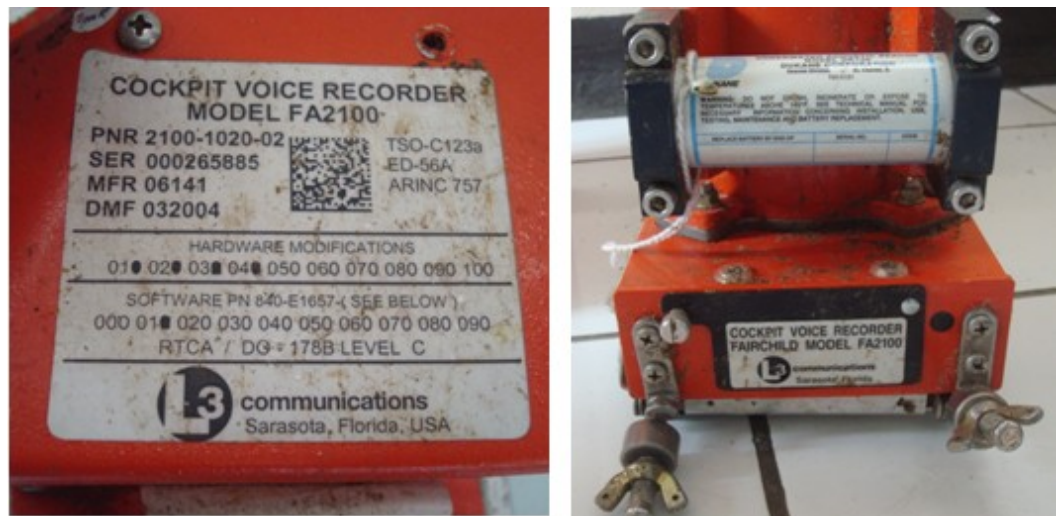
Figure 4: Data plate on Cockpit Voice Recorder from PK-BRD

The CVR contained good quality data that was transcribed and synchronised with the FDR recorded data.

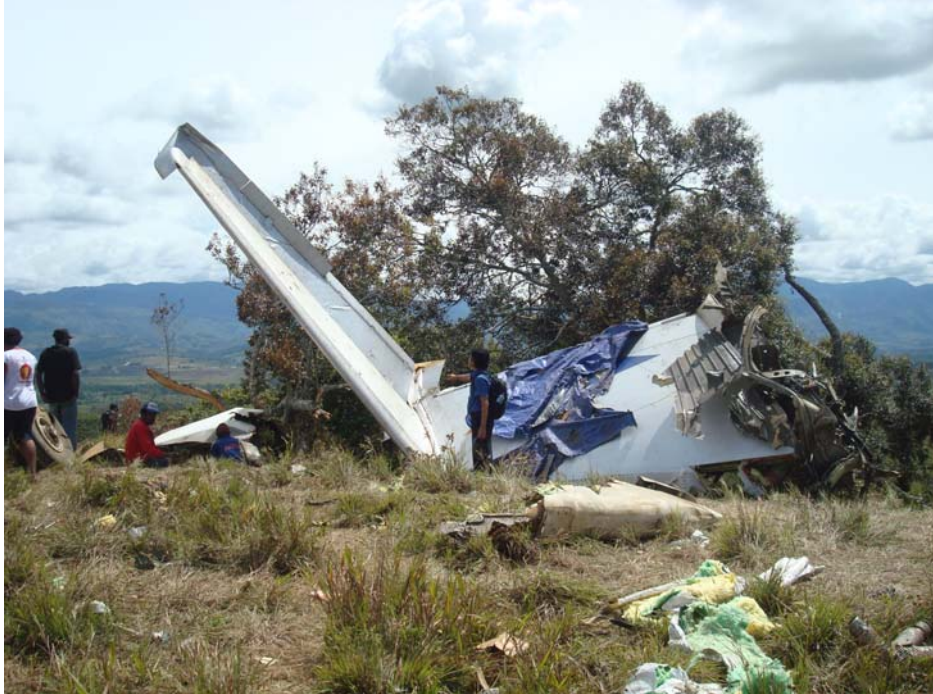
The impact site was located 3.55 NM to the north west of Wamena Airport. The aircraft was destroyed by the impact forces and the post-impact fuel-fed fire. The wreckage was distributed in the general direction of the last recorded heading of the aircraft prior to its impact with terrain.

Figure 5: Empennage section of PK-BRD

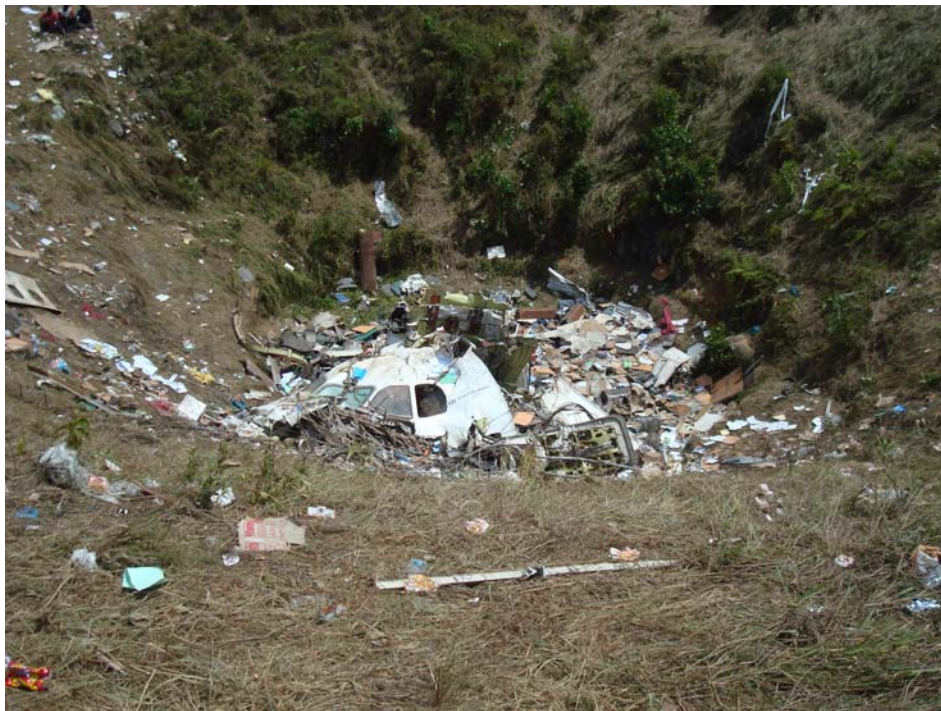
Figure 6: Cockpit section of PK-BRD
