KNKT.09.10.26.04

Aircraft Serious Incident Investigation Report

**PT. Garuda Indonesia
PK – GGQ
Boeing Company 737-300
Soekarno – Hatta Airport, Jakarta
Republic of Indonesia**

30 October 2009

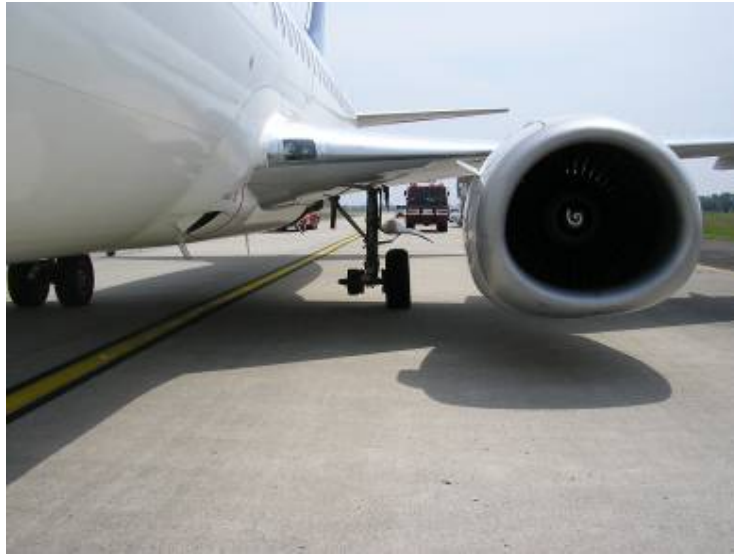
Figure 1: View after landing showing the number-two axle without wheel

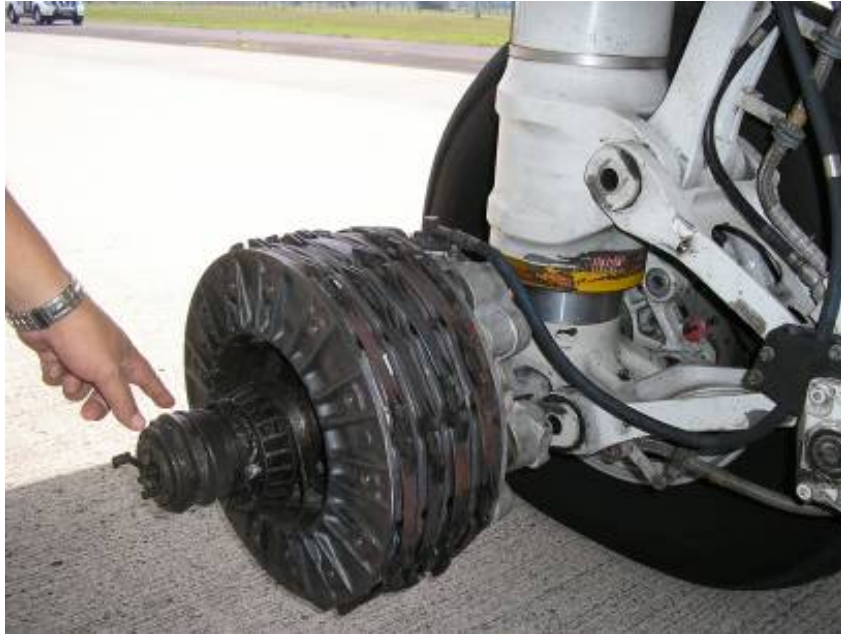
The number-two main wheel separated from the axle. The axle was damaged and required replacement. However, the aircraft was not damaged.

Figure 2: The number-two main wheel separated from its axle

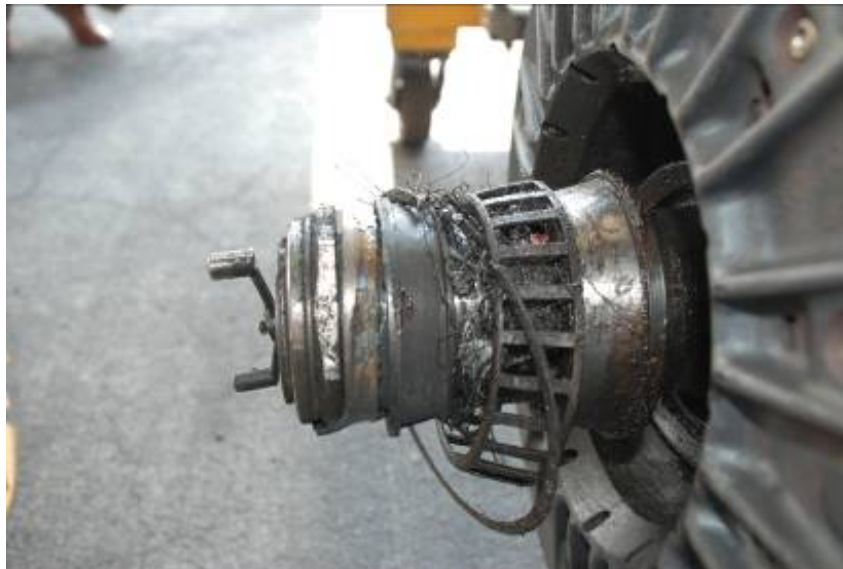
Figure 3: Damaged inner and outer wheel bearing race on number-two axle

The investigation determined that the detachment of the number-two main wheel from its axle was due to the catastrophic failure of the wheel bearings. It is likely that the bearing failures resulted from an under-torque condition during the re-installation of the number-two main wheel, following the replacement of the brake unit. The investigation determined that it was likely that the wheel was not correctly positioned on the axle when the wheel nut was being tightened. The manufacturer's specified torque value was reported to have been applied. However, if the wheel was not correctly positioned on the axle, once the aircraft was lowered back onto the ground and with the aircraft weight on wheels, the wheel may have moved on the axle. The torque value of the wheel nut may then have been inaccurate, and therefore less than manufacturers specifications. The torque value applied at fitment may therefore have been false.

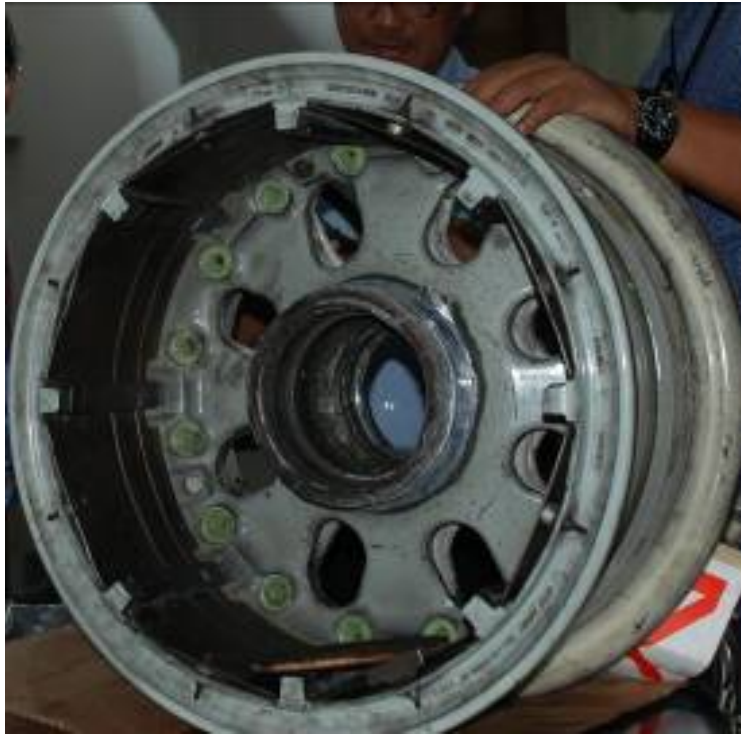
Figure 4: Number-two main wheel hub assembly after removal of the tire.

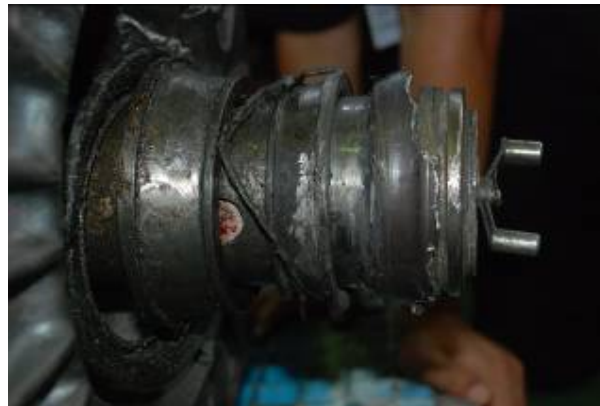
The axle nut was still on its original position with its locking mechanism. The failed bearings were dismantled from the axle on 4 November 2009 (Figure 1). The outer raceways which were still attached on its place in the wheel-hub were then removed by pressing them out of the wheel hub. There was no bearing roller found in the axle and wheel hub assembly.

Figure 1: Bearing failures on the axle.

Note the axle nut and the severely deformed spacer.

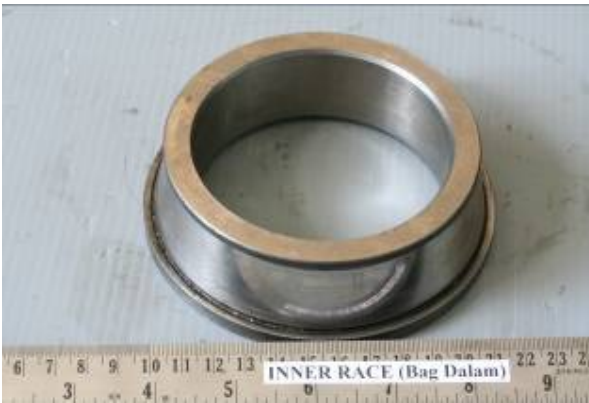
Visual observation on the inner race of the inboard bearing (Figure2) showed indentation marks of the rollers at about equal distance on the shiny surface of the raceway (Figure 3).

Figure 2: Shiny surface of the inner raceway of the inboard bearing

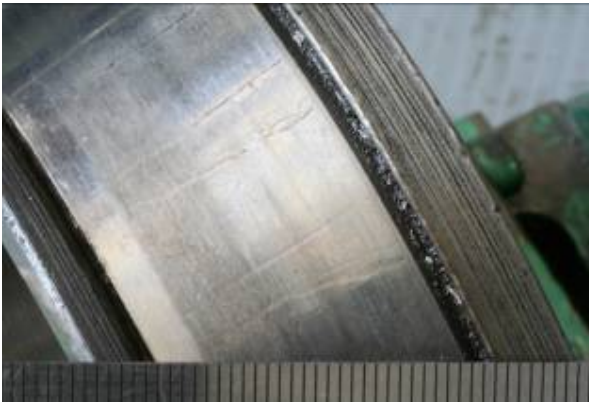
Figure 3: Roller impressions on the shiny surface of the inner raceway were indications of true Brinelling as a result of under torque.

Each of indentation markings showed two lines; one line was parallel to the axis of the axle, and another line was at angle to the axis.

- 4.1. The marking lines on the shiny surface of the inner race are indentations of the rollers. It is a characteristic of true Brinelling which is associated with improper mounting of the bearing⁸, in this case due to an under-torque situation. This situation might lead to a misalignment of the rollers relative to the raceway causing the contact surface to be smaller. The roller markings were also due to hammering during static loading. In case of such an under torque, excessive loads were exerted between the rollers and the raceway. It caused an abnormal operation of the bearing, and led to destruction of the bearings.

To prevent an improper wheel mounting, more specifically an under torque situation, a continuous rotation of the wheel shall be performed during tightening, loosening (until zero torque) and re-tightening of the axle nut to the prescribed torque value.

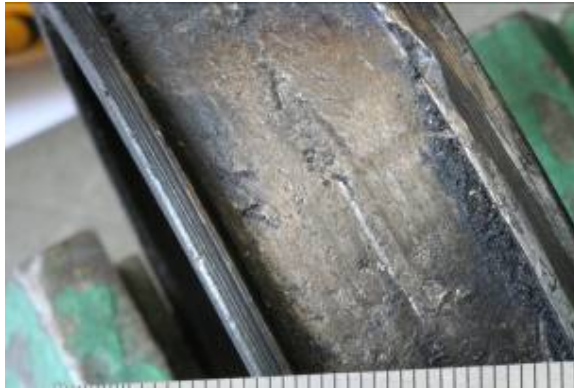
The inner race of the outboard bearing showed a dull appearance with several roller indentations (Figure 4).

Figure 4: Dull surface on the inner raceway of the outboard bearing.
Note the roller impressions indicating false Brinelling due to vibration.
