KNKT.09.02.05.04

Aircraft Accident Investigation Report

**PT. Lion Mentari Air (Lion Air)
Boeing McDonnell Douglas MD-90 ; PK – LIO
Hang Nadim Airport, Batam, Riau Islands
Republic of Indonesia
23 February 2009**

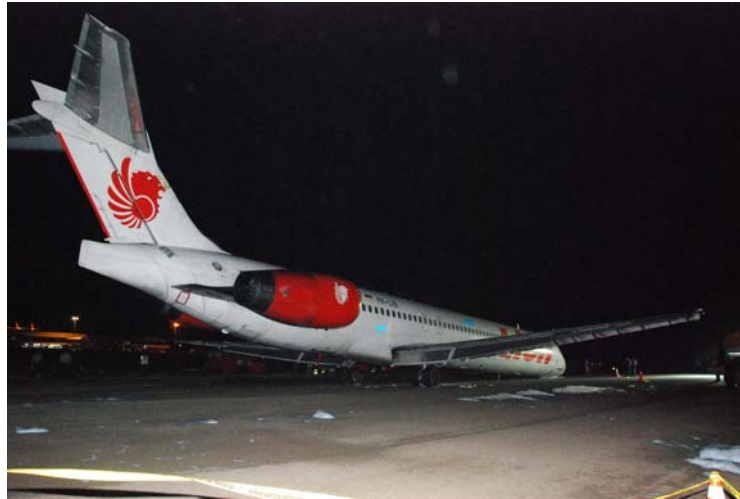
Figure 1: PK-LIO on runway at Hang Nadim Airport, Batam after accident

The nose-section lower fuselage area of the aircraft was damaged due to contact with the runway surface.

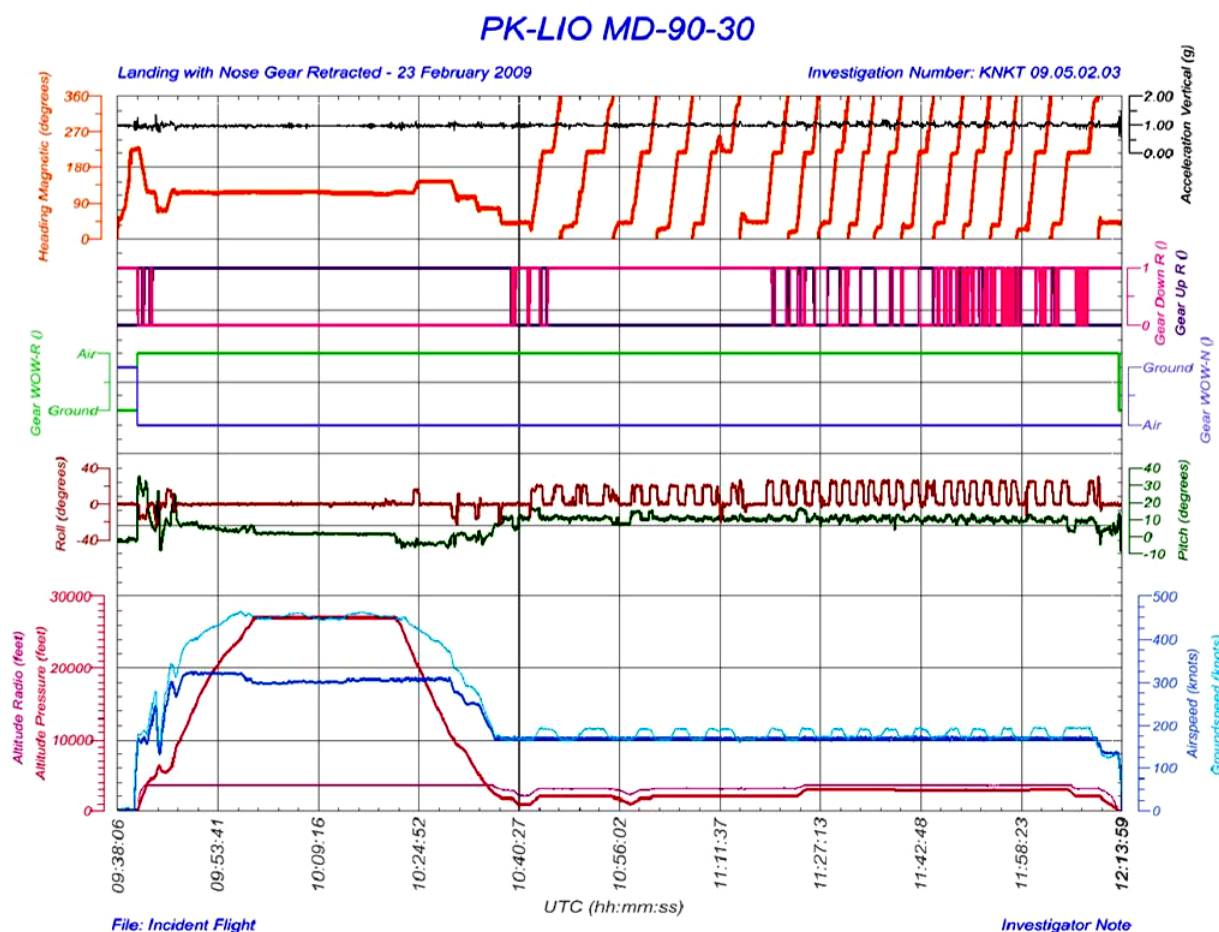
Figure 2: FDR readout

Regarding the gear position parameters, the right gear is the only one recorded and selected as an indication of nose gear position. Gear cycles shortly after takeoff indicates that pilot realize there was an issue concerning nose landing gear up or down position. The procedure was repeated after descent between 10:39:17 – 11:19:37 UTC and the decision to perform go-around manoeuvre indicates the problem persist. Other numerous attempts to cycles the landing gears were performed during holding flight.

The holding maneuver was performed using a right circuit between 10:42:17 – 12:10:45 UTC at an average altitude of 2,402 feet and average speed of 170 knots. Numerous attempts by the pilot to cycle the landing gear and the length of the maneuver indicated that they were unsuccessful in lowering the nose landing gear and therefore tried to burn fuel in preparation for an emergency landing.

The aircraft touched down at 12:13:30. This was indicated by the right landing gear weight-on-wheel parameter as 'Ground'. The nose landing gear weight-on-wheel parameter was appeared as 'Air' which means no force applied to the gear and indicated that the nose gear was in 'up' position. The touchdown speed was 120 knots and the aircraft travelled for another 26 seconds. The final position attitude was -8 degrees pitch angle and -1 roll angle, as a result of the forward fuselage resting on the runway without nose landing gear.

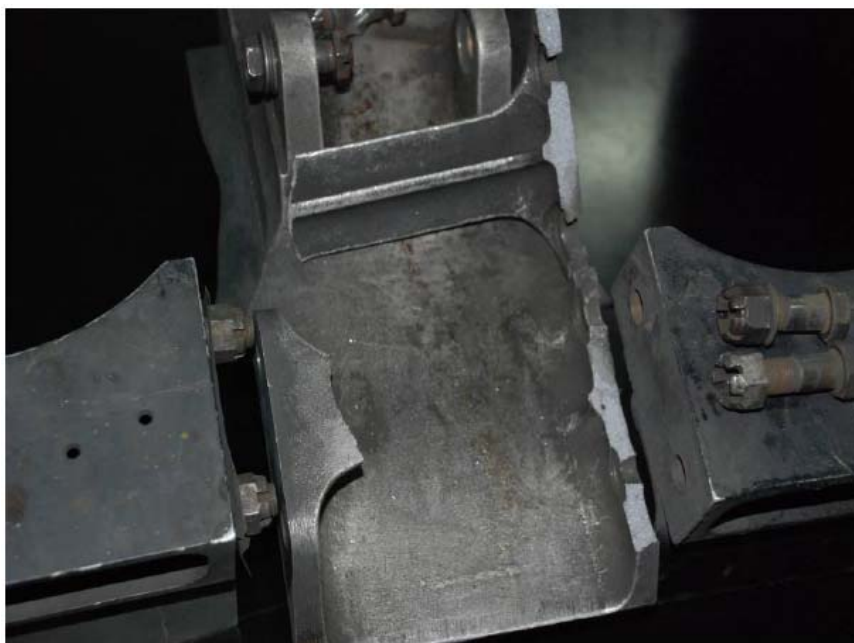
The nose landing gear right water spray deflector fractured and detached. The center deflector was broken.

Figure 3: The fracture surface shows a dark colored portion indicating a pre-existing crack

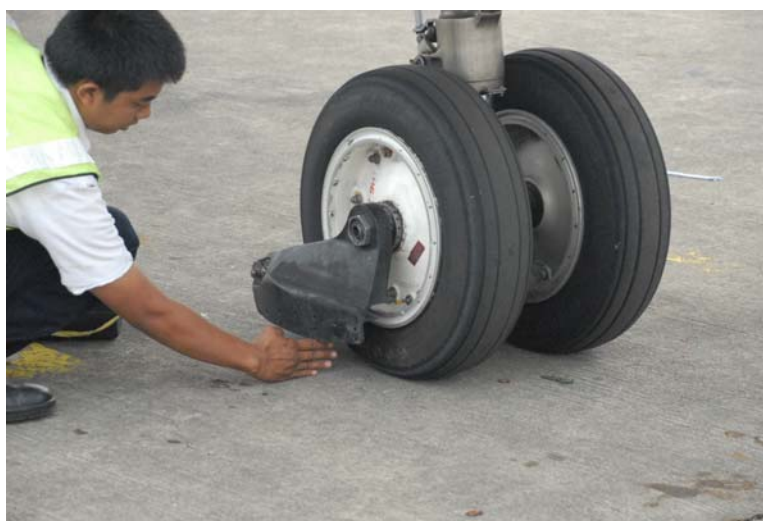
Figure 4: Showing the ground clearance of water deflector relative to the surface

The pictures above show that the ground clearance of the water deflector is quite low. The low ground clearance might be an object during taxi and may cause the deflector rear attachment damage.

The cause of the damage (upward bending) of water spray deflector could not be accurately determined (Figure 4).

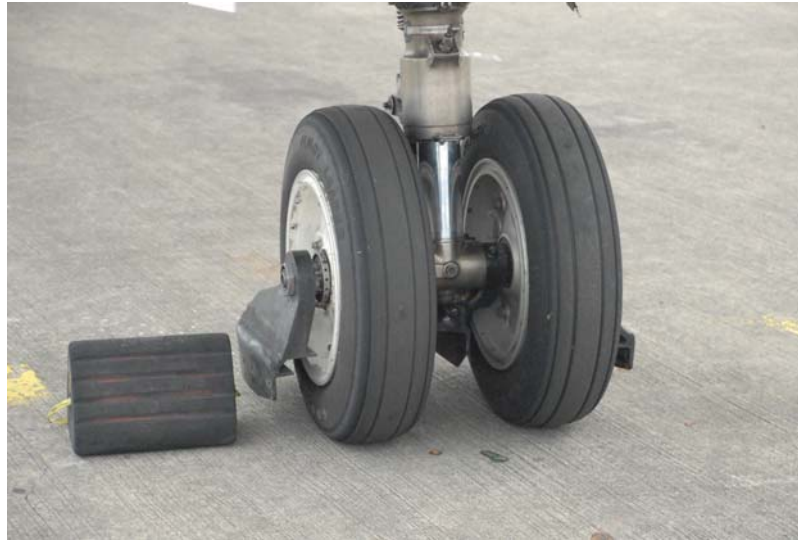
Figure 5: The association of wheel chuck to the ground clearance which usually used on nose gear during park, could cause the damage of the water deflector

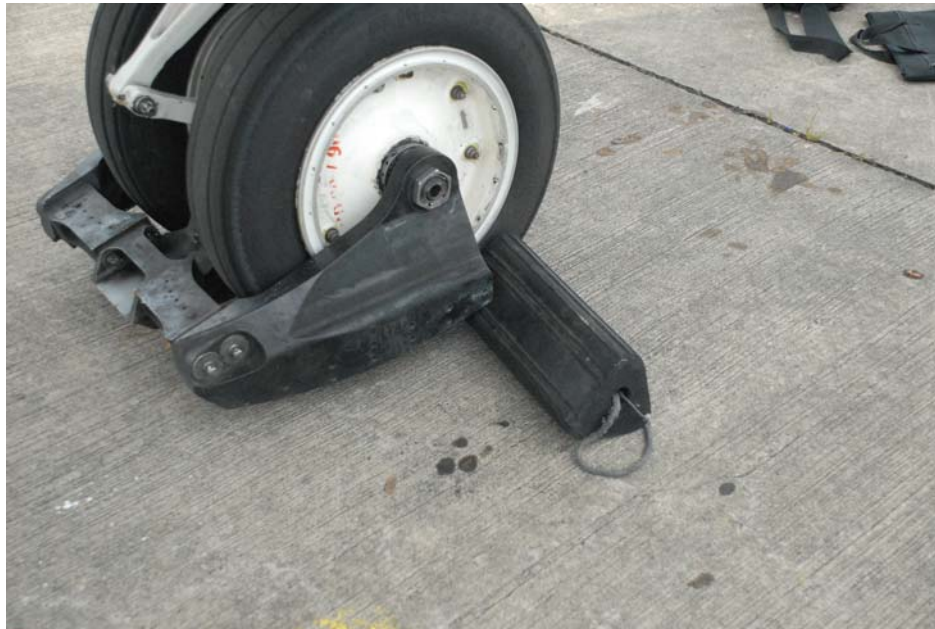
Figure 6: an example of the many possibilities of object which may strike by the deflector during Aircraft Park.

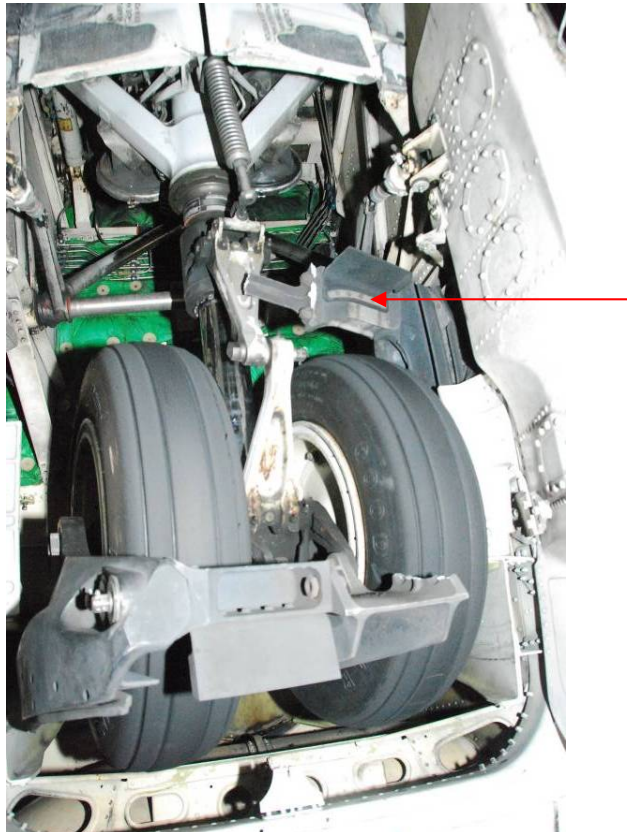
The nose gear could not be put in to gear-down position due to the damage and distortion of the nose gear water spray deflector. The distortion of nose gear water spray deflector moved out to the nose wheel well structure, preventing the nose gear to be down.

During the aircraft evacuation process, it was found that the left portion of the broken nose water spray deflector was stuck at the nose landing gear bay structure. This condition prevented the nose landing gear to extend.

Figure 7: Damaged and distorted nose landing gear spray deflector

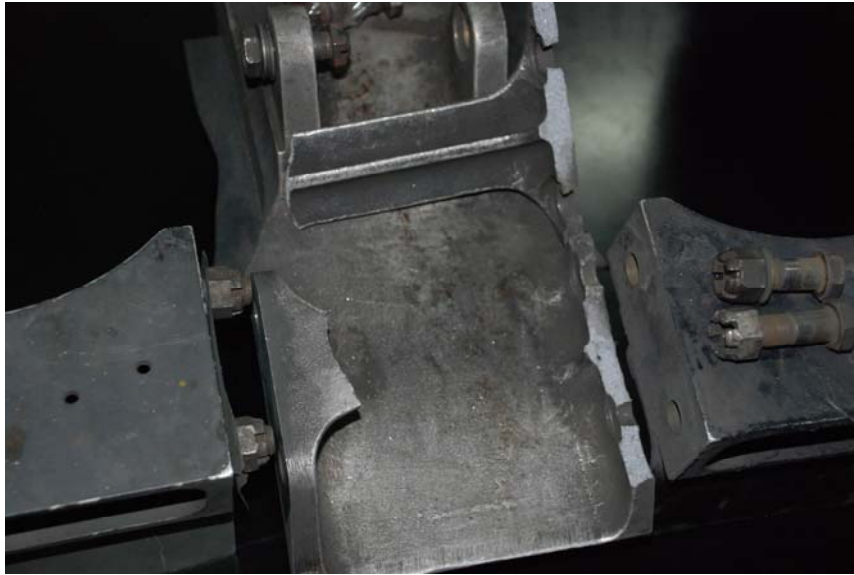
The right side of water spray deflector was detached at the center of water spray deflector. The attachment flange of the center deflector was broken. (Figure 8) The fracture surface shows a dark colored portion indicating a pre-existing crack.

Figure 8: The broken attachment flange

The National Transportation Safety Committee recommends that the Directorate General of Civil Aviation mandate an inspection requirement, specifying inspections procedures and intervals for crack detection of the nose landing gear spray deflector fitted to MD-90 aircraft.

- An inspection on the flange is recommended to detect a crack at the flange. The inspection should be performed at the time of tire change.

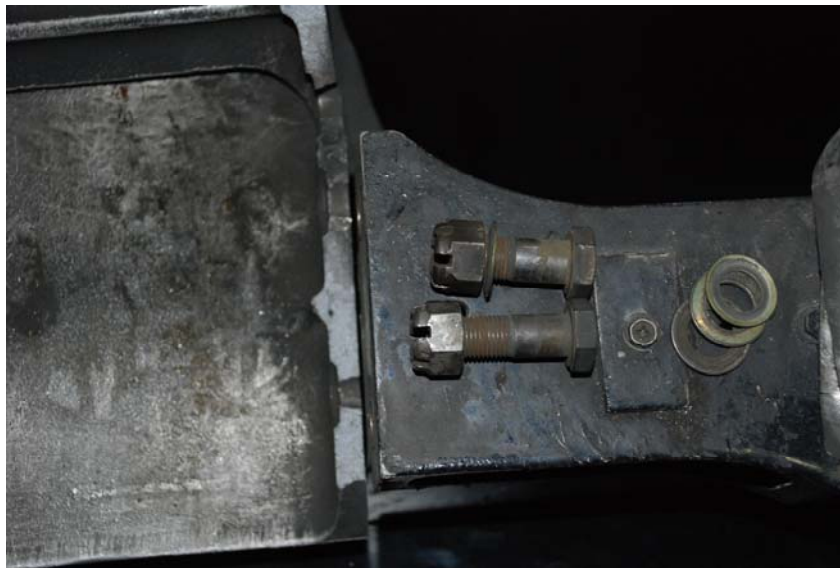
The dark colored portion in the crack area has a longer side at the right edge (Figure 9), indicating banding moment acted upward at the right deflector, and this colored portion is a fatigue crack.

Figure 9: crack area at the right edge

The evidence at the pre-existing crack indicated that extraneous upward bending acted on the flange. The evidence at the right deflector (i.e. dent and wear at the rubber liner) suggested that an upward force could have acted at the deflector.

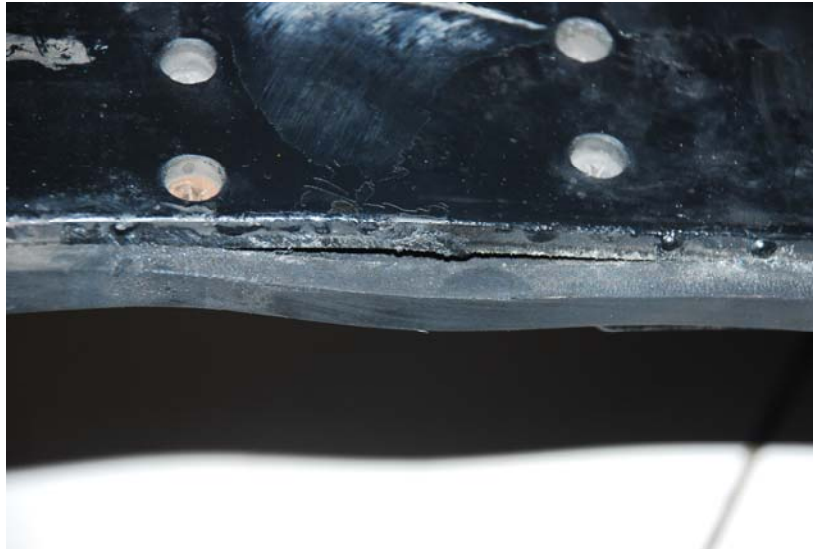
Dent and wear were observed on the rubber part of the right deflector (Figure 10).

Figure 10: rubber part of the right deflector

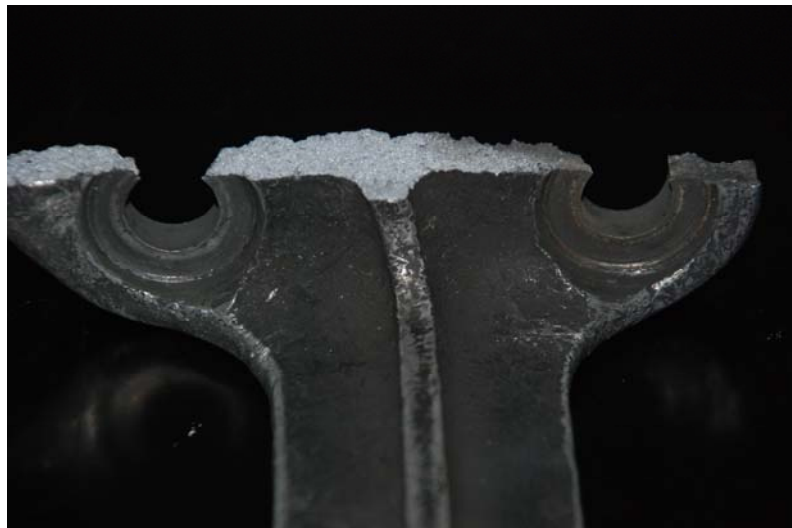
A sign of over-torque was found on one of the flange hole edge (Figure 11).

Figure 11: The flange hole edge was over-torque
