KNKT.09.04.13.04

**NATIONAL
TRANSPORTATION
SAFETY
COMMITTEE**

Aircraft Accident Investigation Report

Pilatus Porter PC-6 ; PK-LTJ

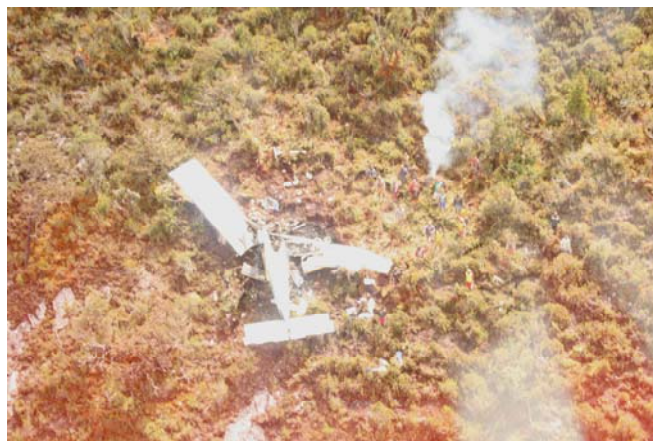
On 18 April 2009, search aircraft located the wreckage of the Porter at an elevation of about 12,000 feet on Mt Gergaji; 03°52'050"S, 137°45'48"E. The location was on the direct track between Ilaga and Mulia. All occupants were fatally injured.

Figure 1: Aerial view of the wreckage of PK-LTJ on the slope of Mt Gergaji

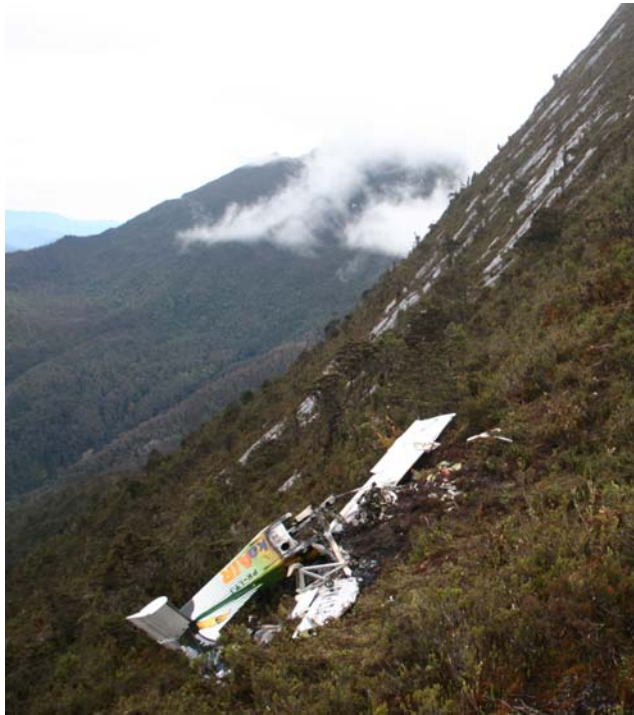
Figure 2: View along slope of Mt Gergaji

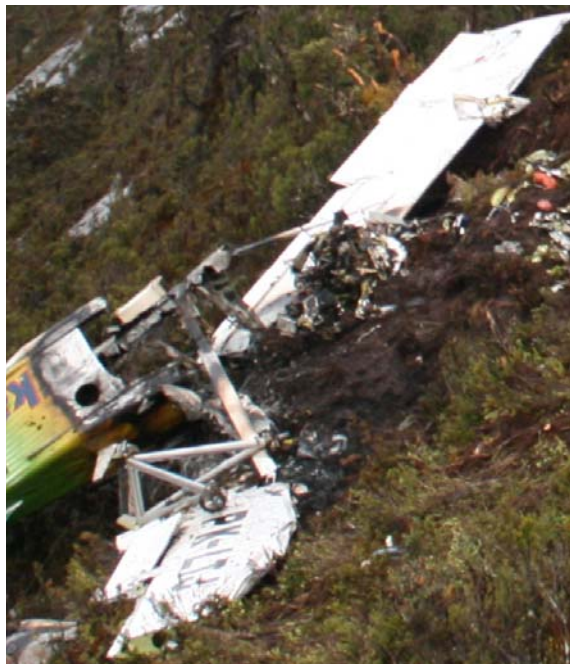
The aircraft was inverted at impact. The engine, propeller, cockpit, and cabin were destroyed by the impact forces and the post-impact fire. Both wings were substantially damaged. The outboard section of the left wing was destroyed. Both main landing gear assemblies were destroyed, but the tail wheel assembly was not damaged.

Figure 3: Destroyed forward fuselage and wings at the completion of on-site activities

A post-impact fire destroyed the cabin and forward fuselage.

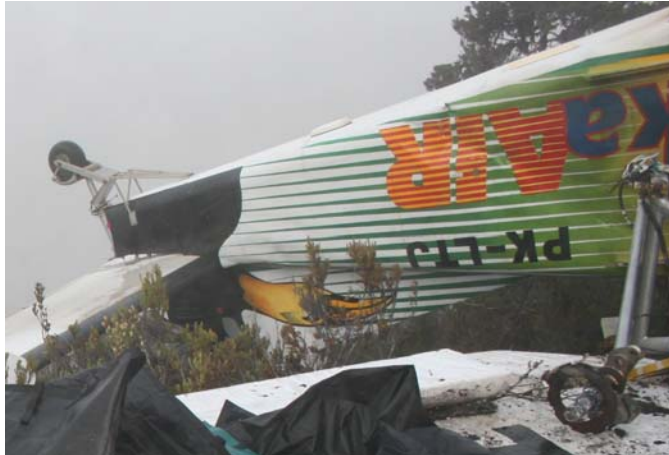
Figure 4: Inverted rear fuselage showing undamaged tail wheel
