FINAL
KNKT.09.12.21.04

Aircraft Accident Investigation Report

**PT. Sinar Mas Super Air
Fletcher FU24-950 ; PK-PNX
Ketapang, West Kalimantan
Republic of Indonesia**

31 December 2009

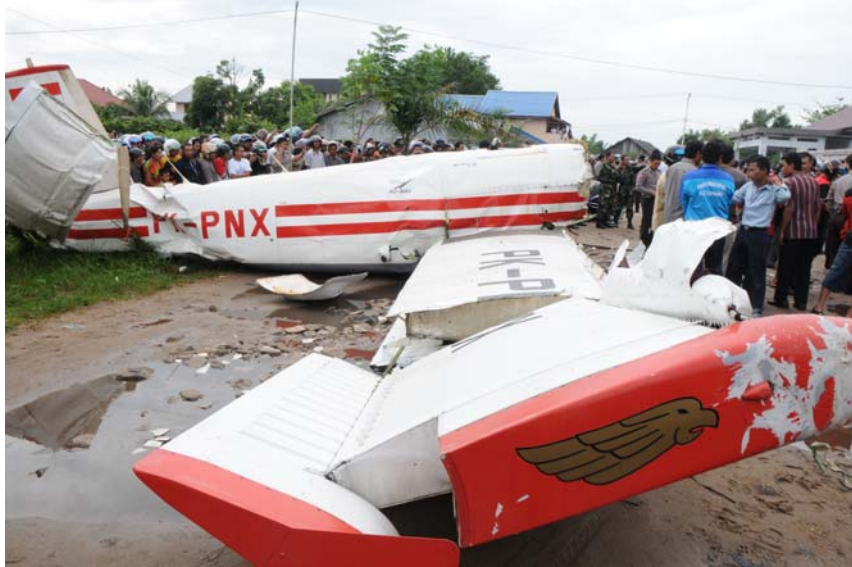
Figure 1: Main wreckage of PK-PNX

Aircraft was substantially damaged with nose section, left wing, and left elevator was separated from the main wreckage. Part of the left wing tip was found in the roof of hospital.

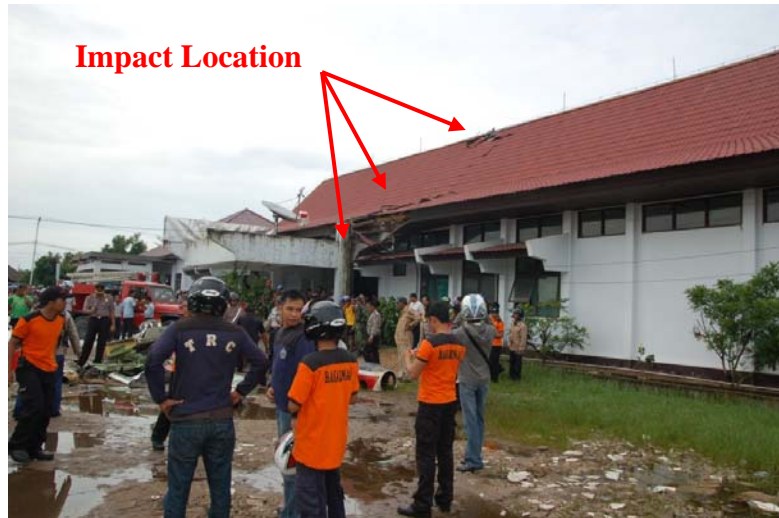
Figure 2: The hospital roof after impact

The aircraft crashed striking the roof of the hospital and broken down into pieces at the parking area in which have had approximate 1.5 kilometres to the left side from the flight path centreline.

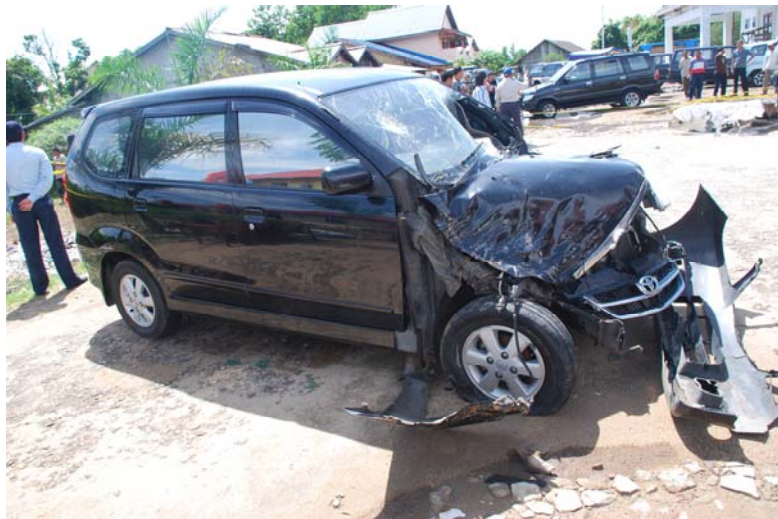
Figure 3: the car damages in the parking area

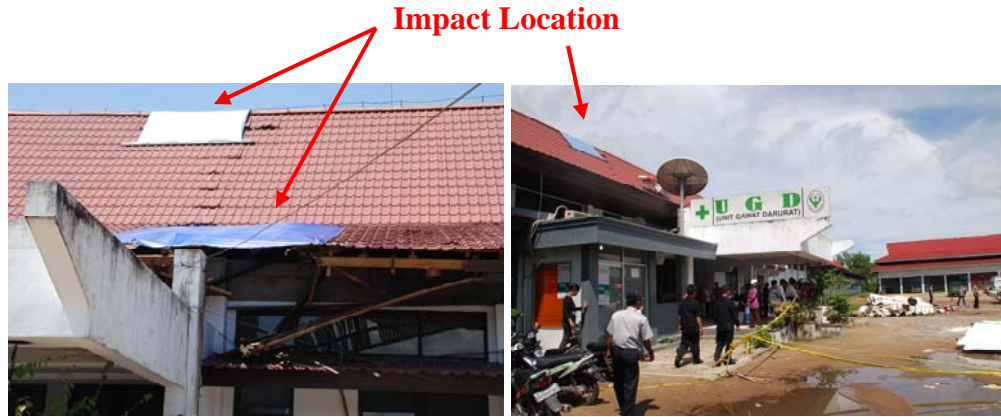
The nose landing gear was hit the top of the hospital roof (see Figure 5)

Figure 5: Initial impact on the roof of hospital

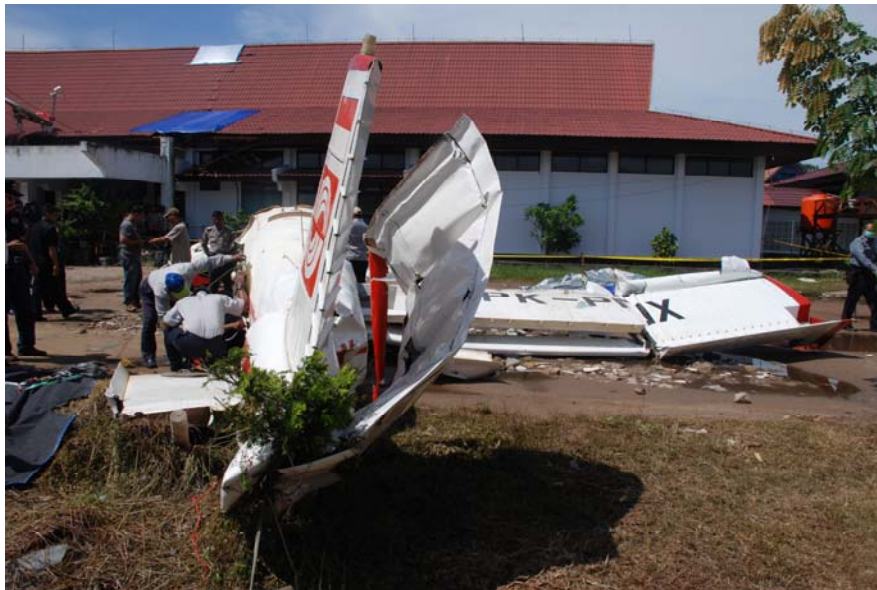
The aircraft stop faced opposed to the direction of flight, the wing and horizontal stabilizer was broken.

Figure 6: The tail section damaged

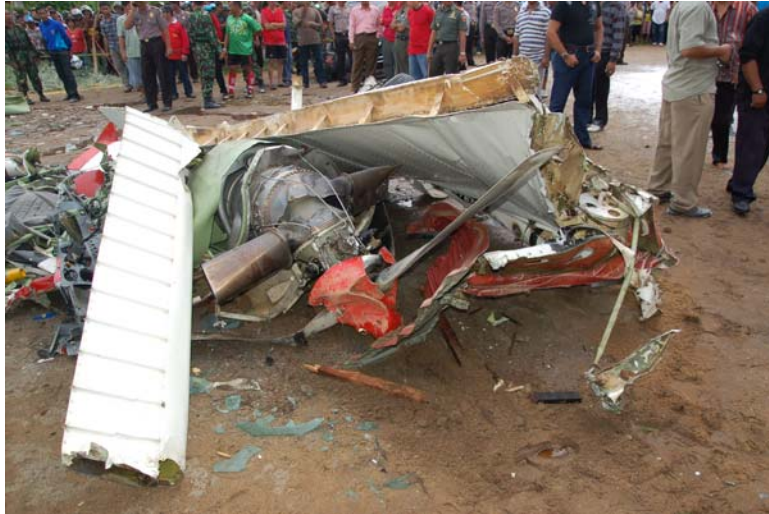
The propeller blades were on fine pitch and no sign of rotating impact.

Figure 7: The Engine & Propeller damaged

The propeller blades were on fine pitch and no sign of rotating impact, showing that the engine was not in powered when striking the ground.

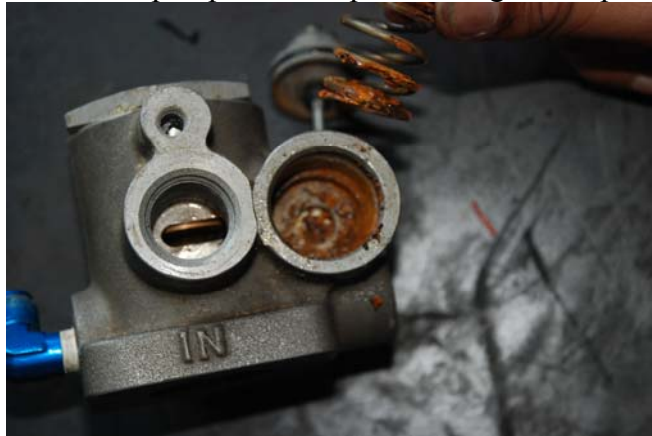
The airframe fuel pumps investigation; part number CJ 10000-D, serial number K 2705-1, corroded at the pump vent and pressure regulator spring.

Figure 8: Booster Pump Pressure Regulator shown the spring was surface corrosion

The booster pump removed from PK-PNX, the investigation found of evident of surface corrosion on the spring, plate and van pump indicated that the reaction of the remaining contaminated fuel.

The investigation concluded that the aircraft engine was not in power during impact the hospital roof. There was a corroded fuel pump, that indicated of contaminated fuel.

The National Transportation Safety Committee recommends to the Director General of Civil Aviation to ensure that the maintenance program of the airframe fuel pumps, part number CJ 10000–D from an on condition to be a hard time maintenance bases.

- Review the maintenance program of the airframe fuel pumps, part number CJ 10000–D from an on condition to be a hard time maintenance bases.
- Review the policy of take-off at intersection for the first operation of the day.

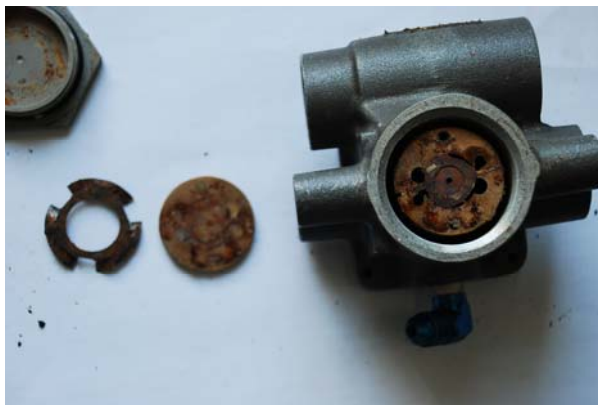
Figure 9: The Plate & Van pump was surface corrosion
