**KOMITE NASIONAL KESELAMATAN TRANSPORTASI  
REPUBLIC OF INDONESIA**

**Aircraft Accident Investigation Report**

**PT. Lion Mentari Airlines (Lion Air)**

**Boeing B737-400 ; PK-LIQ**

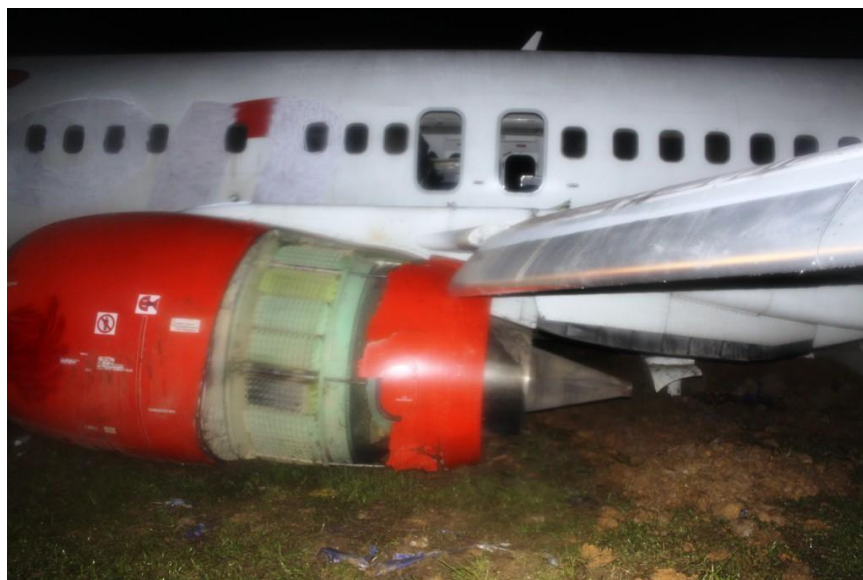
Field observation found that the aircraft severely damage, the damages were on the following sections: nose landing gear, right engine, nose section lower fuselage (aft of the nose wheel bay) and right engine.

Figure 1: The damage of the left engine

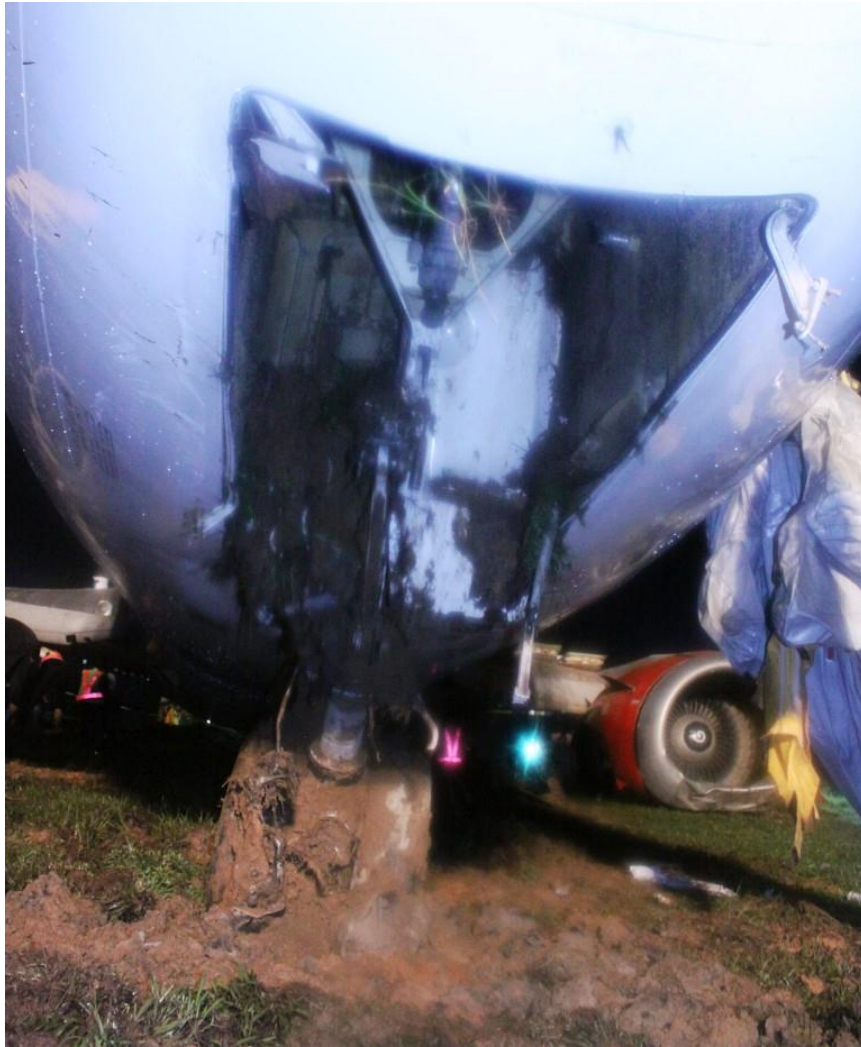
**Figure 2: The damage on the nose landing gear**

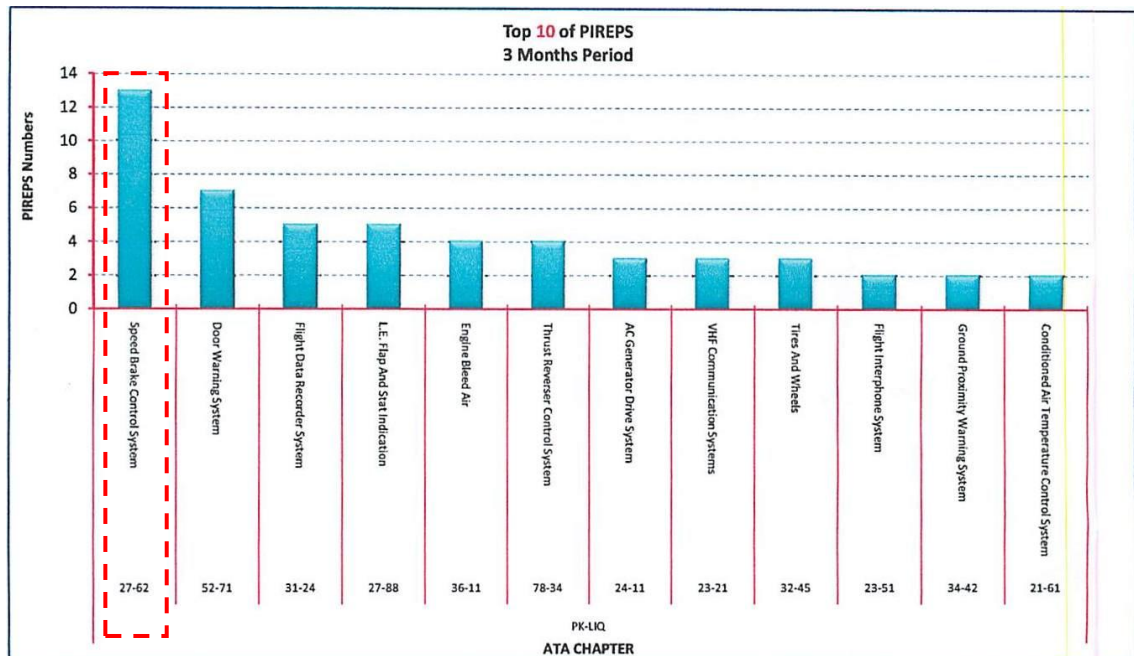
Since 03 September to 27 October 2010, 13 PIREP recorded related to the speed brake failure to auto deployment (ATA 27). The rectifications carried out were;

Figure 3: Top 10 PIREPS indicated that there were 13 PIREP related to speed brake control system (red dash box).

There were 13 repetitive pilot reports (PIREP) of the speed brake fail for auto deployment (ATA 27) recorded since 03 September up to 27 October 2010. The maintenance rectifications carried out were:

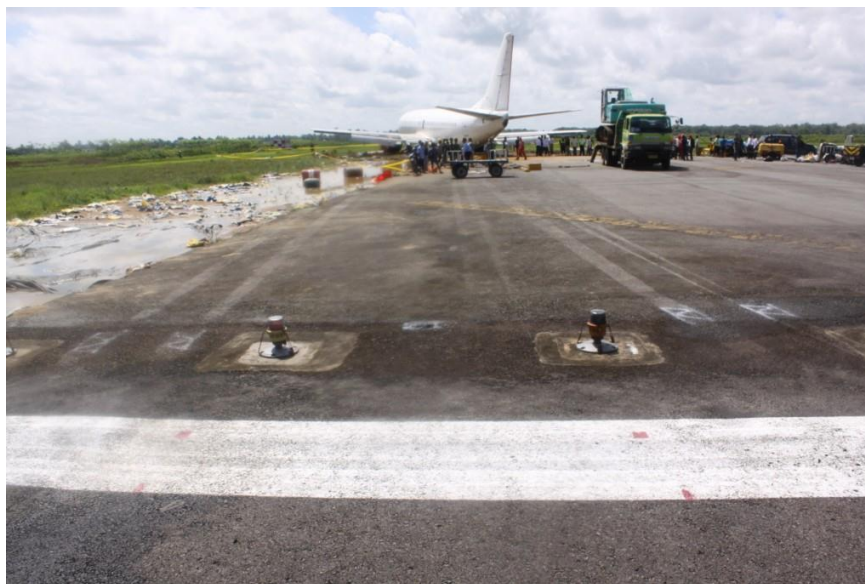
The aircraft run out of runway and stopped at approximately 70 meters from the runway end or 10 meters from the end of stop-way on heading 135°.

The front left escape slide flatted and the tire no 3 ripped and also there were scratches as an indication of hydroplaning of the four wheel tires which shown along the stop way area of runway 15.

Figure 6: Aircraft track and hydroplaning marks

There were indications of hydroplaning on No 3 tire and mark of all tires on the paved surface after the runway end. This condition is classified as a hazard that might contribute and endanger the safety of the flight. Therefore, the KNKT recommends to airport authority to be aware and takes necessary safety action to minimize the risk.

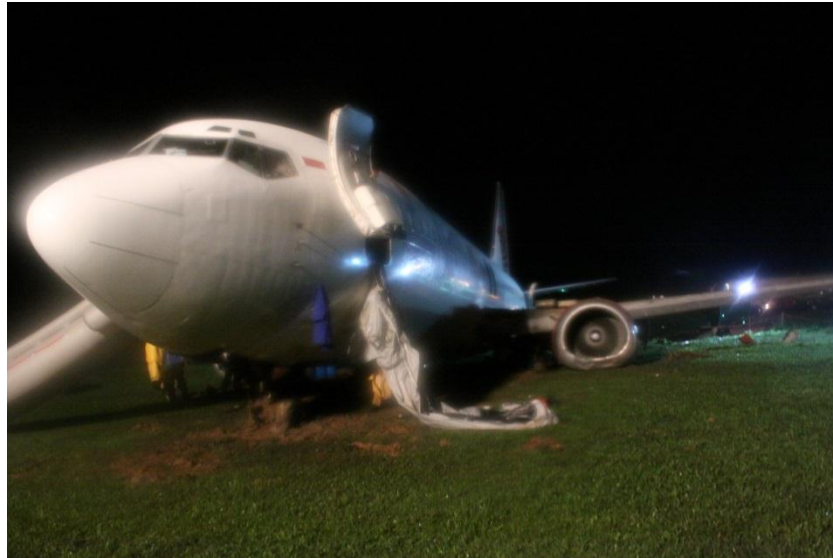
**Figure 7: The front left escape slide flattened**

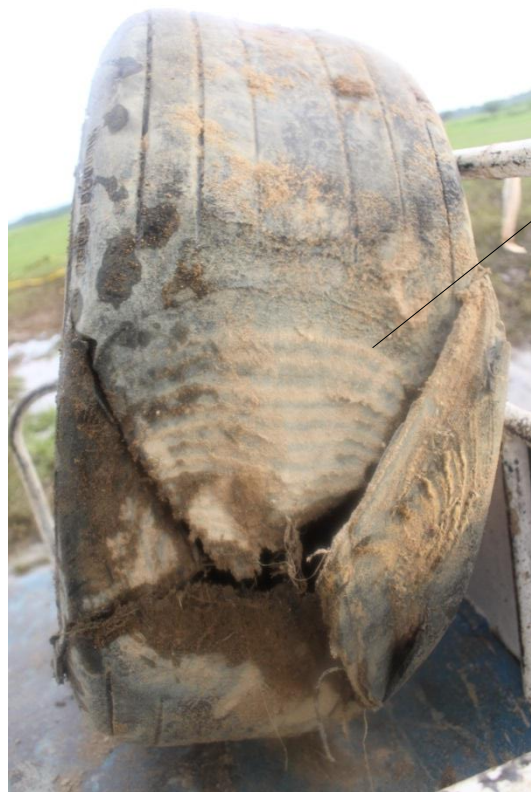
Ripped and an indication of hydroplaning

**Figure 8: The number 3 tire ripped and scratched**

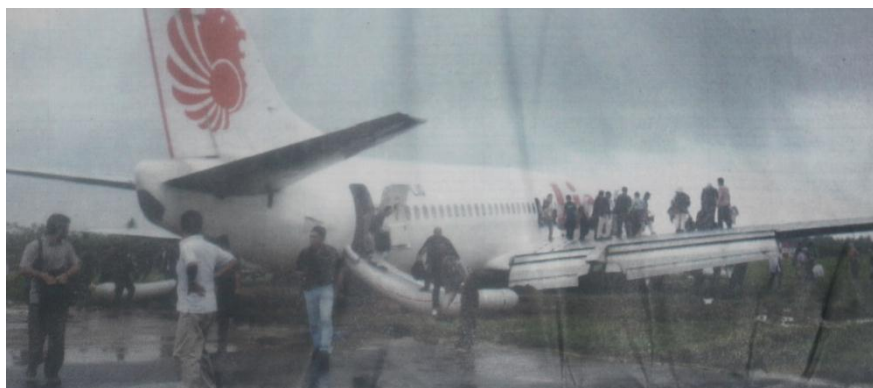
Refer to the picture taken during the evacuation process (see figure 9), some passengers were standing on the wing carried their luggage and there was no person who assisted or guided the passengers. The flaps were full down and speed brakes were on retracted position.

Figure 9: Passengers evacuation process (picture courtesy of local newspaper)
