# NATIONAL TRANSPORTATION SAFETY COMMITTEE

*Aircraft Serious Incident Investigation Report*

**Cessna C208B Grand Caravan; PK-RJS**

**Kobakma Airstrip, Papua  
Republic of Indonesia**

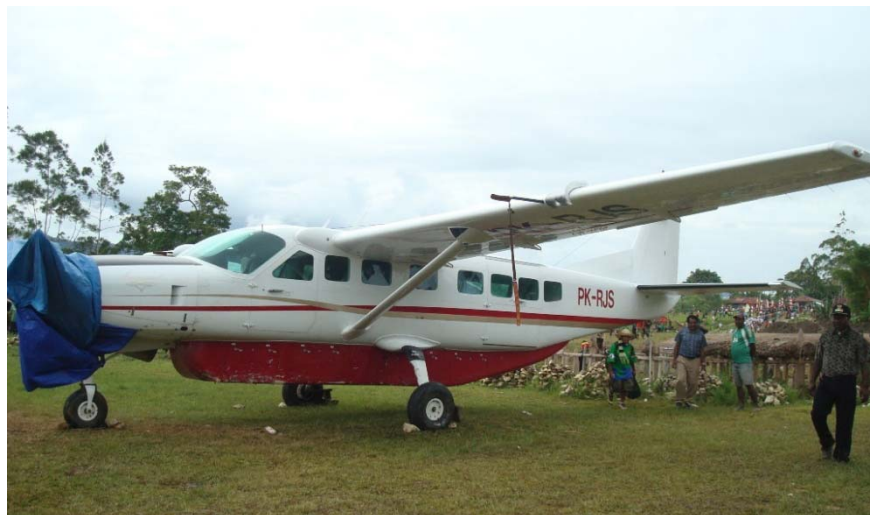
Figure 3. The aircraft condition and parked on the apron

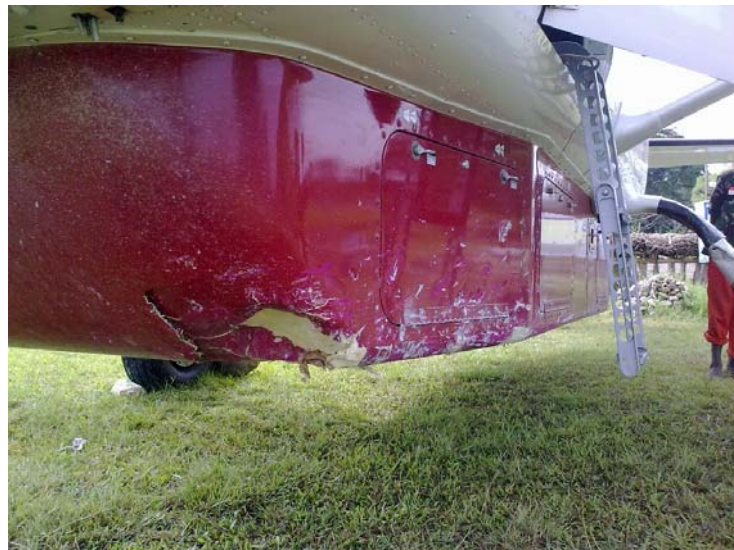
- All three propeller blades damaged,
- Lower cargo port fairing damaged,
- Left main gear fairing damaged,
- Left lower flap surface holed.

Figure 4. Lower Cargo Fairing

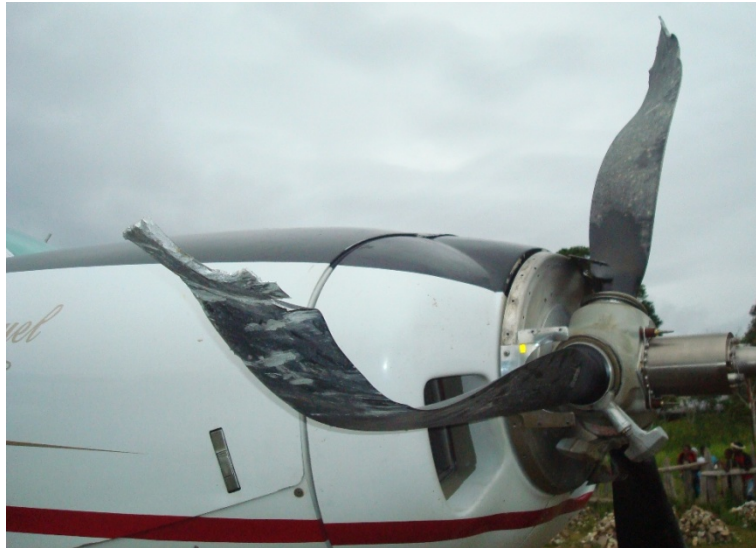
Figure 5. Cessna 208 PK-RJS Propeller Blades

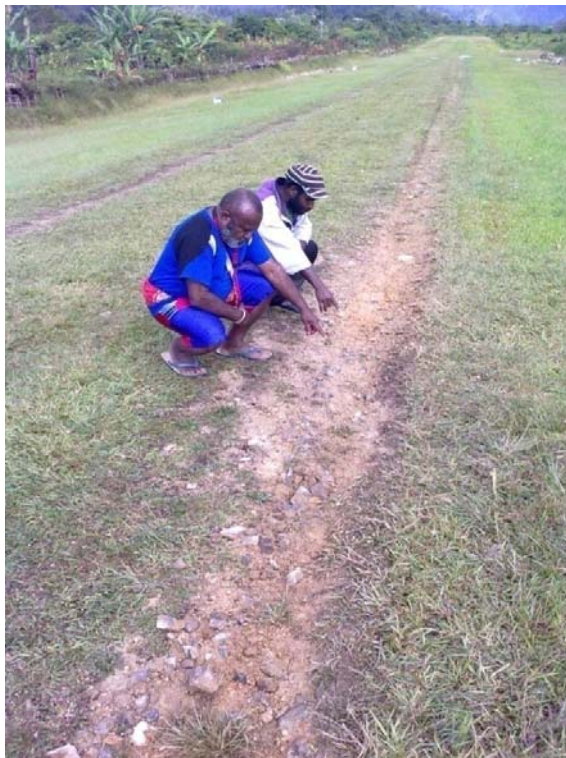
The field observation found that excavated line starting 450 meters from the beginning of runway 09 and the tire marks shown that the left deeper than the right.

Figure 6. Excavated line

The field observation found that the excavated lines starting 450 meters from the beginning of runway 09 and the tire marks shown that the left deeper than the right. The aircraft start veered to the left of runway about 150 meters before the end of Runway 09. The aircraft hit the stones piled on left side of the runway and stopped.

It could be concluded that the deceleration value of the left main tire was greater than the right main tire causing the aircraft veer off to the left.

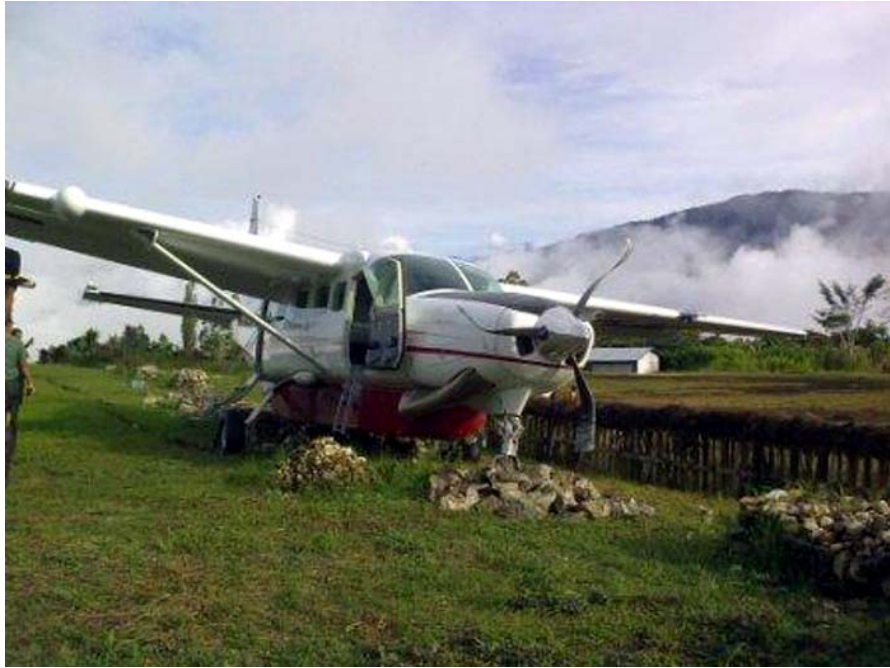
The aircraft hit the pile of stones on the side of the runway and stopped at 15 meters before left end marker.

The tire marks shown that the left deeper than the right, the aircraft start veered to the left of runway about 150 meters before the end of Runway 09. The aircraft was stop by the pile of stones along the side of the runway.

Figure 7. Cessna 208 PK-RJS after the Occurrence

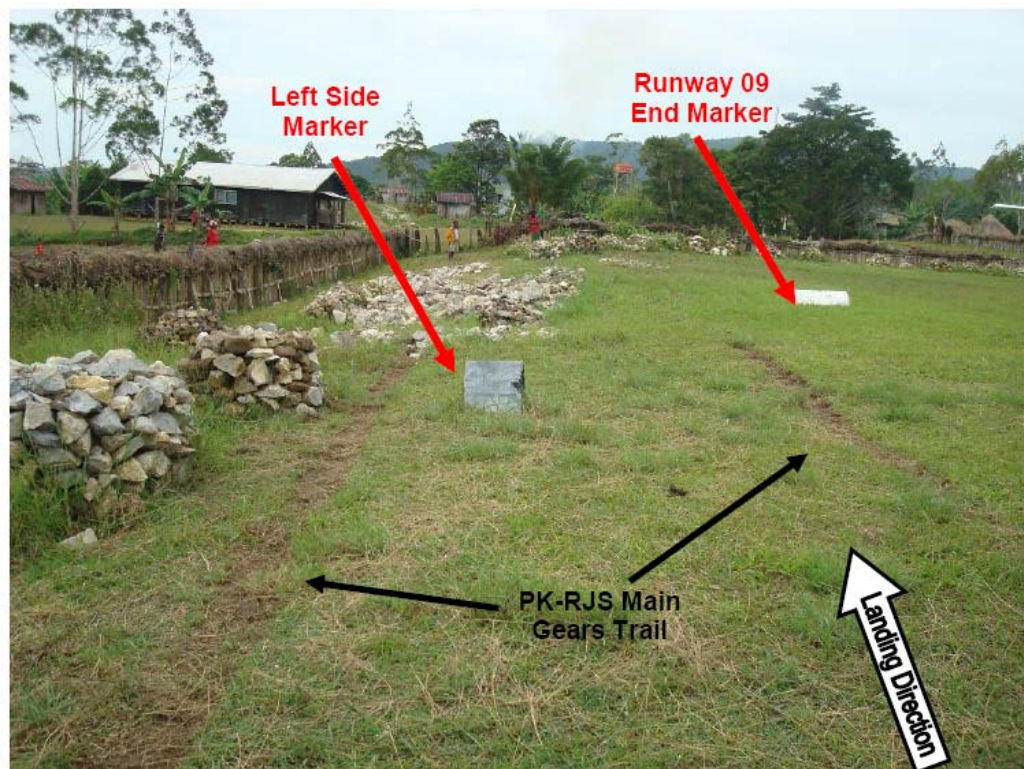
Figure 8. End of runway 09 Condition

Moreover also found that there were some works in progress such as, runway hardness and piled supporting materials about 2 - 3 metre from runway's side marker along the side of runway.

- To improve ongoing process to identify the runway condition and the mitigation to ensure its condition meet the requirements.
