FINAL
KNKT.10.09.14.04

NATIONAL TRANSPORTATION SAFETY COMMITTEE

Aircraft Accident Investigation Report

**Bali International Flight Academy
Cessna 172 Skyhawk; PK-ROG
2.4 km SW Blimbingsari Aerodrome
Banyuwangi, East Java
Republic of Indonesia
1 September 2010**

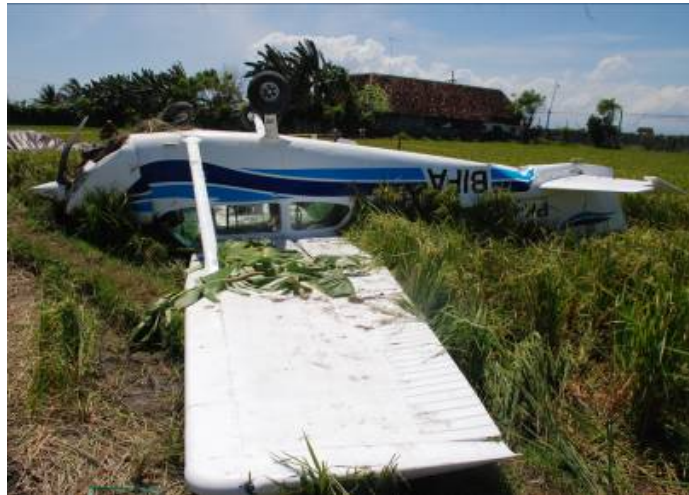
PK-ROG was found landed in rice field at about 2.4 km south west from Blimbingsari Aerodrome. The aircraft stopped with upside down position.

Figure 1: PK-ROG on rice field about 2.4 km SW from Blimbingsari Aerodrome

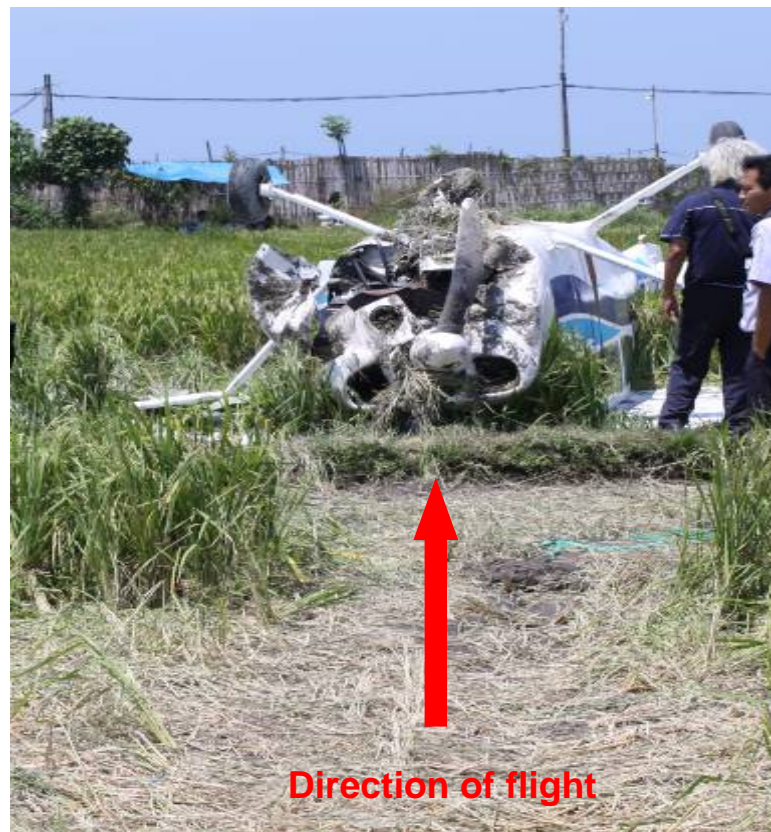
- The wing, landing gears, engine and propeller remained attached to the fuselage wreckage.
- The propeller blades were bent backward.
- The aircraft empennage area was buckled.
- The nose gear was collapsed.
- The aircraft left wing tip was bent.

Figure 2: The aircraft's propeller and nose landing gear were damaged

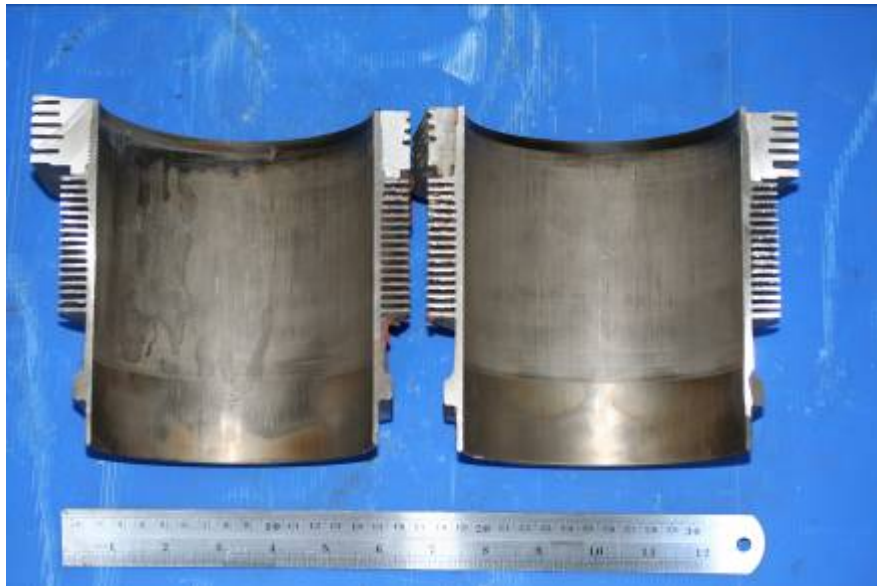
On the engine cylinder block #2, it was found that some scratches and de-lamination of the coating materials on the inner side, and the piston crown discoloured.

Figure 4: De-lamination of coating.

On the engine cylinder block #2, it was found that some scratches and de-lamination of the coating materials on the cylinder liner, and the piston crown was discoloured (See Appendix A).

The de-lamination of the cylinder liner decreased the engine power due to leakage of the combustion gas into the crank-case. Consequently, the engine temperature increased, the oil pressure decreased and the engine power decreased significantly and finally the engine quit.

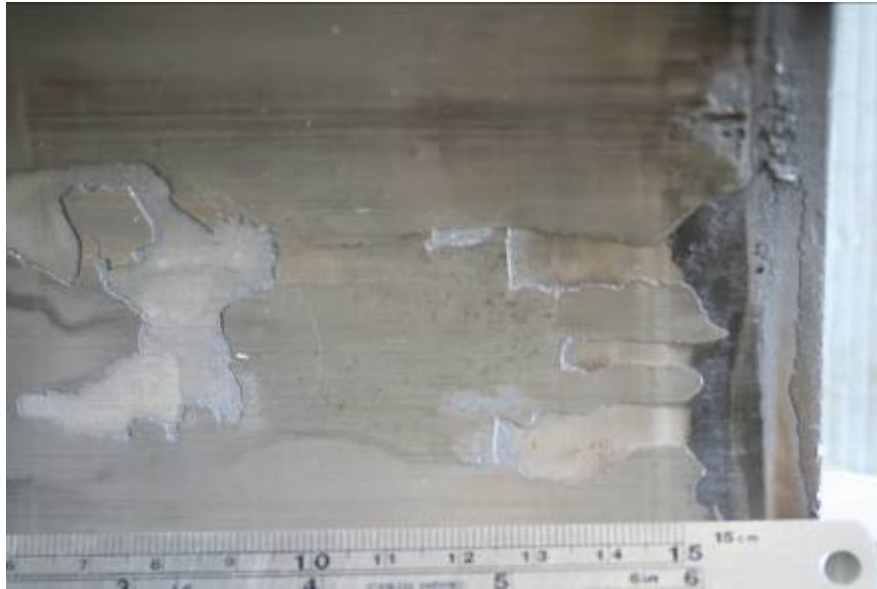
- The coating de-lamination started earlier from the location near the TDC (Top Dead Centre).
- Blisters were found on the coating. It suggested that foreign particles / materials were presence on the cylinder liner surface before coating deposition. It suggested also that the surface preparation during manufacturing was not properly done.

Figure 5: De-laminations started earlier from location near the TDC as indicated

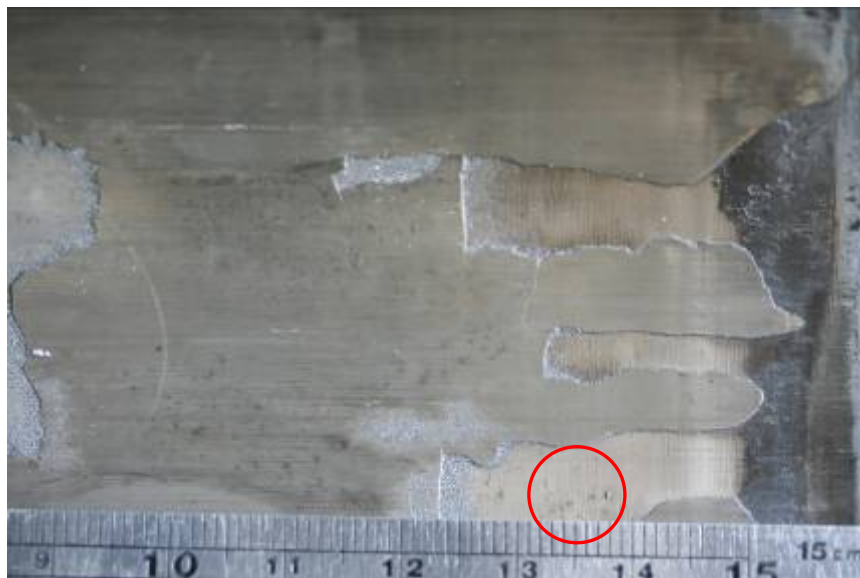
Figure 6: The cylinder surface shows fine scratch lines which were intended to improve the mechanical binding of the coating. A small metallic particle is observed at position near 13.7mm of the ruler

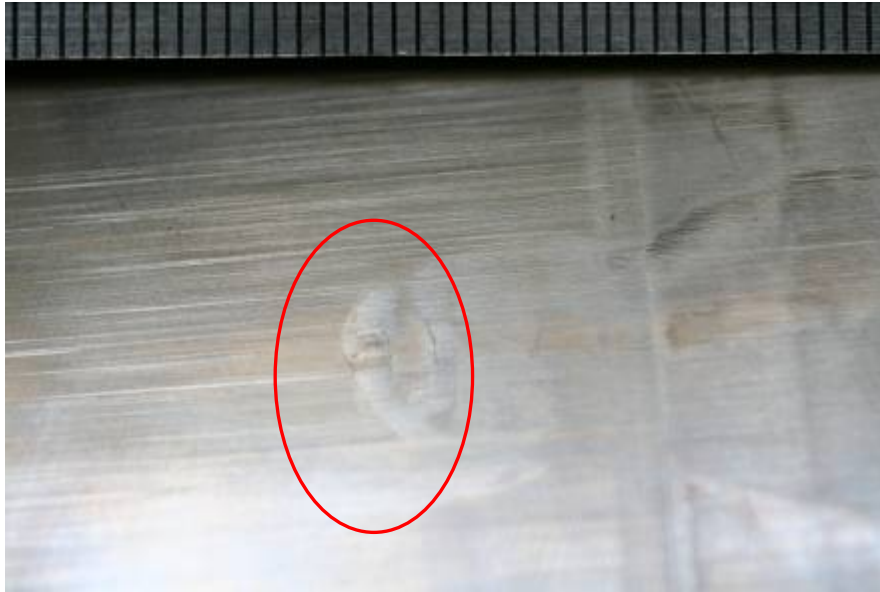
Figure 7: Blister of long type found near the BDC (Bottom Dead Centre). Cracks started to develop at the blister

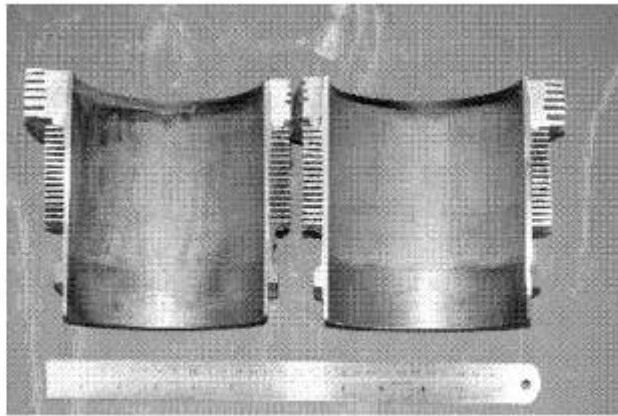
The examinations were performed on the damaged cylinder, i.e. the number 2 cylinder. Fig.1 shows cylinder number 3 which is identical to the number 2. The number 2 cylinder was cut into halves to show the damages (Fig.2).

Fig.2. De-lamination of coating.

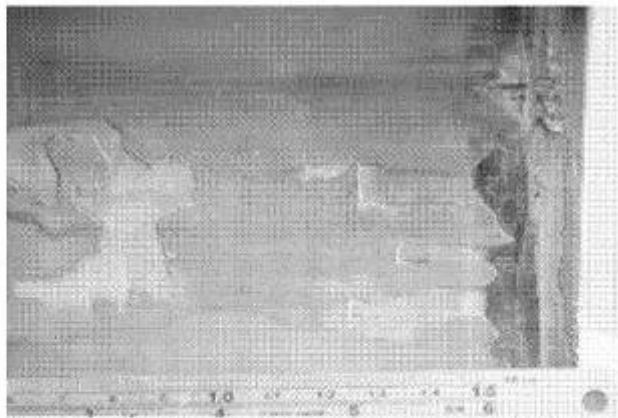
Fig.3. De-laminations started earlier from location near the TDC as indicated by dark colors.

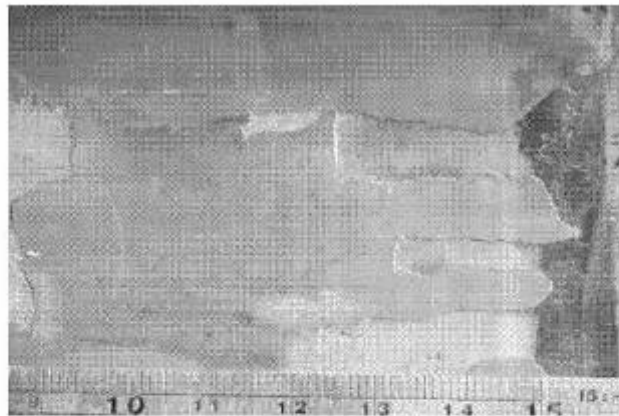
Fig.4. The cylinder surface shows fine scratch lines which were intended to improve the mechanical binding of the coating. Dark color indicated that de-lamination occurred earlier near the TDC. A small metallic particle is observed at position near 13.7mm of the ruler.

Fig.4. The cylinder surface shows fine scratch lines which were intended to improve the mechanical binding of the coating. A small metallic particle is observed at position near 13.7mm of the ruler.

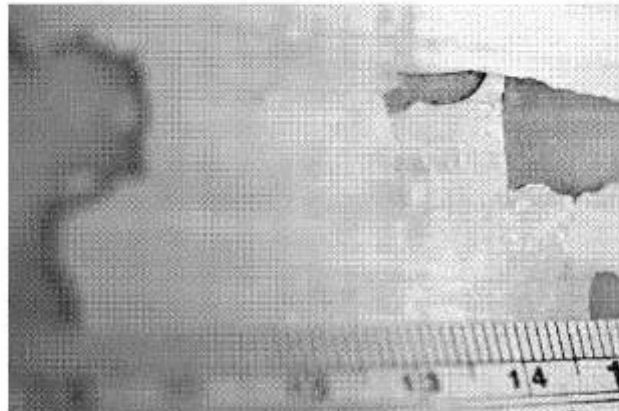
Fig.5. Four small blisters are observed on the coating. The blister form is similar to the metallic particle on the cylinder surface in Fig.4.

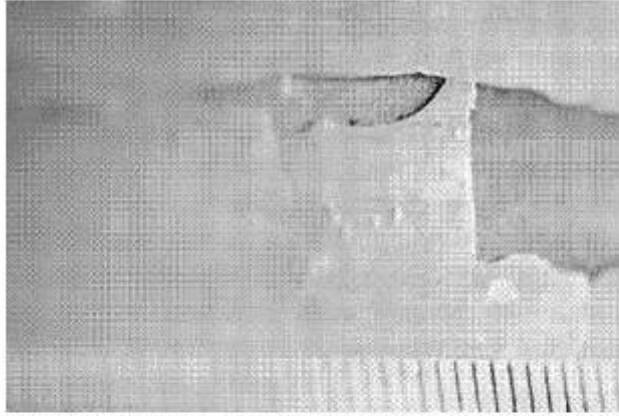
The laboratory observations show that the cause of the coating de-lamination was the presence of foreign particles / materials on the cylinder liner surface. It could be due to improper surface preparation during manufacturing.

Fig.6. Detail of blisters suggested the presence of metallic particle under the coating.

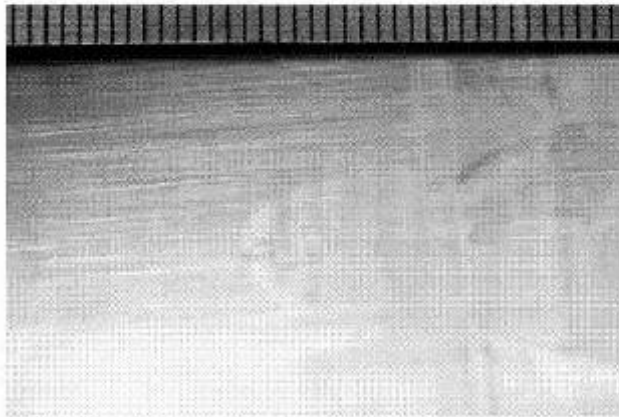
Fig.7. Blister of long type found near the BDC (bottom dead center). Cracks started to develop at the blister.

Fig.7. Blister of long type found near the BDC. Cracks started to develop at the blister.

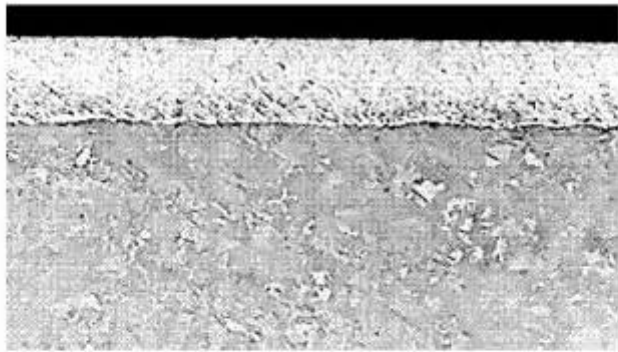
Fig.8. Coating materials on top of cylinder liner base metal.

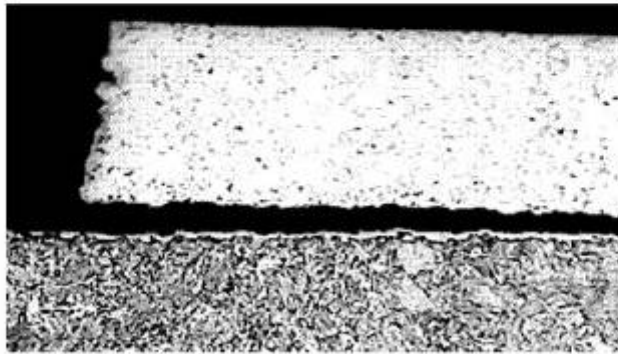
Fig.9. De-lamination of the coating.

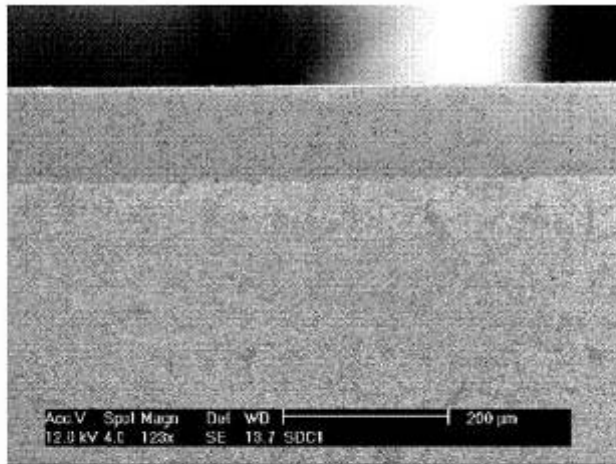
Fig.10.SEM observation: coating thickness is approximately 100 μm.

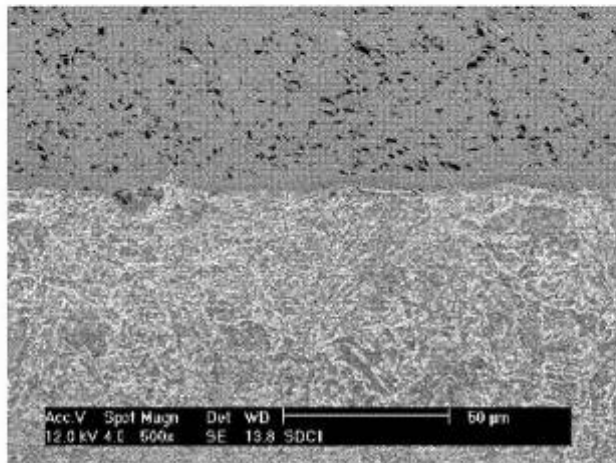
Fig.11.Detail of the coating: The dark particles are SiC (Silicon Carbides). The matrix is Ni (Nickel).

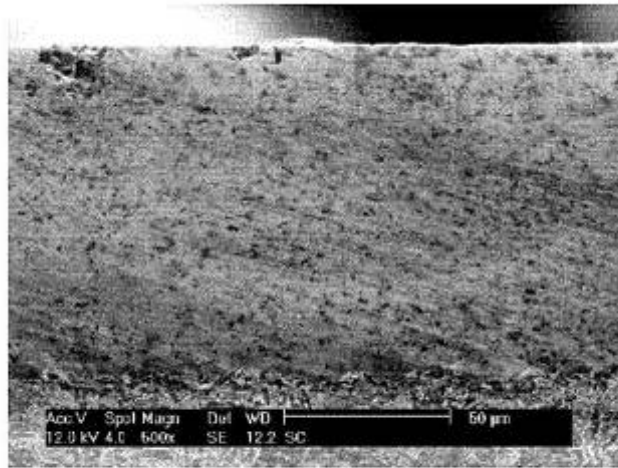
Fig.12.Deformation lines in the coating was due to frictional force from the piston ring.
