**NATIONAL
TRANSPORTATION
SAFETY
COMMITTEE**

Aircraft Accident Investigation Report

**PT. Alfa Trans Dirgantara
PA 34-200T ; PK-SUV
Halim Perdanakusuma Airport, Jakarta
Republic of Indonesia**

20 June 2010

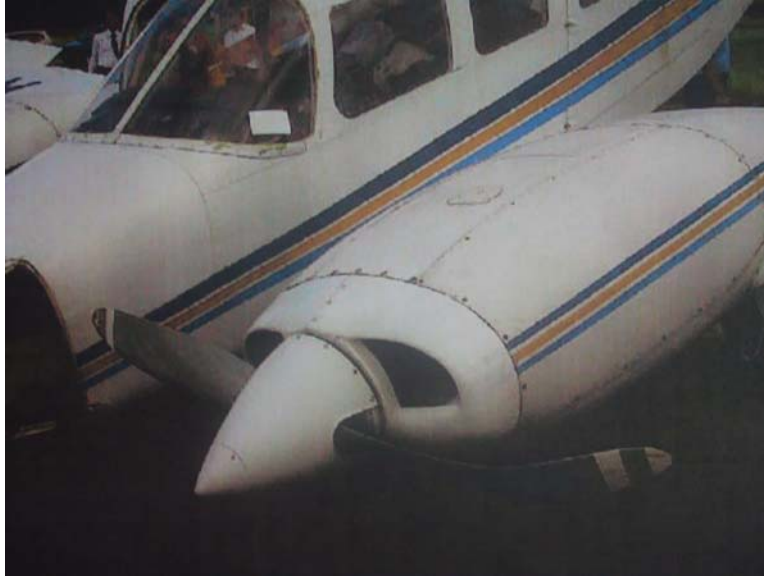
Figure 2: PK-SUV at accident site. Left engine propeller blades were bent

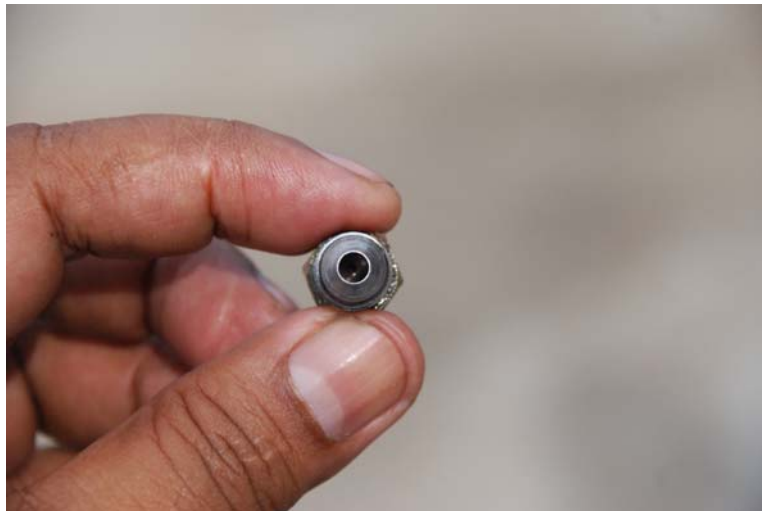
Figure 6: Hydraulic restrictor 0.31 diameter

The hydraulic system pipe line between nose landing gear actuator up line and restrictor on the up pipe line. The down line flow of landing gear hydraulic system was block at the nose landing gear actuator restriction valve “0.31 diameters” by some dirt.

The nose landing gear could not be extended due to the down line flow of landing gear hydraulic system was block at the restriction valve 0.31 diameters.
