**NATIONAL
TRANSPORTATION
SAFETY
COMMITTEE**

Aircraft Accident Investigation Report

**PT. Trigana Air Service
PK – YRP
Avions de Transport Regional ATR 42-320
Samboja Area, Km 41 Balikpapan
East Kalimantan
Republic of Indonesia**

11 February 2010

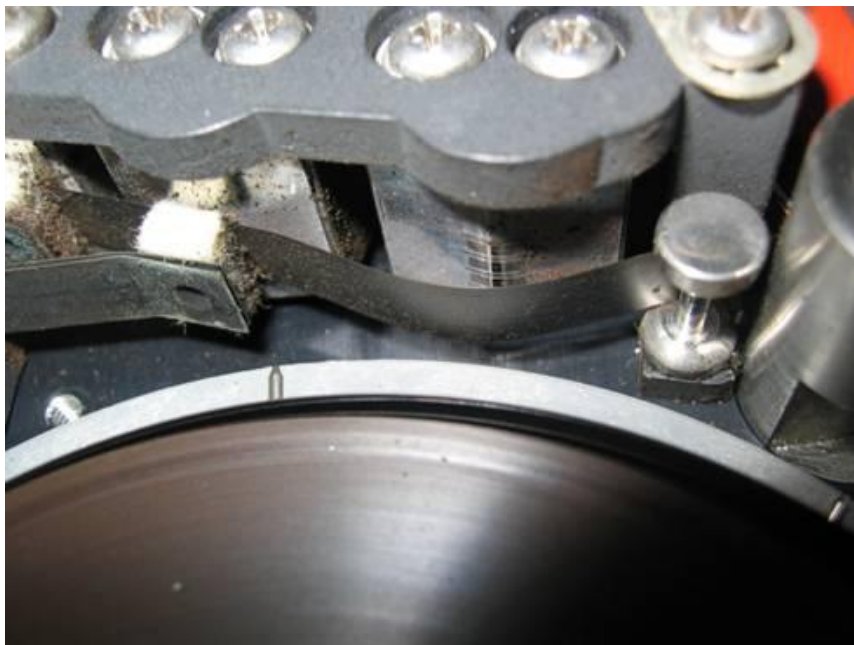
Figure 5: CVR recording head was worn-out and dirty

- The last flight recorded in the CVR was likely TGN542 from Denpasar to Ampenan followed by TGN561 from Ampenan to Sumbawa at an unknown time.
- A functional test at a maintenance facility found that the CVR read, write and erase heads were extremely worn and had a brown residue covering them. The motor that drove the CVR tape did not function at all, due to an open circuit in the motor assembly. As such, the recorder was unable to operate correctly.

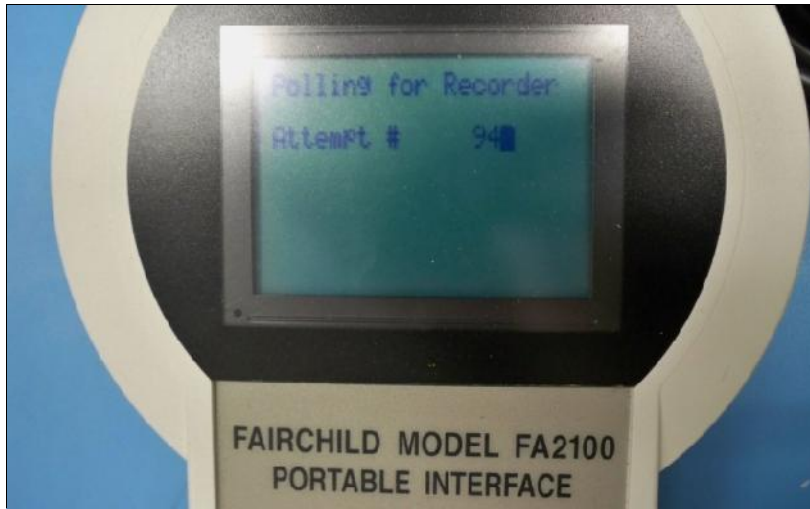
An attempt at downloading the FDR information was made on 22 February 2010 using the recorder manufacturer's portable interface (PI) equipment. The initial download attempt at the ATSB was performed using the accident FDR chassis. This resulted in a polling error (as reported to have occurred during a previous download attempt at the NTSC's facility) (Figure 6).

Figure 6: Polling error code during downloading

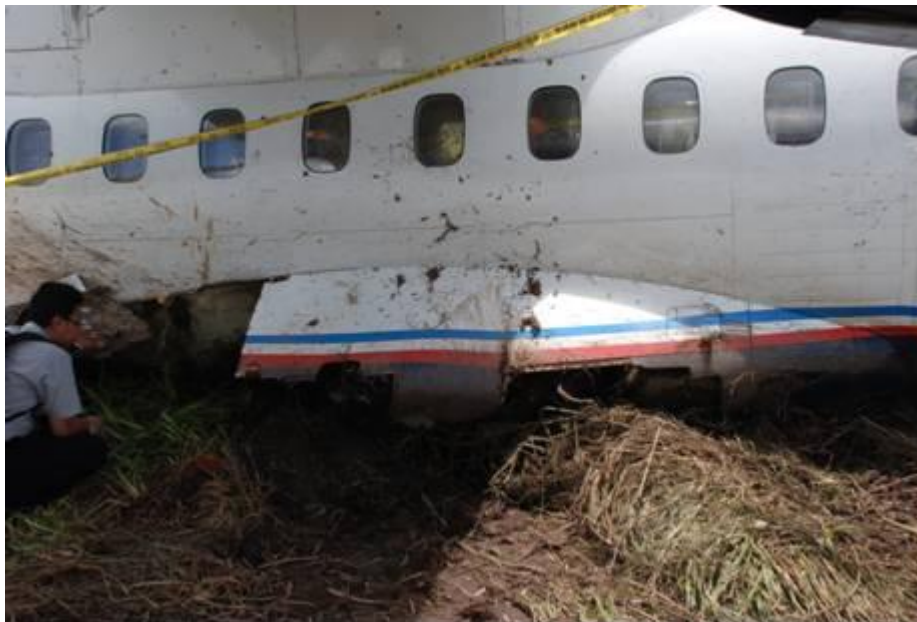
Figure 9: The right main landing gear door was broken

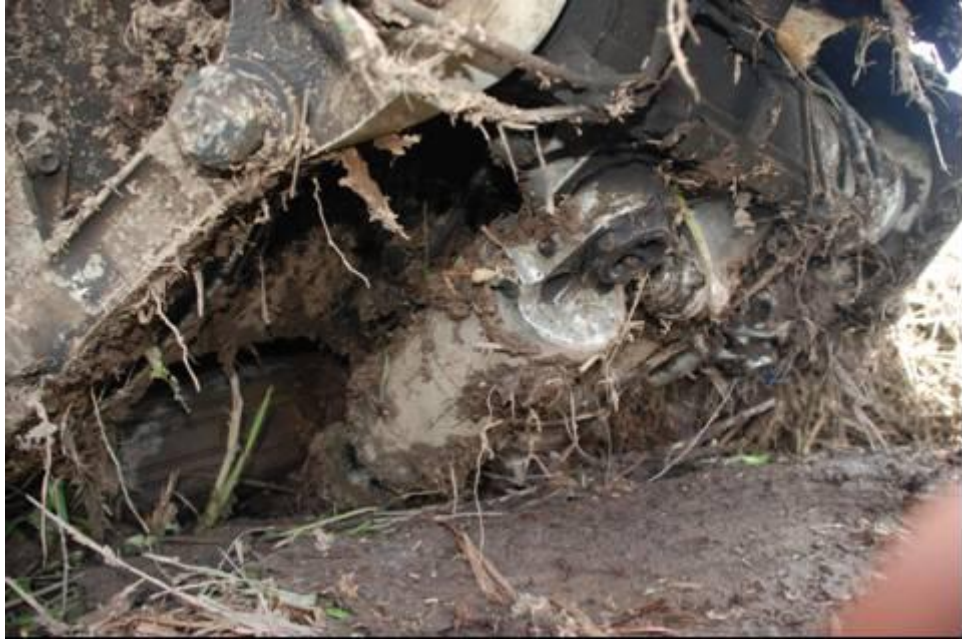
Figure 10: The right main landing gear was broken

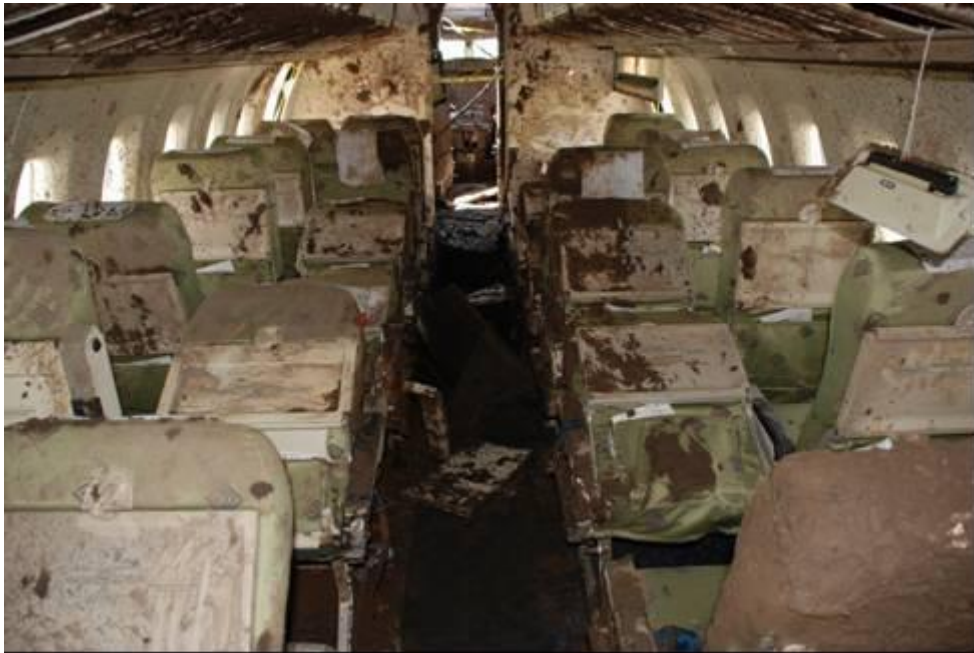
Figure 12: View of passenger cabin damage

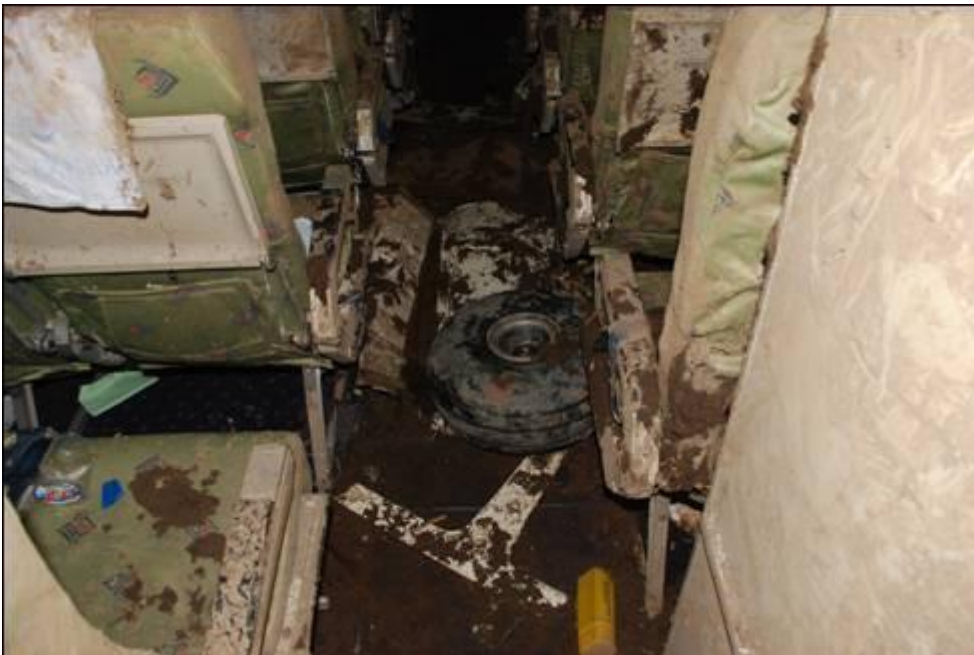
Figure 13: Nose wheel found inside the cabin

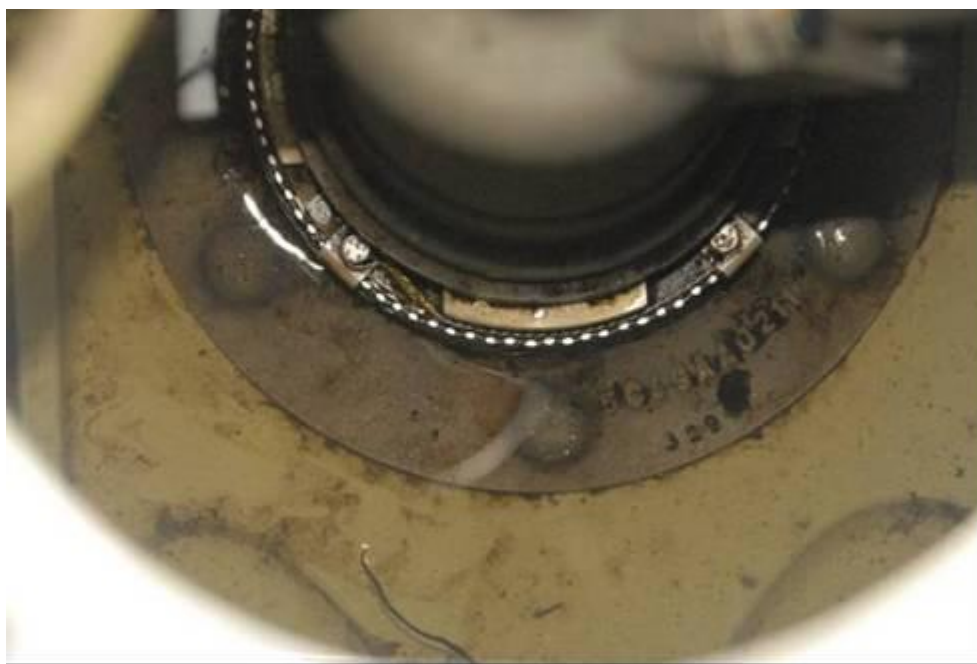
Figure 16: The inside wing tank a lot of dirt and sealant debris

- Both wing tanks were a lot of deposits and dirt.
- The uncured sealant found in the both wing tanks.

- Review and improve the Implementation of CRM and technical knowledge.
- Ensure the actual of fuel quantity on both fuel tanks was equal and balance prior departure.
- Ensure that the modification of fuel system referred to service bulletin No ATR42-28-039 and technical instruction No: 006/ENG-07/2008, was tested referred to the correct procedure as per AMM (JIC) 28-42-00 FUT 10000.
- Ensure the FDR and CVR read out and calibration in accordance to the manufacture standard and should be done by approved repair station
- Ensure that the wing tank is clean and free from debris
- Ensure that the correct sealant type for the wing tank application and correct procedure to be followed to avoid uncured process of it.

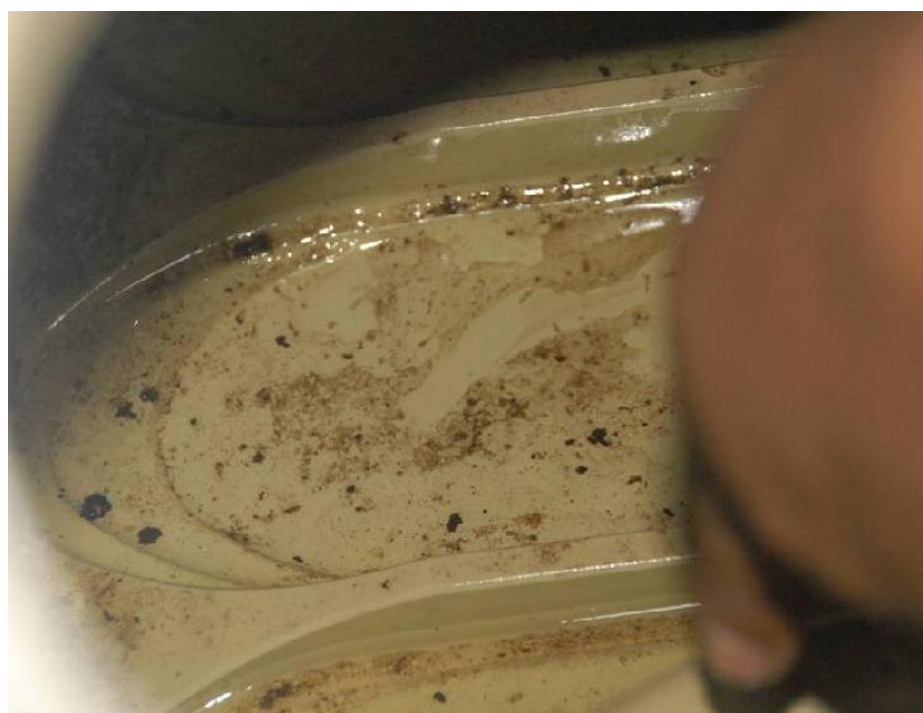
Figure 17: Uncured sealant and deposit

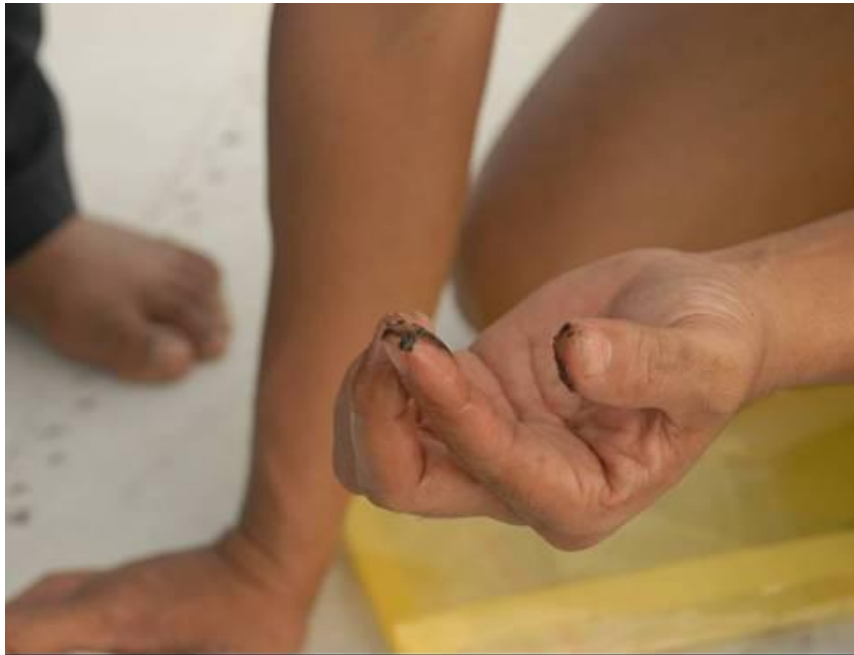
Figure 18: Uncured sealant from the wing tank
