PRELIMINARY
KNKT.10.02.05.04

Aircraft Serious Incident Investigation Report

Boeing 737-200; PK-YTR

Juanda International Airport, Surabaya

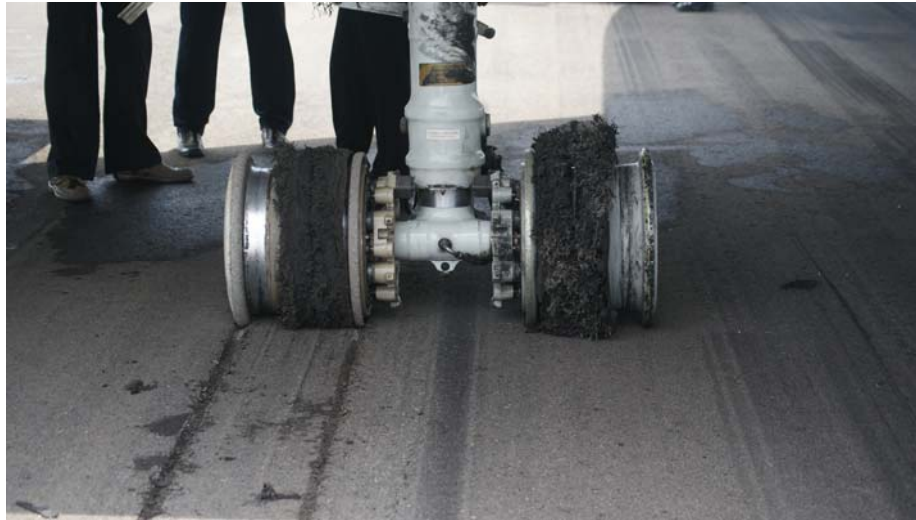
Figure 2: Main landing gear wheels one and two

The aircraft commenced the take-off roll on runway 10 at 0235 UTC (0935 LT). Approximately 300 meters after commencing the take-off roll, main-wheel tire number one (left outboard) exploded followed by tire number two (left inboard) approximately 1,100 meters further along the runway. Both tires shredded and the aircraft rolled along the runway on the wheel rims.

The tires on main landing gear wheels one and two shredded, and tires three and four deflated. There was no other damage to the aircraft.

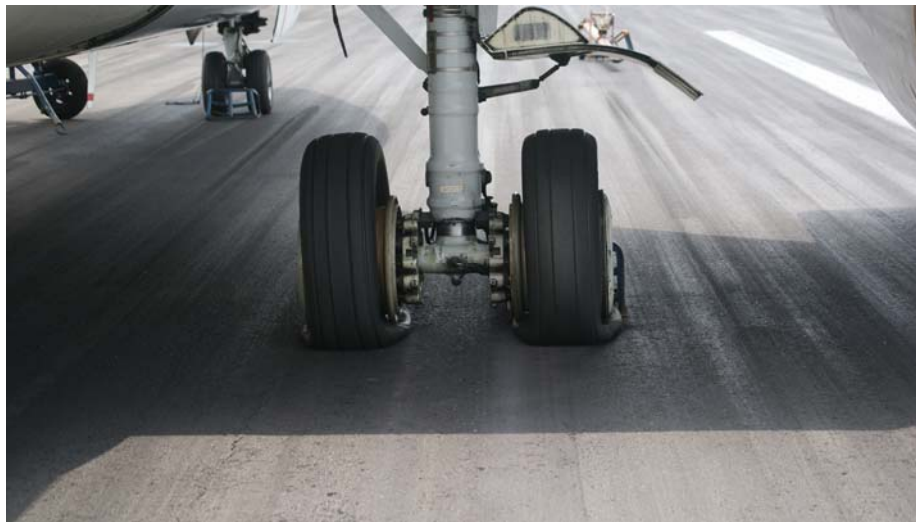
Figure 3: Main landing gear wheels three and four

The copilot decided to abort the takeoff and stopped the aircraft at intersection N6, approximately 350 meters from the departure end of runway 10. Tires numbers three and four deflated.

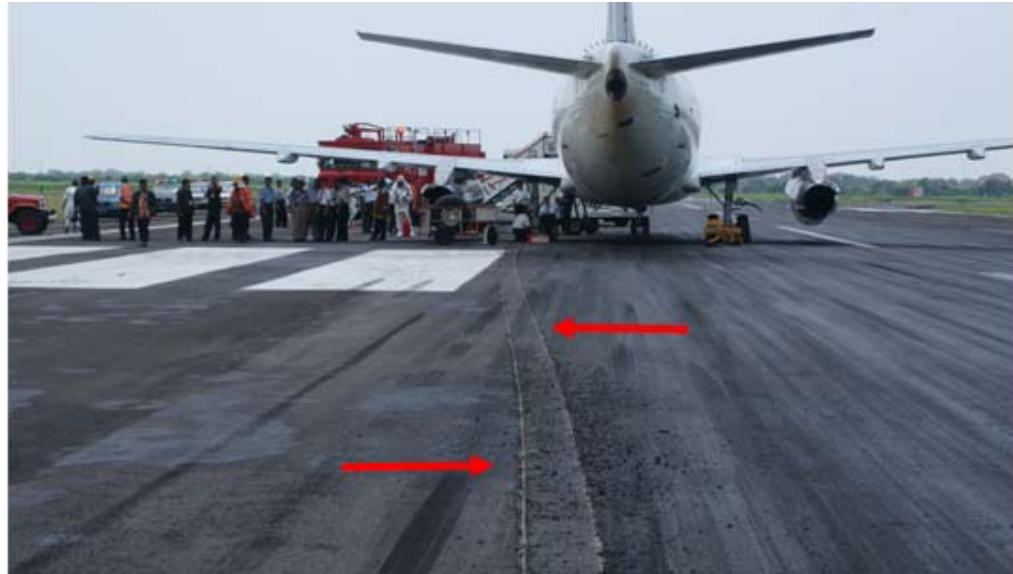
Figure 4: Runway damage

The asphalt surface of runway 10 was damaged by the number-one and – two main landing gear wheels for a distance of approximately 925 meters between taxiways N3 and N6.

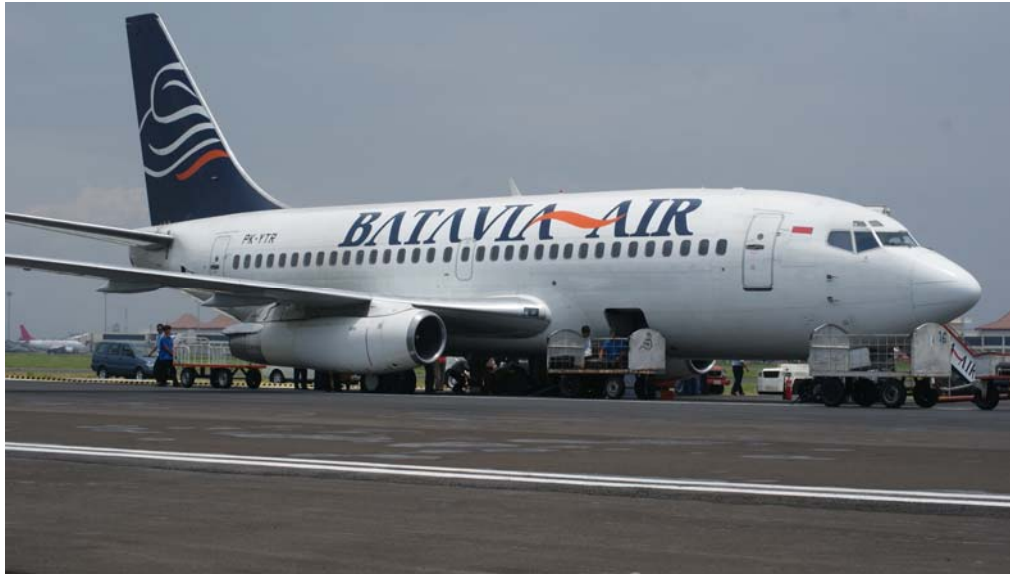
Figure 8: The aircraft at the final position (N6 intersection)

The copilot decided to abort the takeoff and stopped the aircraft adjacent to taxiway N6, approximately 350 meters from the departure end of runway 10. Tires numbers three and four deflated.

Apart from the main landing gear wheel assemblies, the aircraft was not damaged.
