**KOMITE NASIONAL KESELAMATAN TRANSPORTASI
REPUBLIC OF INDONESIA**

Aircraft Serious Incident Investigation Report

PT. Wings Abadi Airlines

ATR 72-212A; PK-WFG

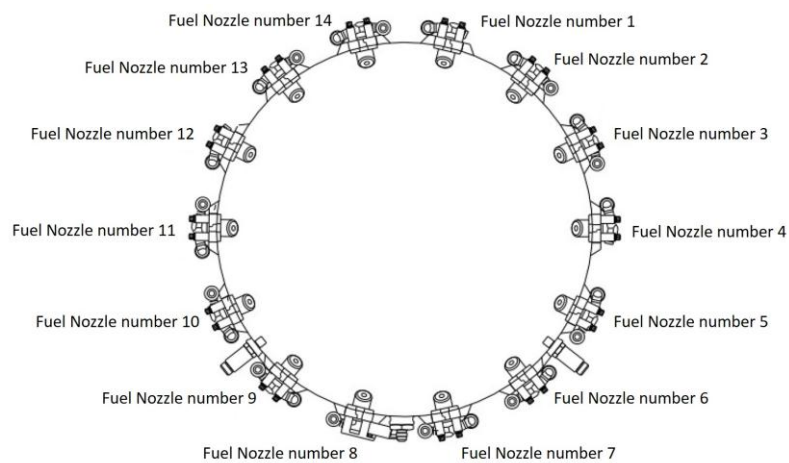
Figure 4: Fuel nozzle arrangement

1. Based on all the evidences, the examination confirmed that the source of the right engine nacelle fire event originated from fuel leakage at the inlet fitting of the secondary fuel flow manifold hose and adapter of the fuel nozzle number 1 (see Figure 4: Fuel nozzle arrangement).

The fuel leakage from the fuel nozzle number 1 was primarily due to a stretch pinch-fracturing of the preformed packing of the inlet fitting.

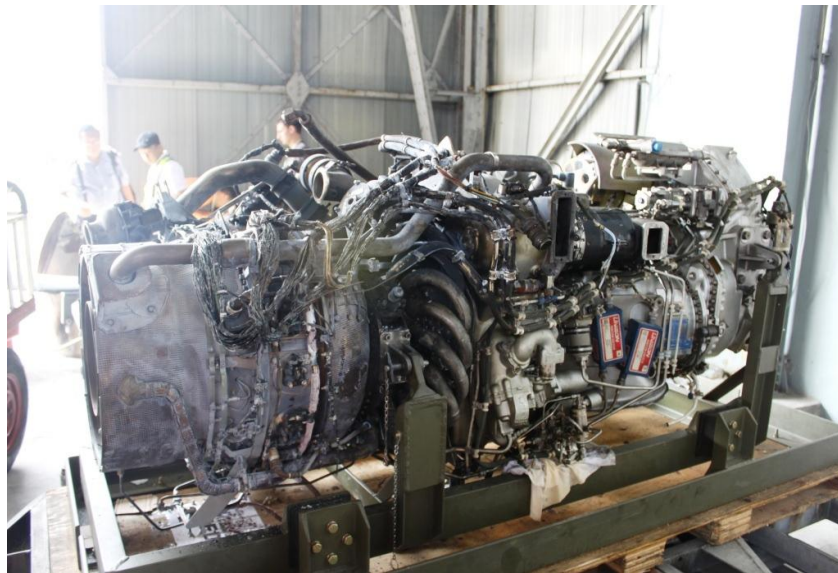
The investigation found that most of the engine components on the engine hot section had fire damaged. The damages observed on the engine cowling and in several engine components, such as ruptured Inter-compressor Bleed Valve (IBV), deteriorated flexible fuel manifold, burnt wire harnesses, and melted drain plumbing.

Figure 11: The damaged on the hot section

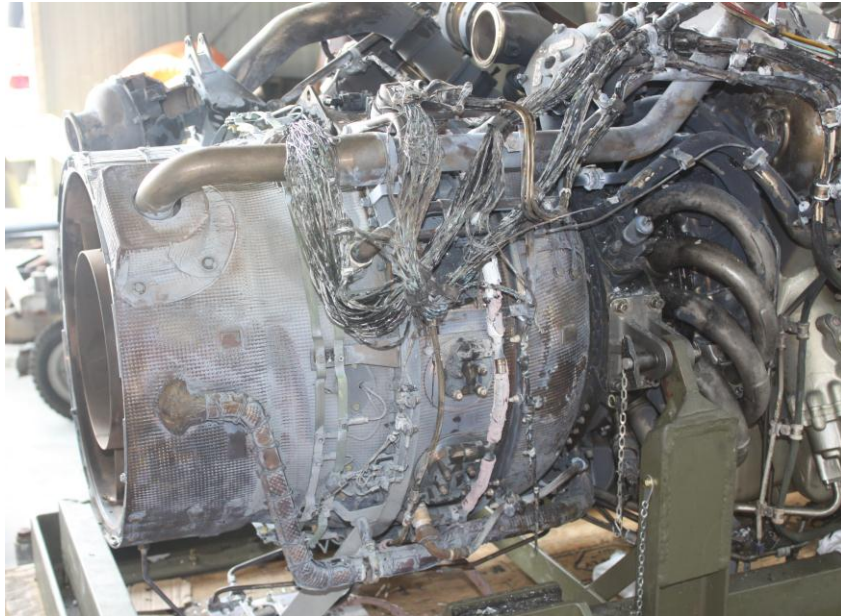
Figure 12: The evidence of fire on the external of hot section area

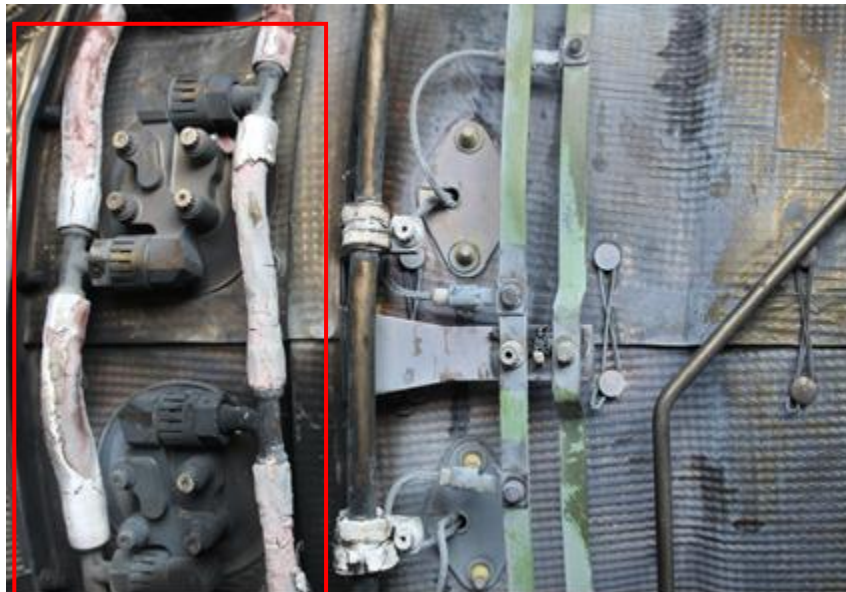
Figure 13: The burn of flexible fuel hose with whitish coloured

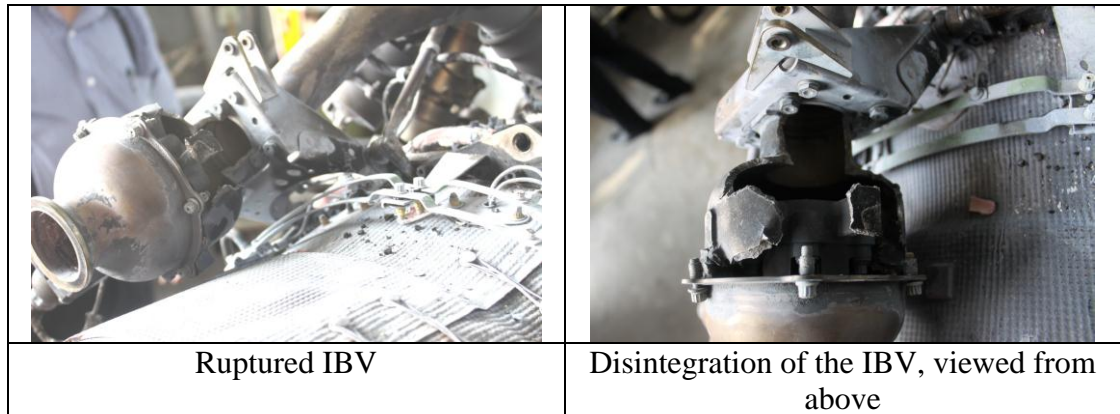
Figure 14: The ruptured Inter-compressor Bleed Valve (IBV)

3. The damage to the engine externals including the inter-compressor bleed valve (IBV), except for the elbow inlet-fitting packing fracture at the secondary fuel nozzle number 1, was considered secondary due to being exposed to elevated temperature generated from the engine nacelle fire.

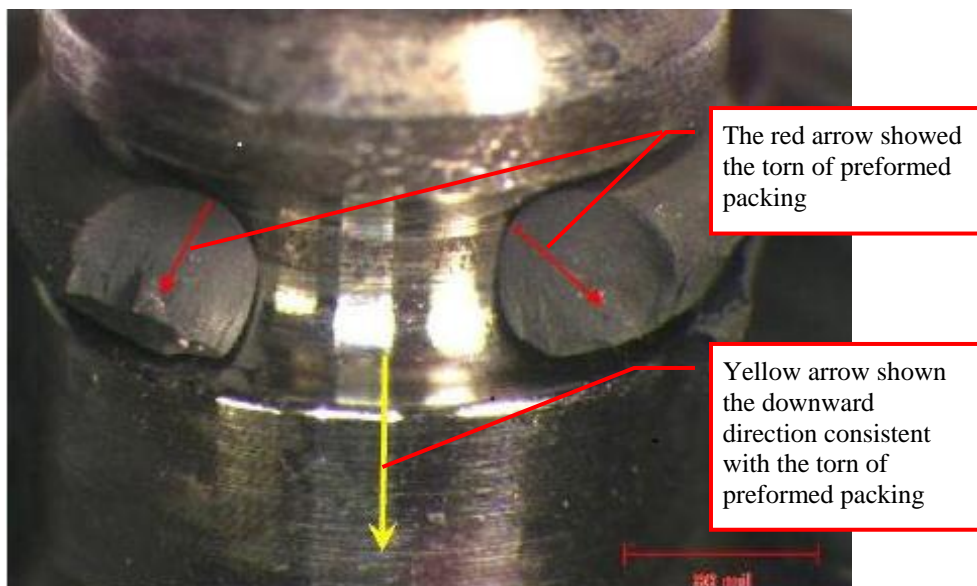
2. The torn-off preformed packing fragment being trapped at the conical face of the hose/adapter inlet fittings would interfere with the interface seating of the fittings and the coupling nut torque process. In addition, the missing section of the preformed fractured packing would cause the relaxation of the packing stretch pinch on the hose inlet fitting and manifold inlet fitting bore. In fact, the combination of the above conditions would generate an improper centering and seating of the hose inlet fitting within the manifold inlet fitting bore. The evidence of torn-off preformed packing is shown in the figure below.

Figure 15: The torn-off preformed packing

The torn-off preformed packing (O-ring) fragment being trapped at the conical face of the hose of the adapter inlet fittings would interfere with the interface seating of the fittings and the coupling nut torque process.

In addition, the missing section of the fractured packing would cause the relaxation of the packing stretch pinch on the hose inlet fitting and manifold inlet fitting bore. The combination of the above conditions would generate an improper centering and seating of the hose inlet fitting within the manifold inlet fitting bore. The fuel can escape from improper centering of the fuel nozzle which resulted in the fuel leak.

The evidence shows that the preformed packing fracture occurred during the handling installation of the hose elbow inlet fitting to the adapter inlet fitting bore. This likely occurred during replacement of the fuel flow manifold adapters at engine TSN of 2775.3 hours.

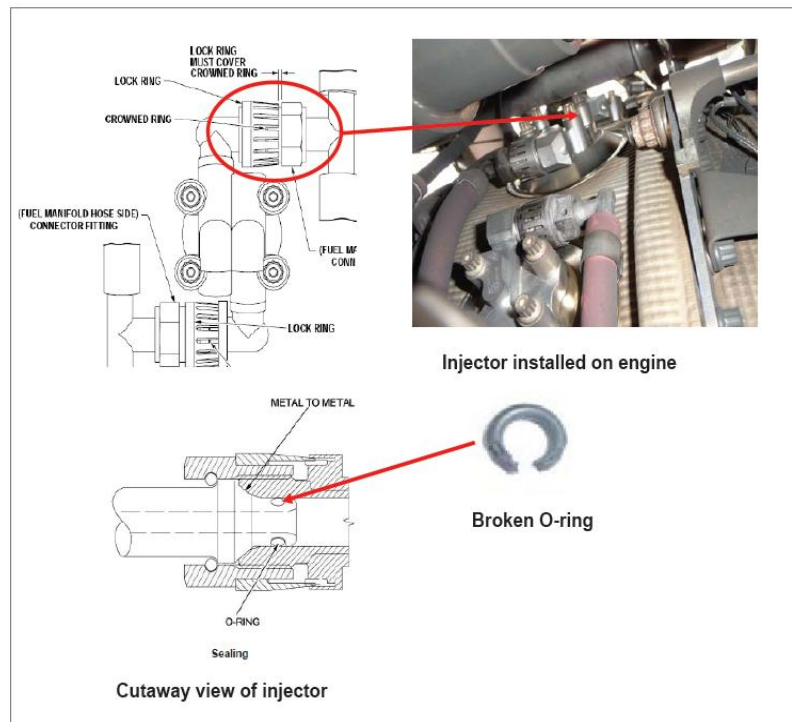
The maintenance manual specifies changing the fuel nozzle every 1,000 flying hours. After the installation, sealing of the fuel nozzle can be checked by leakage check (wet ventilation), then by a ground run at 80% of TQ for 10 minutes. The incorrect tightening left a leak at the level of the metal to metal contact and led to a fuel leak at the level of the number 14 fuel nozzle when the preformed packing (O-ring) was damaged.

Figure 21: The Sample of Broken Pre-formed packing (O-Ring)

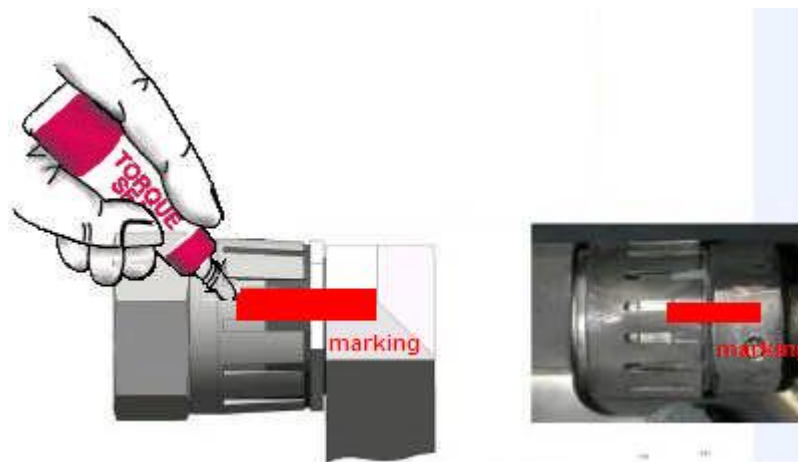
Figure 22: The marking on of the Moeller Finger and Moeller Ring to ensure the tightness

4. The Wings Air Engineering Instruction No. ATR72-EA-73-013R4 mainly to fulfill SB No 21803 R4 and additional marking to ensure that the tightness easy to check.
