**FINAL**  
KNKT.11.12.31.04

**Runway Excursion Investigation Report**

**PT. Sriwijaya Air  
Boeing 737-200; PK-CJD  
Sultan Mahmud Badarudin II Airport,  
Palembang, Sumatera Selatan,  
Republic of Indonesia  
24 December 2011**

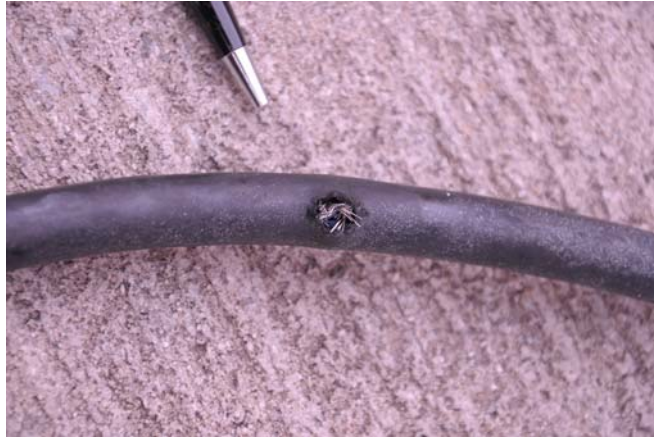
There was no substantial damage to the aircraft except the Hydraulic Hose of RH MLG up-lock actuator at the “Lock Port” position was leak.

Figure 1: Hydraulic Hose shows burst at middle position

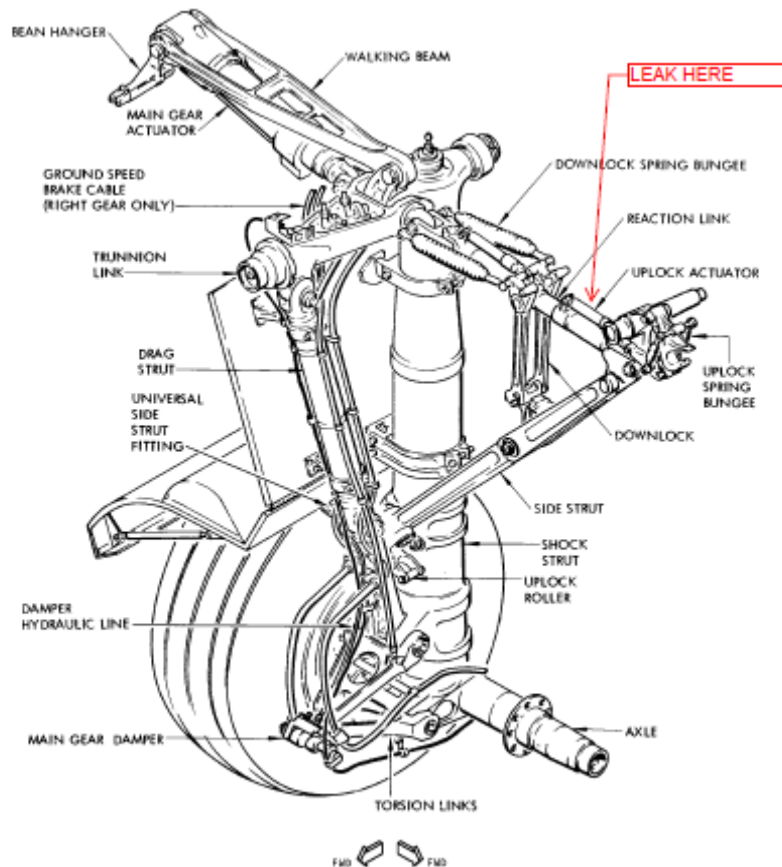
Engineer checked the aircraft and found the Hydraulic Hose of RH MLG up-lock actuator at the "Lock Port" position was leak.

Figure 2: Leak Position on RH MLG

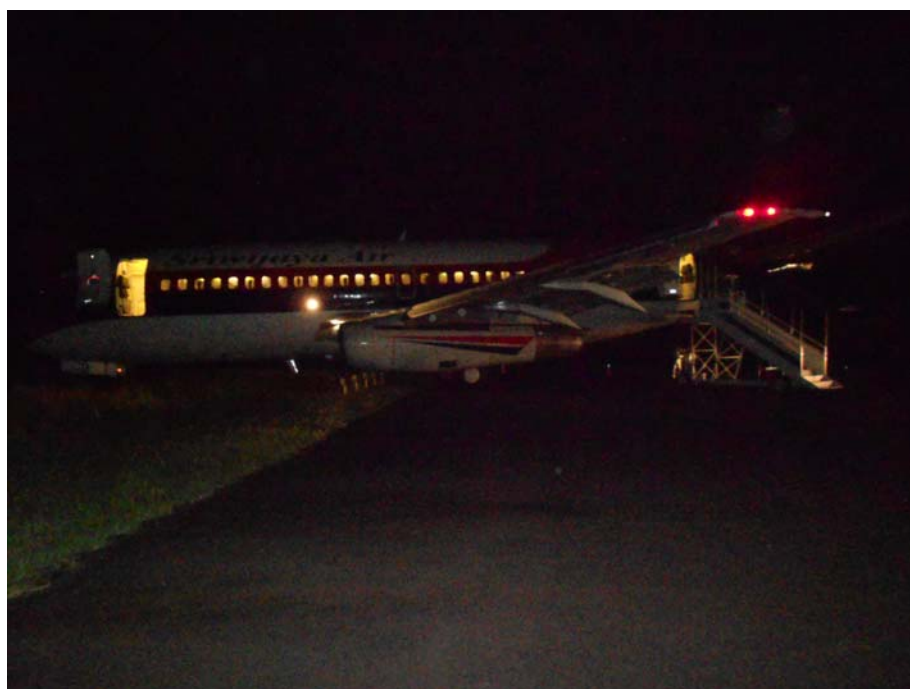
The aircraft main wheels went out at approximately 20 meter from the end of runway 11.

Figure 5: Aircraft last position at over run area 11

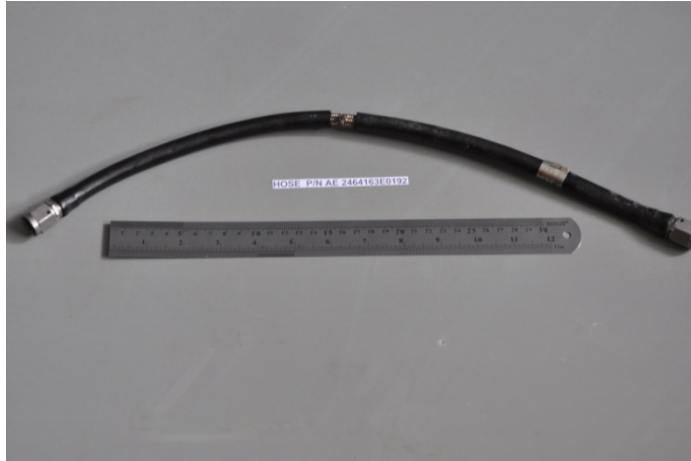
The damage component is Hydraulic Hose P/N AE2464163E0192 taken from PK-CJD on 24 December 2011 was part of hydraulic system A. The operating pressure is 3000 psi.

Figure 7: The hose shows damage in the middle

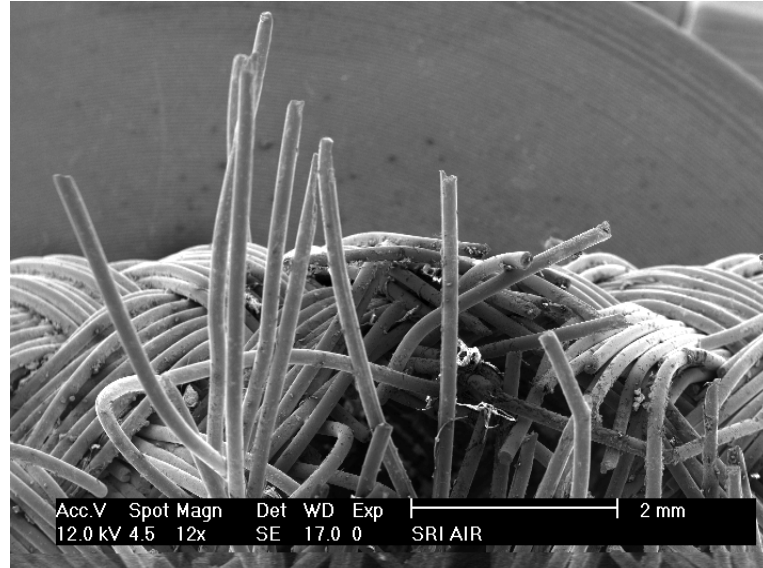
Figure 9: Fracture wire mesh at the burst area

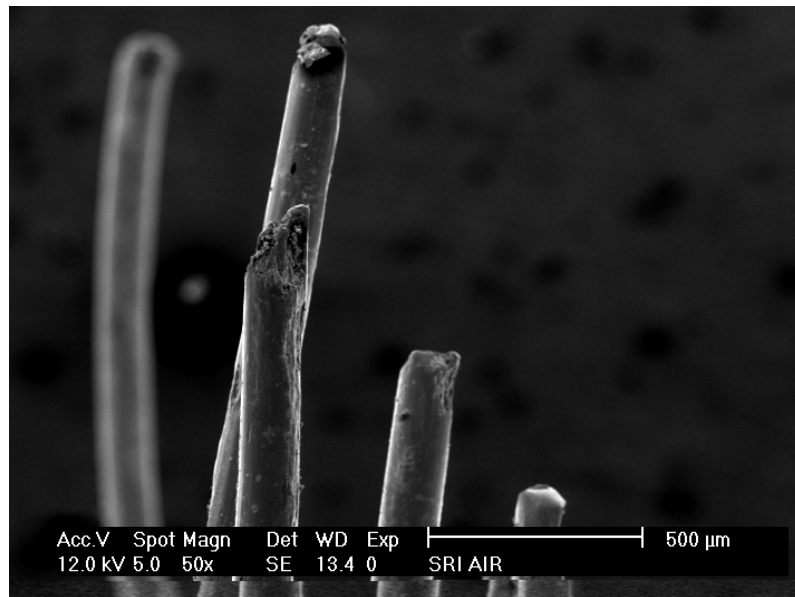
Figure 10: Detail fractures tip

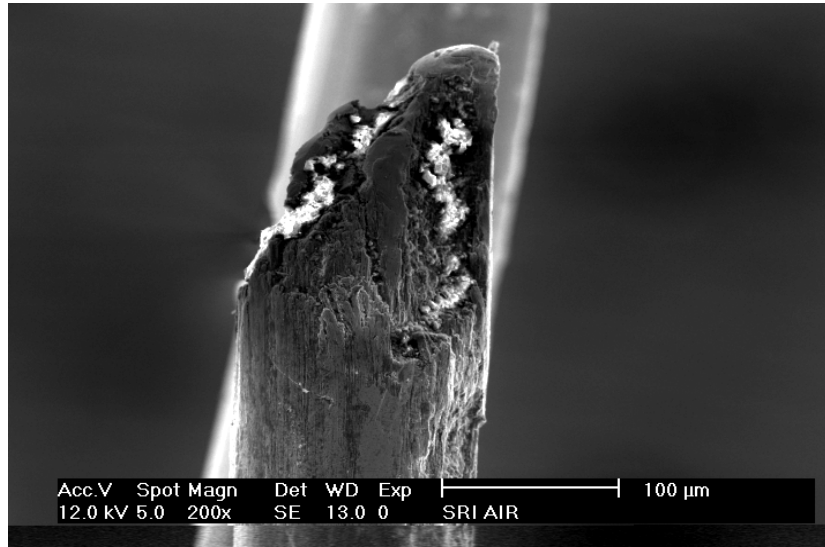
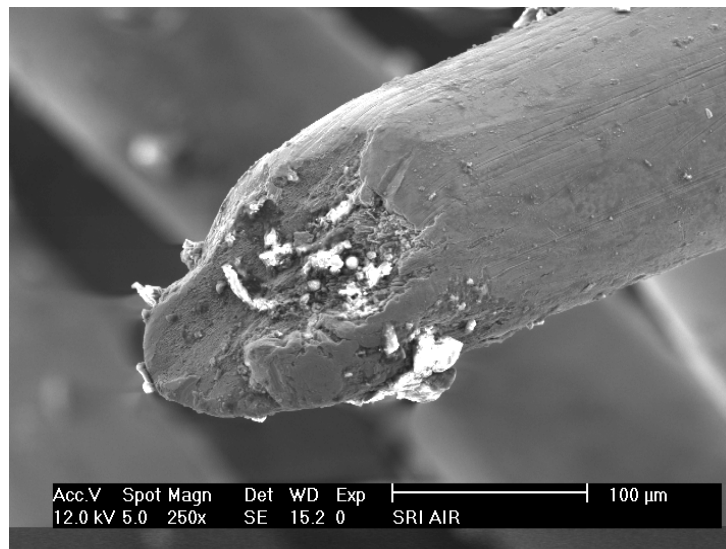
Static fracture characteristics due to tensile load: deformation and an angle of 45 °.

Figure 11: Static fracture characteristics due to tensile load (the deformation with an angle of 45°)

Figure 12: Static fracture characteristics due to tensile load (the deformation with an angle of 45°)

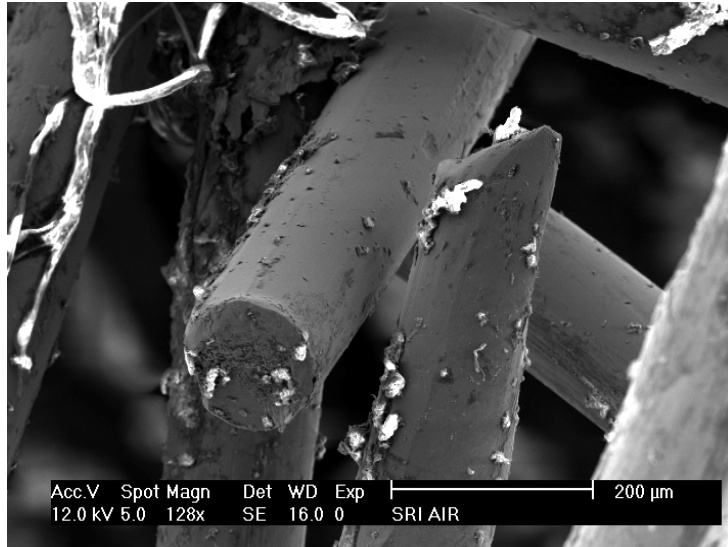
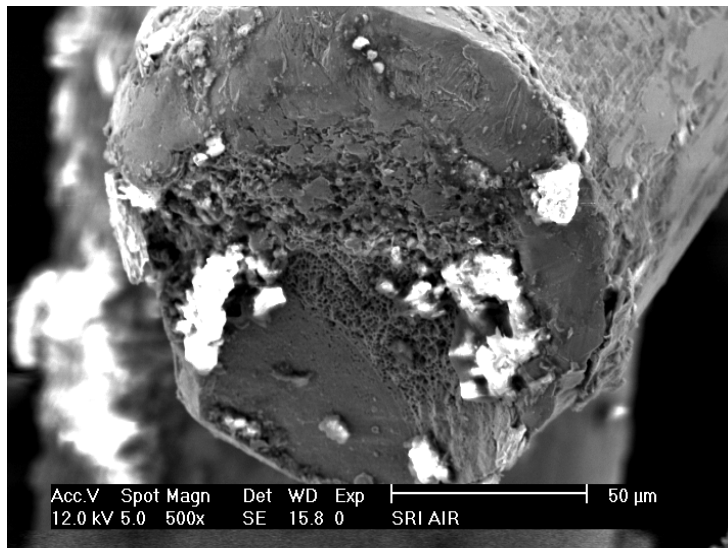
Figure 13: Fatigue fracture characteristic (no deformation and the 90° fracture)

Figure 14: Fatigue fracture characteristic (no deformation and the 90° fracture). The initial fatigue crack is at the bottom part of the wire

As a result of repetitive load of hydraulic operation at the hose and the present of fretting defects due to hose vibration, some wires mesh were fracture because of fatigue. Since there were wires mesh fractures at that location, the integrity of the hose become weak and finally burst. The sudden burst indicated by the presence of deformation on the wires and fractures tip angle about 45°. The hose vibration also led wire broken despite the broken wire was not in burst location.

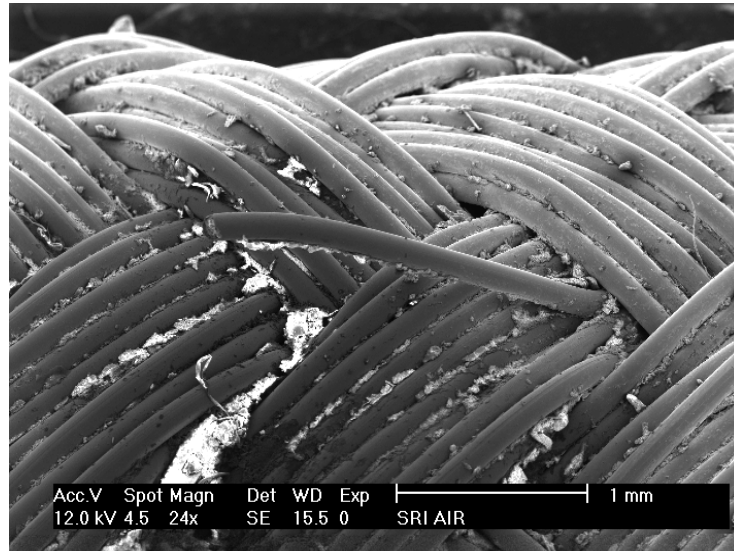
Figure 15: One wire was fatigue fracture at other location near the burst area

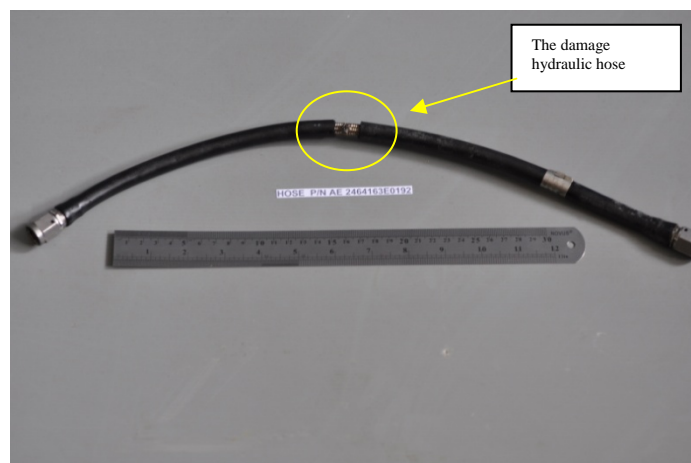
The damage component Hydraulic Hose P/N AE2464163E0192 taken from PK-CJD on 24 December 2011 was part of hydraulic system A and the operating pressure inside the hose was 3000 psi.

Figure 17: The damage hydraulic hose

As a result of repetitive load of hydraulic operation at the hose and the present of fretting defects due to hose vibration, some wires mesh were fracture because of fatigue. Since there were wires mesh fractures at that location, the integrity of the hose become weak and finally burst. The sudden burst indicated by the presence of deformation on the wires and fractures tip angle about 45°.

The burst of the hydraulic hose is likely due to fatigue mode initiated by fretting damage on the wire mesh as a result of vibration.

The defective hydraulic hose was most likely consistent with fatigue mode initiated by fretting damage on the wire mesh as a result of vibration, and it could be happen again to the other similar aircrafts as such, The NTSC recommends that the DGCA has to oversight this recommendation implementation.

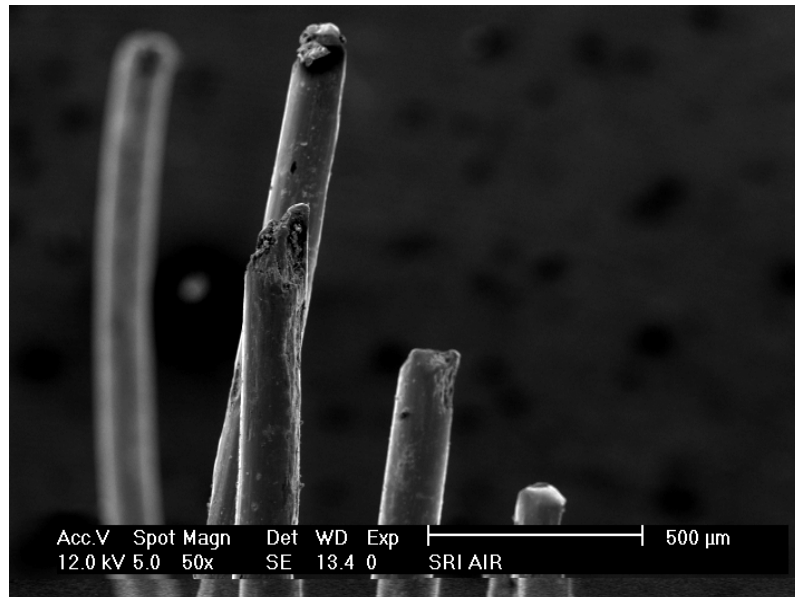
Inspection and studied on static fracture characteristics due to tensile load: found

deformation and an angle of 45 °.

Figure 18: Shows static fracture due to tensile load

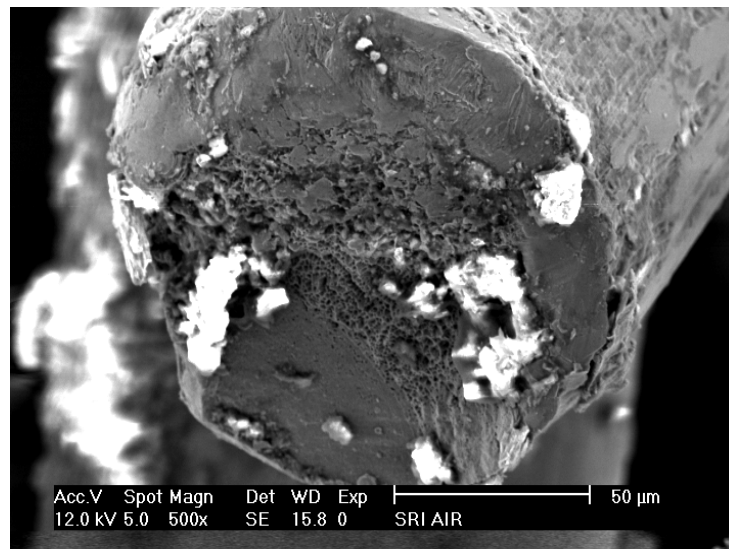
Fatigue fracture characteristic (no deformation and the 90° fracture). The initial fatigue crack is at the bottom part of the wire as shown on the figure bellow.

Figure 19: Shows the initial crack

- Most probably frequent Hose vibration.
- Some wires mesh were fracture because of fatigue. Since there were wires mesh fractures at that location, the integrity of the hose become weak and finally burst. The sudden burst indicated by the presence of deformation on the wires and fractures tip angle about 45°.
- The hose vibration also led wire broken despite the broken wire was not in burst location.
