NATIONAL TRANSPORTATION SAFETY COMMITTEE

Aircraft Accident Investigation Report

PT. Sriwijaya Air

Boeing 737-300

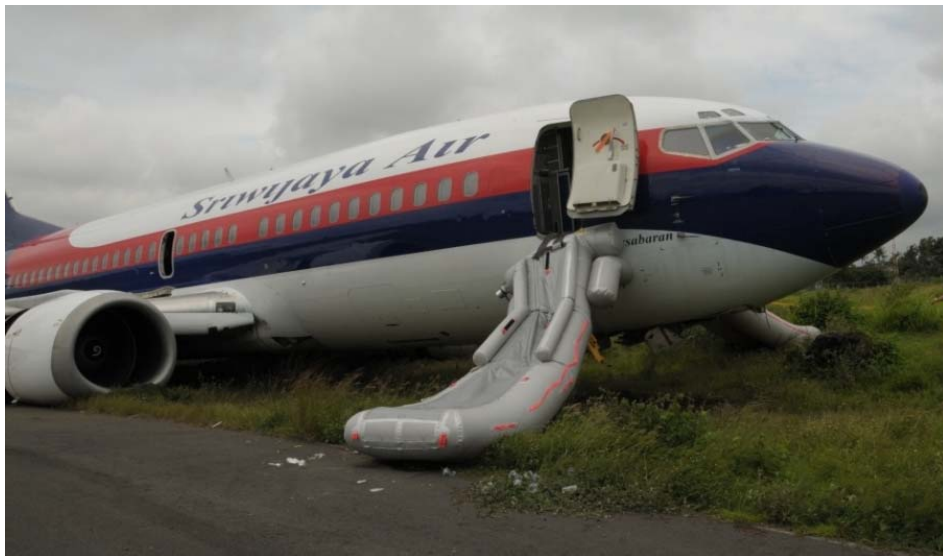
The aircraft stopped at 75 meter from the end of runway 09 and 54 meter on the left side of the centre line.

Figure 1: PK-CKM stopped at 75 meters from end of runway 09

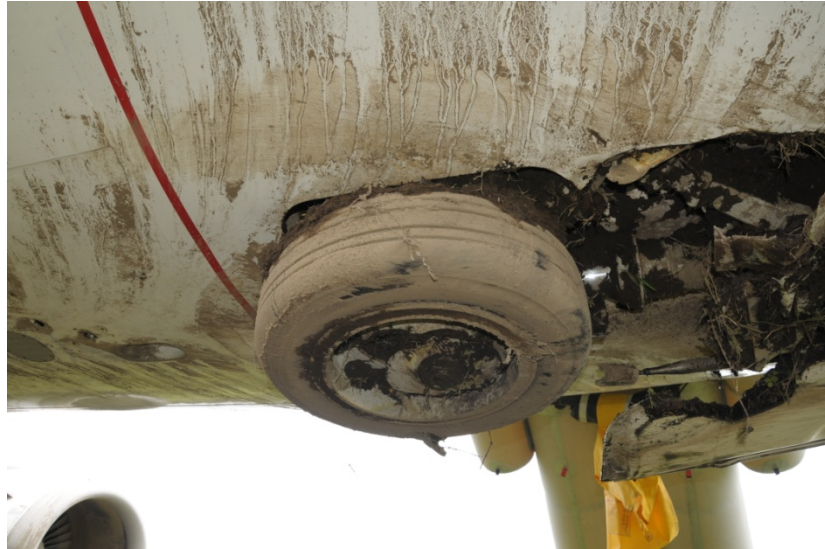
The aircraft hit the ground with nose landing gear and right main landing gear collapsed, damaged the aircraft bottom structure.

Figure 2: Nose wheel

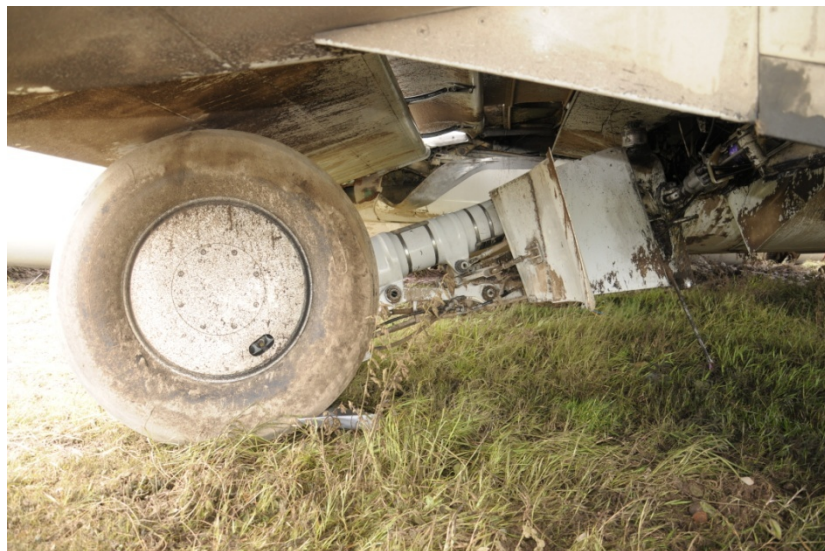
Figure 3: Right main gear.

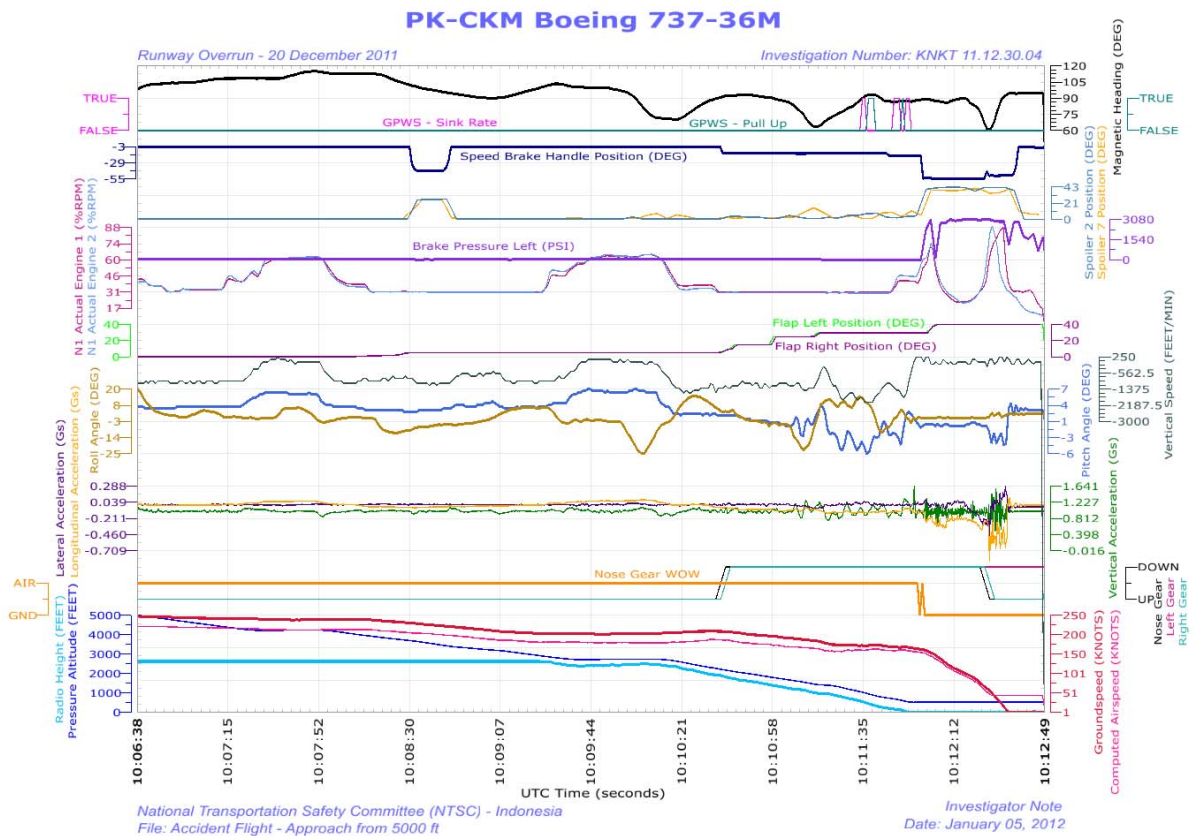
- The aircraft was at heading greater than 090 after started to descend left 2500 ft;
- At below 1000 ft, the aircraft heading was relatively constant;
- The rate of descend recorded vary and up to 1920 ft per minute and below 500 ft AGL, the rate of descend recorded up to 2040 ft per minute.
- The aircraft touched down at 10.12 UTC at speed 156 Kt before it bounced.
- The left and right engines indications were relatively equal during the approach phase. After landing, the N1 value increased then decreased to idle value and increased until the aircraft about to stop.
- The ground spoilers were extended, immediately after landing.
- The flap extended to 40 after the aircraft touch down.
- The brake pressures were relatively at maximum pressure from few moments after touch down until the aircraft stop.

Figure 5: The FDR data plot on approach started from altitude 5000 ft.

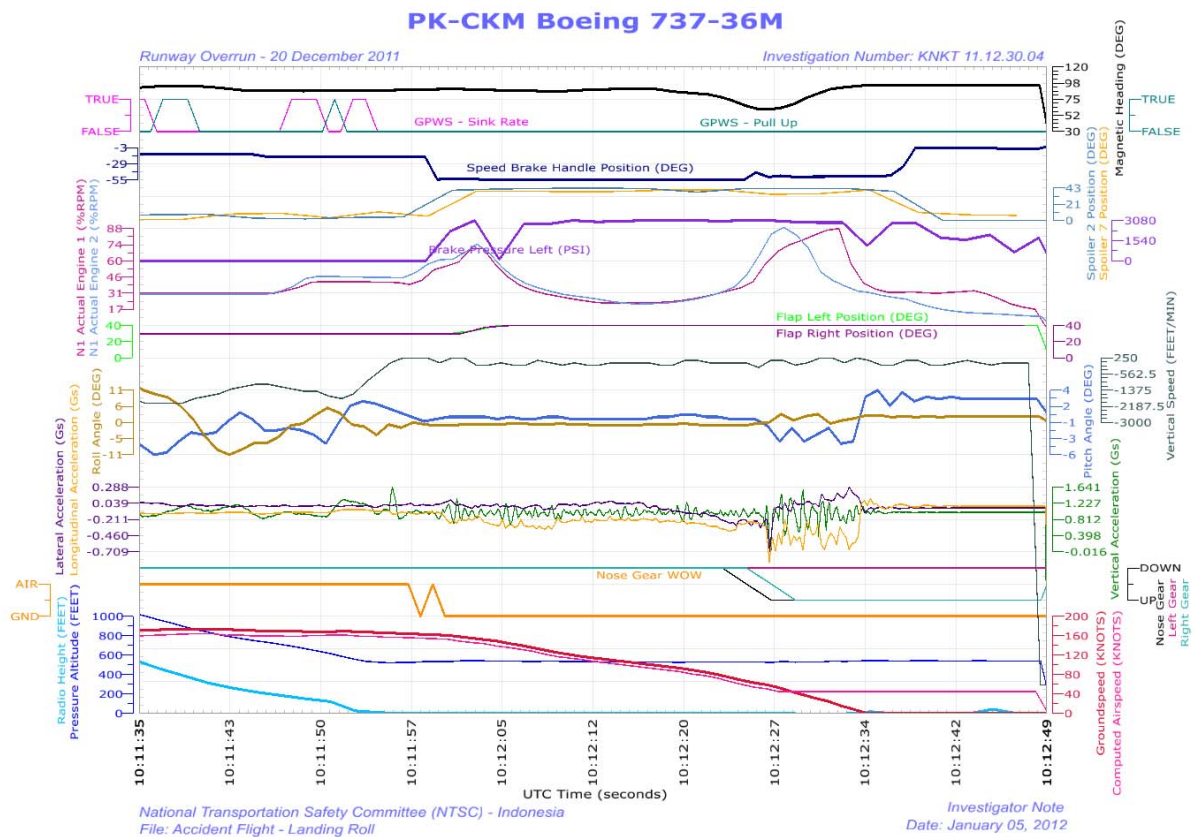
Figure 6: FDR data plot started from altitude 1000 feet.

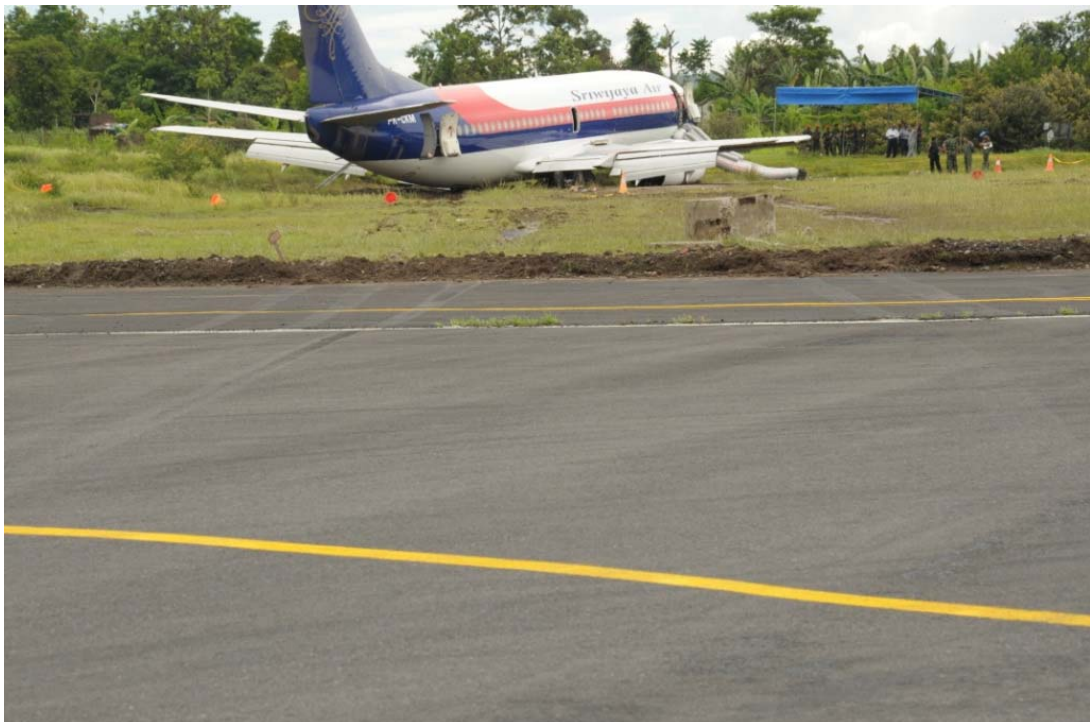
Aircraft tail position was 75 meters from the end of runway and 54 meters left side of runway centreline.

Figure 8: Aircraft final position

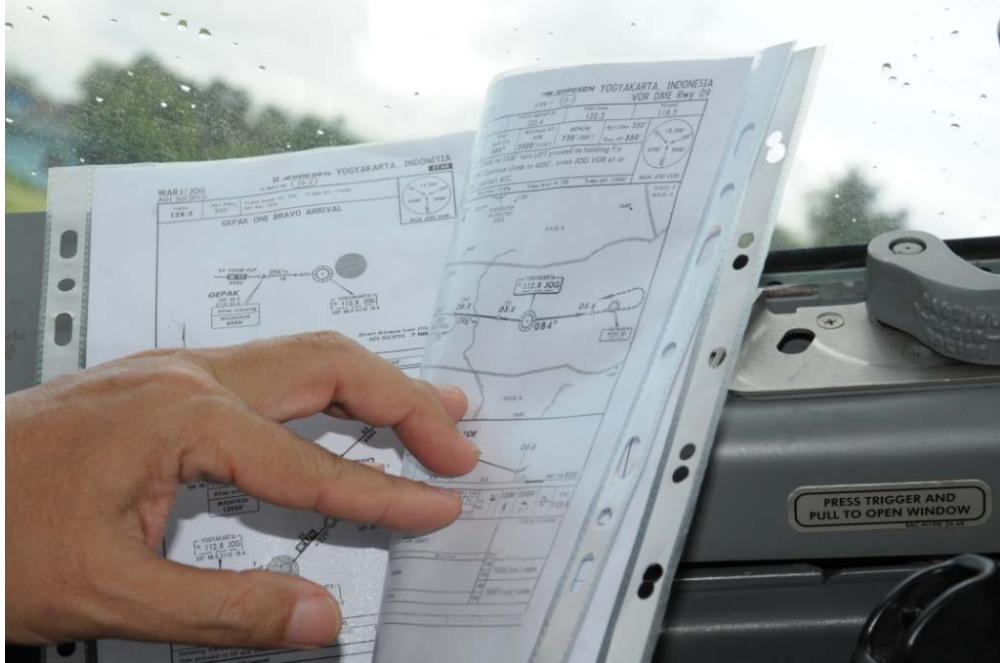
During the investigation it was found on the left writing pad holder found 3 pages of approach chart. The top page was ILS Approach runway 10 Surabaya, second page was ILS approach runway 09 Yogyakarta and the VOR/DME runway 09 on the other side of the page (face down) and the bottom page was Standard Arrival (STAR) runway 09 Yogyakarta.

Figure 9: Approach charts on the PIC pad folder.

The investigation found that the VOR/DME runway 09 was not ready to use on the PIC writing pad holder. The available approach chart was the ILS Approach runway 10 Surabaya. It also found that both pointers of the Radio Magnetic Indicator (RMI) on the left pilot were set to Automatic Direction Finding (ADF).

Missing the crew briefing and no approach chart available might have made the PF not familiar with the VOR/DME runway 09 approach path.
