NATIONAL TRANSPORTATION SAFETY COMMITTEE

Aircraft Serious Incident Investigation Report

PT. Garuda Indonesia

Boeing 737-300; PK-GGO

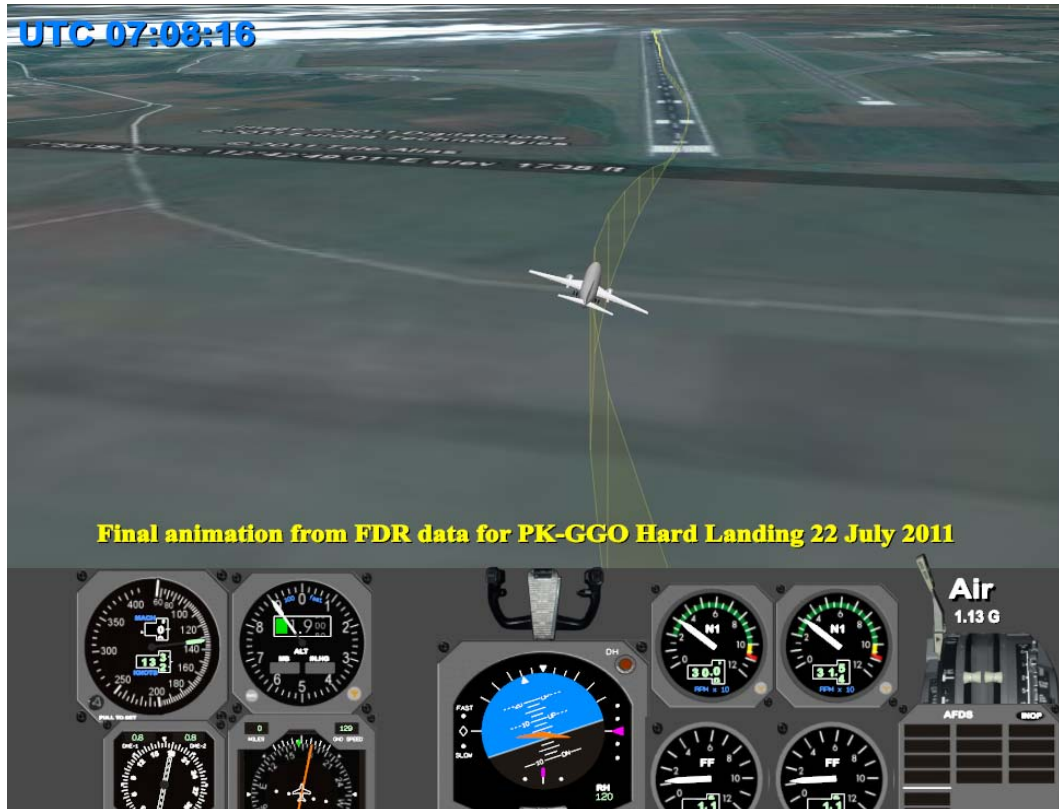
Figure 1: The flight profile from approximately 300 feet AGL based on FDR animation

The examination on the final segment from approximately 300 ft AGL found several significant events as follow:

1. The aircraft heading changed from 140°, 156°, 167° and 174°;
2. Roll angle changed from 15°, 21°, 15° and 9°.
3. Pitch angle changed from 0.8°, 1°, -0°, 4°, 1.7°, 3° and 6°.
4. Speed constantly decelerated from 140 to 118 knots during touchdown.
5. 4 seconds prior to touch down the calculation of rate of descend was 1,080 feet/minute.
6. The aircraft bounced and the first touchdown was 3.473 G.

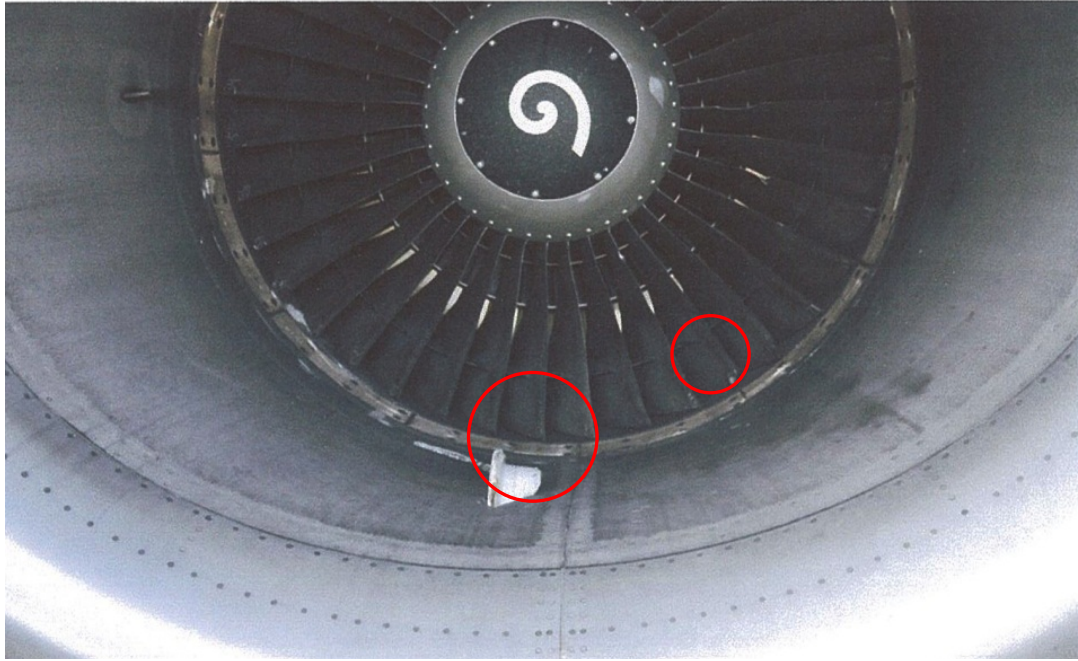
During the visual inspection, found that nose wheel hub broken, left engine inlet cowling and several vane blades damaged. Based on the finding of the initial inspection, the aircraft was grounded for further damage assessment and repair.

- Left nose wheel inner cylinder hub broken;
- Left nose tire worn out and deep cut;
- Right main landing gear cracked;
- Right nose tire deep cut;
- Left engine inlet cowling damage;
- Left engine blades 12ea damage;
- Left engine acoustic damage.

Figure 3: The damages on the left engine

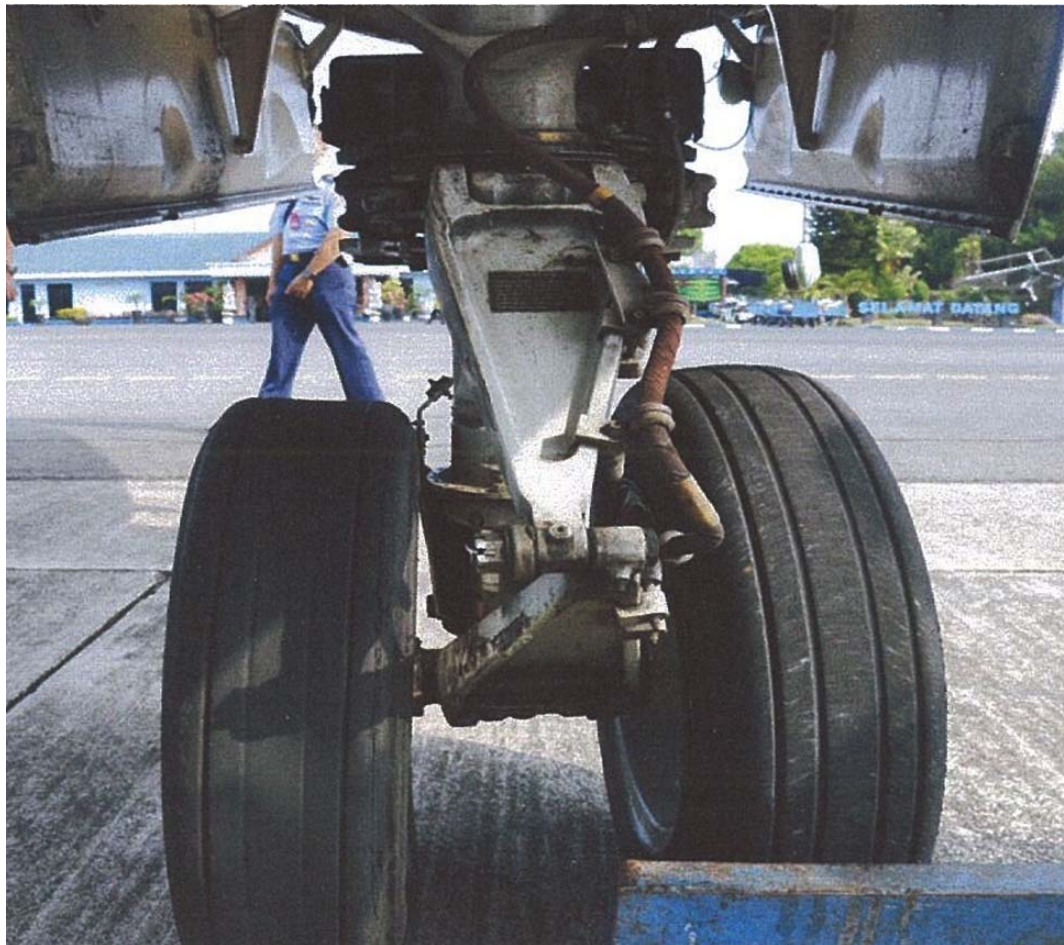
Figure4: The damage on the nose landing gear

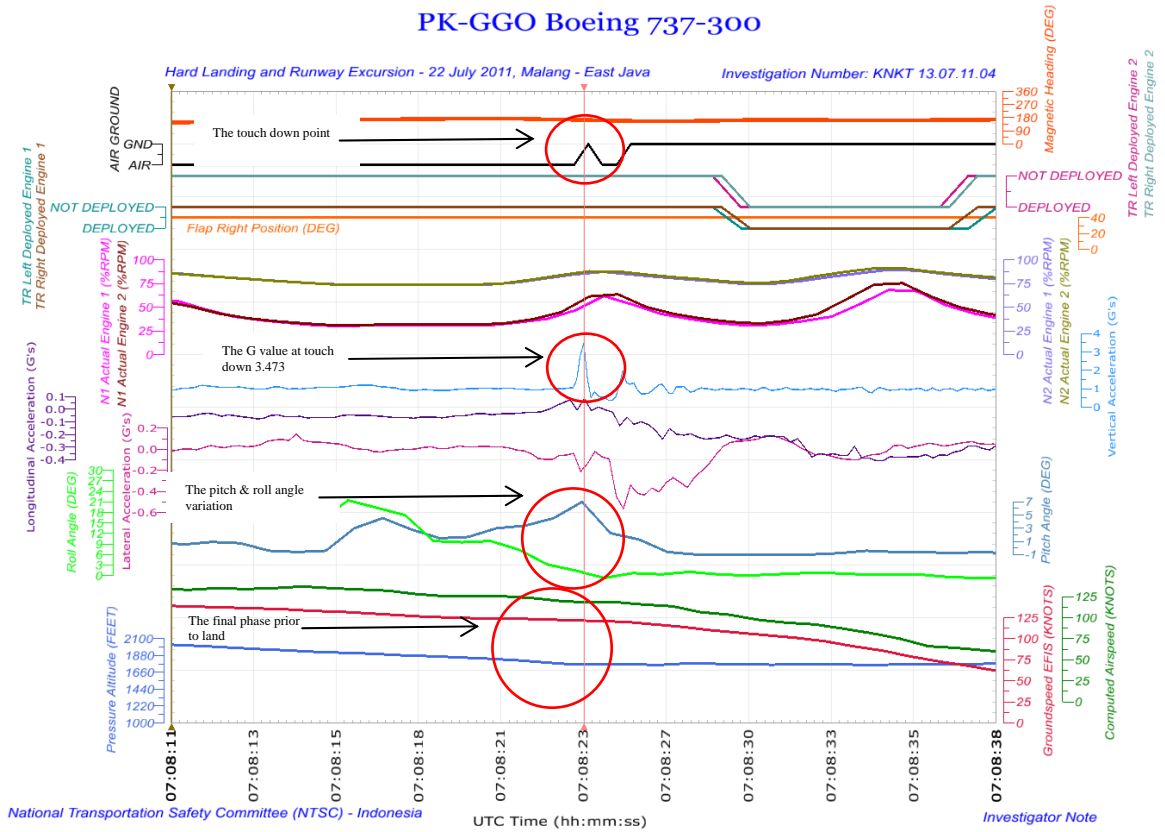
Figure 6: The FDR data of significant events on approach from approximate 300 ft (red circles)

The FDR graph above showed the aircraft roll angle and heading (in the red box) on approach from approximately 300 ft (AGL) prior to touch down and the yellow boxes indicated the touchdown.

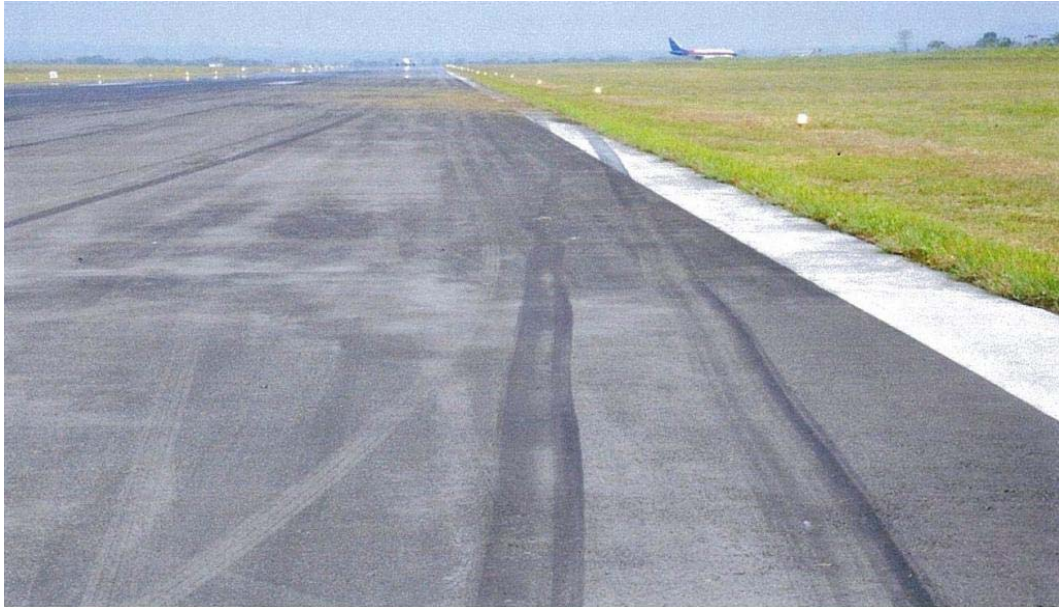
The tire marks of both main wheels and nose wheel were found on the runway surface. The marks started from touchdown at about 300 meters from the beginning of runway 17 heading to the right until the mark of the right main tire out of pavement at about 100 meters from the initial marks.

Figure7: The tire marks found on the runway

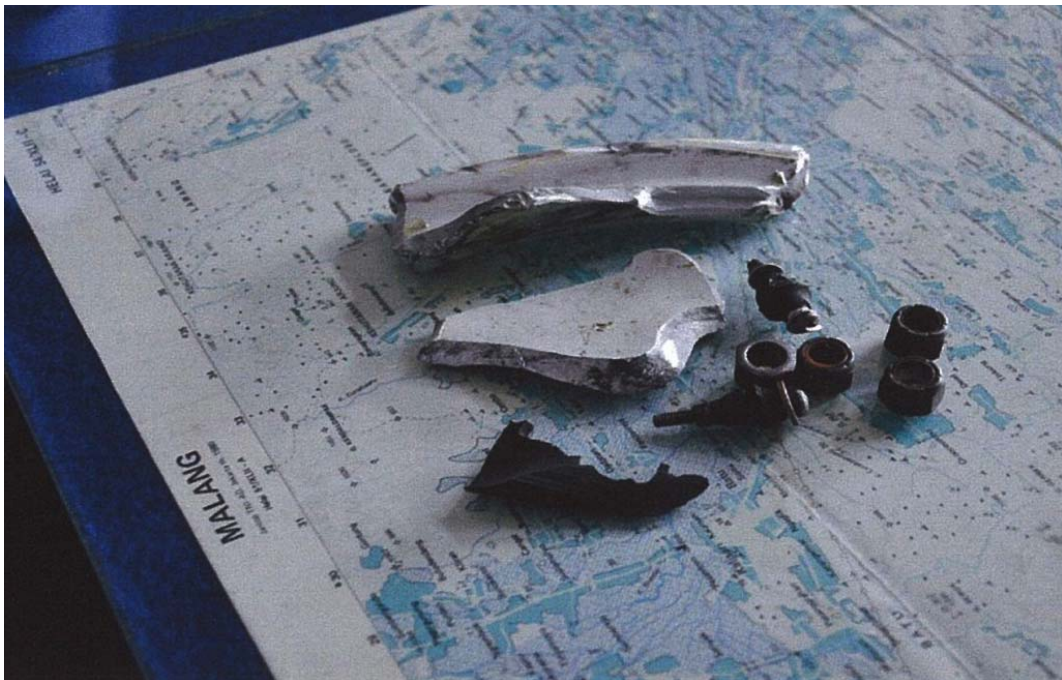
Following the report of hard landing, the local Airport Safety Officers conducted runway inspection. The inspection found some metal debris on the touchdown area of runway 17 which were parts of the nose wheel of the aircraft.

Some broken parts of nose wheel hub were found on the runway by Airport Safety Officer as shown on figure below.

Figure 8: The broken parts of nose wheel hub

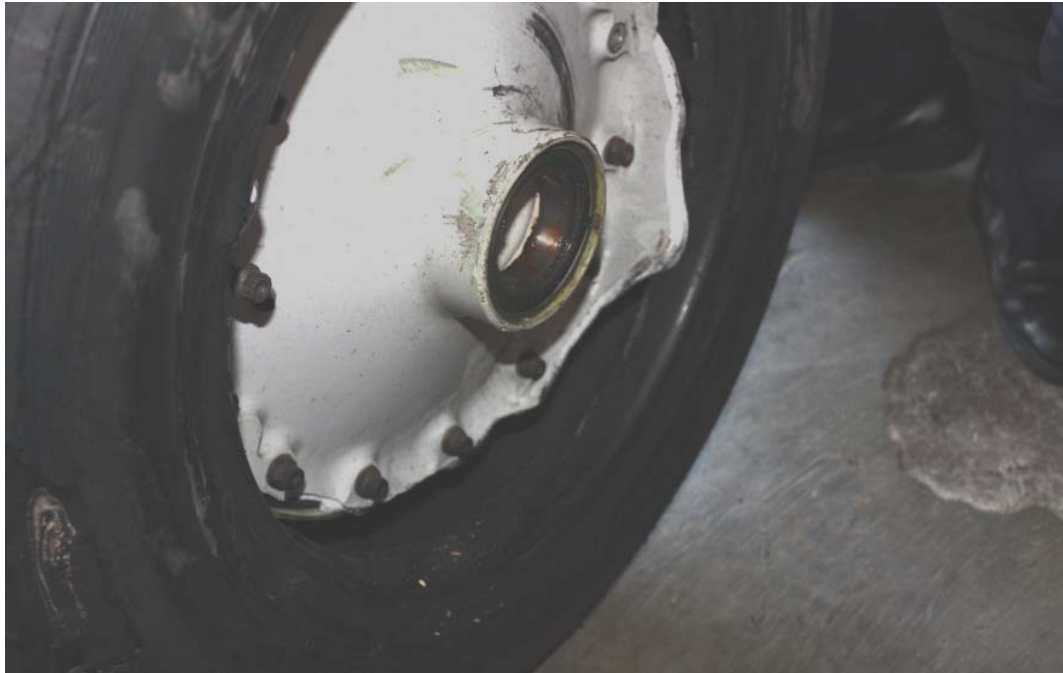
Figure 9: The damage on the nose wheel hub
